**NUMBER:** 23-026-13

Window Travel Calibration Malfunction

2013 (ZD) Viper

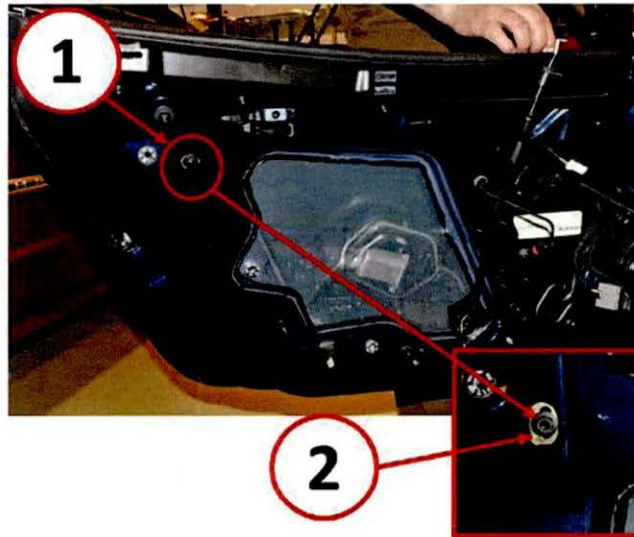
**Fig. 1 Window Up Stop Adjustment**

The door glass regulator up-stop that prevents the glass from over-travel is not adjusted correctly. If an over-travel situation occurs, such as the glass missing the seal channel, a new, closed position will be learned. This condition will result in auto reversals (anti-pinch) and eventually loss of calibration (several consecutive reversals).

1. This procedure is to be performed on both right and left door windows at same time even if only one is found to malfunction.
2. Lower the door window glass on both doors half way to allow for up-stop limit adjustment.
3. Remove the door panel on both doors. Refer to the detailed repair procedures available in: DealerConnect> TechCONNECT under: Service Info> 23 - Body> Door - Front> PANEL, Door Trim> Removal.
4. Loosen the window up-stop limit adjustment bolt (1) and tap area lightly to ensure up-stop limit bracket (2) drops down to bottom of slotted hole. (Fig. 1).

5. Close the doors while sitting in the vehicle.
6. Using WiTech, reset the door modules.
7. Using WiTech, raise the windows fully.
8. Tighten the up-stop limit adjustment bolt (1) to 7 +/- 2N-m.(Fig. 1).
