NUMBER: 23-027-13

Convertible Top Will Not Open

This bulletin describes a potential cause of convertible top malfunction and corrective action is covered.

2011	(JS)	Chrysler 200	
2012	(JS)	Chrysler 200	
2013	(JS)	Chrysler 200

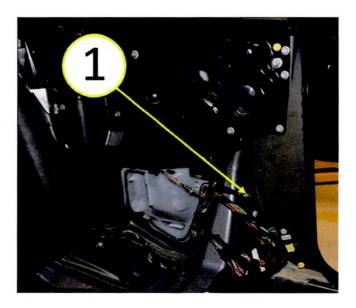
Fig. 5 Ground Connection Location

6. Locate the power top control module ground connection located behind the left quarter trim panel (Fig. 5).

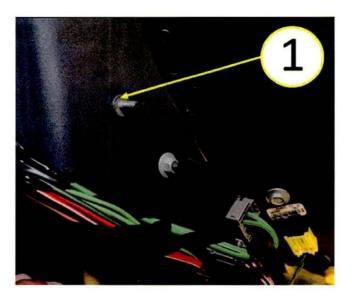
Fig. 7 Ground Connection Stud

8. Inspect the flat surface of the body grounding stud for paint and foreign material that may prevent a good electrical ground connection. Use emery cloth to clean the flat surface of the grounding stud to ensure good ground terminal contact (Fig. 7).
