NUMBER: 23-033-13

DATE: September 12, 2013

Wind Noise And Excessive Gap Left Front Door Handle

Durango

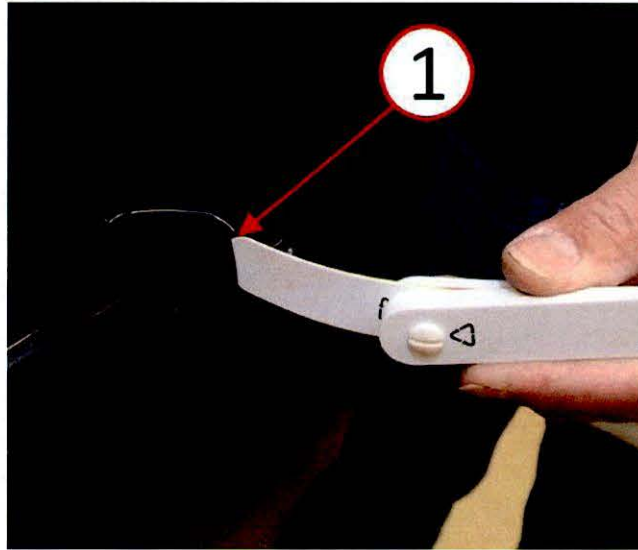
Fig. 9 Clearance Check

The customer may experience wind noise and/or note a large gap between the two pieces of the door handle.

10. Using a feeler gage or equivalent, verify whether the handle to cap gap is 1.0 - 1.5 mm (0.04 - 0.06 in.) (Fig. 9).
 - a. If not within specification, loosen the handle front fastener, then repeat step 9.
 - b. If within specification, proceed with step 11.
