NUMBER: 23-034-13

B-Pillar Body Creak Noise

2012-2013

500

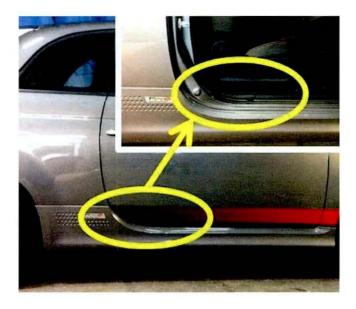
Fig. 1 B-Piller And Door Sill

Body creak noise coming from the passenger side lower B-pillar area during light acceleration, deceleration, and braking.

- 1. If the customer describes the symptom, perform the Diagnostic Procedure.
- 2. Roll up windows and power down all accessories to isolate vehicle interior from all other noise sources such as road noise, HVAC, audio system, etc.
- 3. Accelerate gently to 10 Mph (16 Kph) and brake gently to produce vehicle body movement or by slowly driving with the right rear wheel over an incline to apply a torsional motion to the body while listening for the creak noise.
- 4. Repeat several times to consistently duplicate the creaking noise and to determine if the noise is coming from the identified location (Fig. 1).

5. If noise can be duplicated and identified as a B-pillar creak noise, perform the Repair Procedure.
