**NUMBER:** 23-038-13

Left Front Door To Fender Contact

2014                      RT                                      Caravan / Town & Country

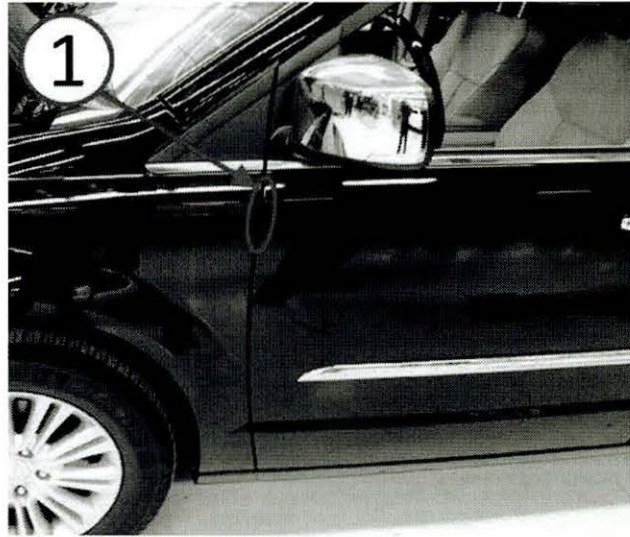
**Fig. 1 Door To Fender Contact**

Customer may note left front door to left front fender contact and/or chipped paint on door and/or fender edge near upper body character line (Fig. 1).

1 - Area Of Concern

1. If any of the following conditions exist, the left front fender will need to be adjusted relative to the left front door.
  - a. Inspect for any chipped paint caused by door to fender contact along the door edge and fender edge at the upper body character line (Fig. 1). If chipped paint is observed, the fender will require adjustment.
  - b. Carefully open the door while inspecting for any contact between the door and fender at upper body character line (Fig. 1). If contact is observed, the fender will require adjustment.
  - c. Using an appropriate non-marring gauge (4), check the flushness and/or gap (1) of the fender surface (2) relative to the door surface (3) at the upper body character line. If the fender surface (2) is less than flush relative to the door surface (3) as shown in (Fig. 2), the fender will require adjustment.

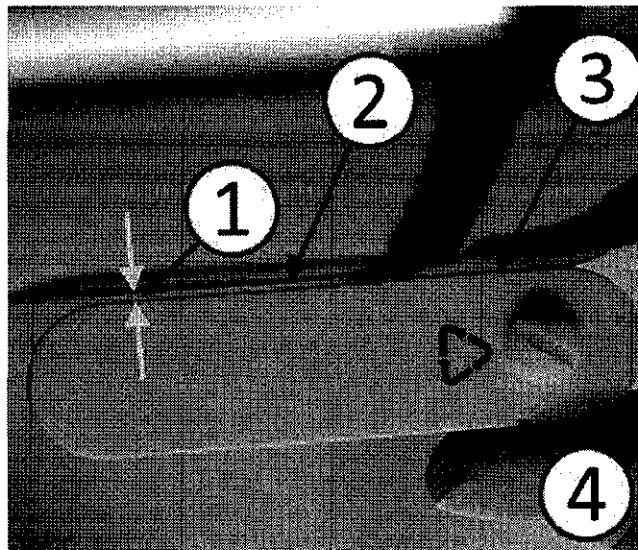
**Fig. 2 Fender Under Flush Of Door**

- 1 - Gap Between Gauge And Fender
- 2 - Fender Surface
- 3 - Door Surface
- 4 - Non-Marring Gauge

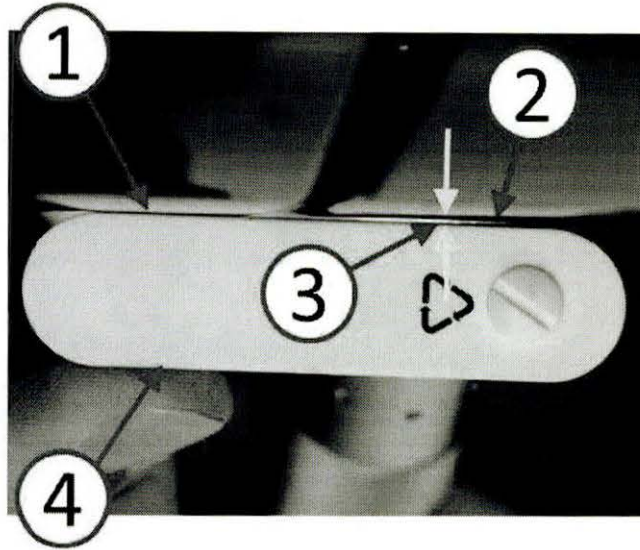
**Fig. 4 Fender Over Flush Of Door**

- 1 - Fender Surface
- 2 - Door Surface
- 3 - Gap Between Gauge And Door
- 4 - Non-Marring Gauge

- 
3. Remove the non-marring tool then inspect for any contact between the door and fender at upper body character line while opening and closing the door. Is any contact observed?
    - a. YES>>> Repeat Step #2.
    - b. NO>>> Proceed to Step #4
  4. Using the non-marring gauge (4), inspect the fender adjustment for flushness and/or gap (3) of the fender surface (1) relative to the door surface (2) at the upper body character line. Is the fender surface (1) flush or over-flush by 0.0 mm to 1.5 mm relative to the door surface (2) as shown (Fig. 4)?
    - a. YES>>> Proceed to Step #5.
    - b. NO>>> Repeat Step #2.
