NUMBER: 23-040-13

GROUP: Body

Front Seat Cushion Cover Appears To Be Cut Or Torn

2012 - 2013 (PF) Dart

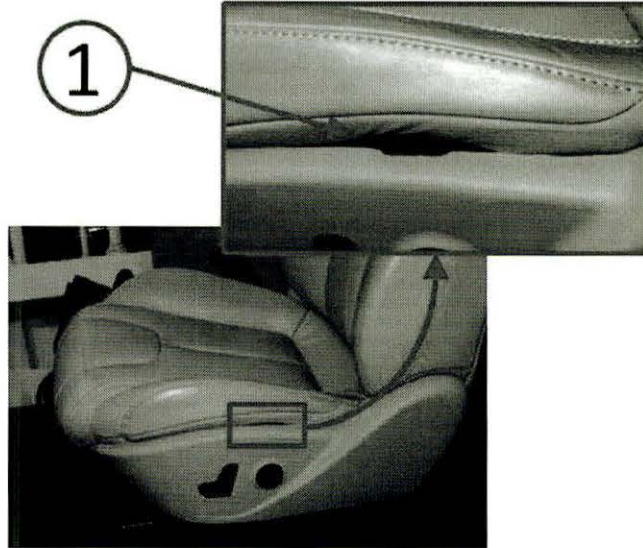
Fig. 1 Seat Cover Visible Side Panel Fabric

The customer may observe the edge of the seat cushion cover side fabric panel exposed above the edge of the plastic side shield giving the appearance that the seat is cut or torn.

1 - Visible Seat Cover Side Panel Fabric

1. Remove the front seat(s) with visible side panel fabric causing the customer concern. Refer to the detailed repair procedures available in: DealerConnect> TechCONNECT under: 23 - Body> Seats, Front> SEAT> Removal (Fig. 1).

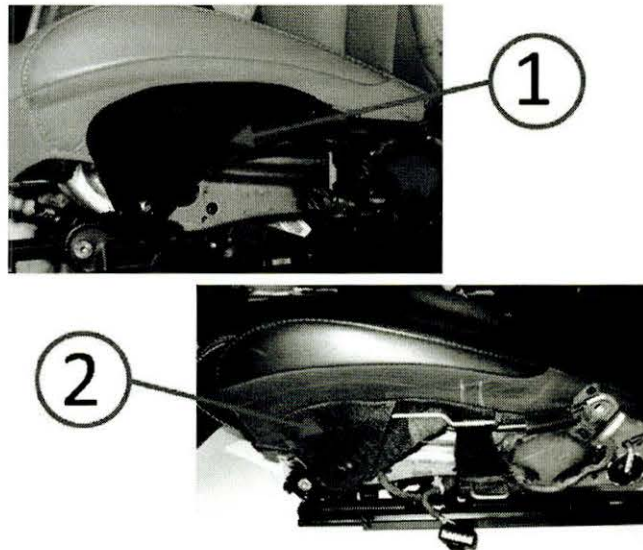
Fig. 2 Seat Cover Design Change

1 - Previous Design Seat Cushion Cover.

2 - Current Design Seat Cushion Cover.

-
2. Remove the previous design seat cushion cover (1) to be replaced with the current design seat cushion cover (2). Refer to the detailed repair procedures available in: DealerConnect> TechCONNECT under: 23 - Body> Seats, Front> COVER, Seat Cushion> Removal (Fig. 2).
