**NUMBER:** 25-001-13 REV. A

**GROUP:** Emissions Control

MIL Illumination Due to P2000, P2A00 and/or P2A01

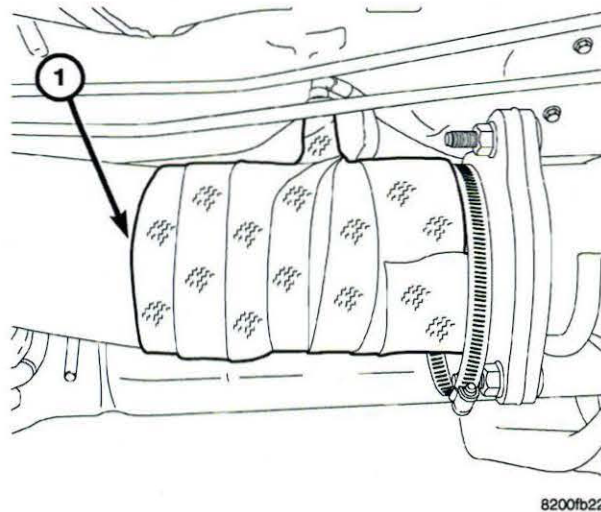
**Fig. 1 O2 SENSOR WRAP**

2. Inspect the front O2 sensor area of the exhaust for the presence of either a wrap or blanket (Fig. 1).

- 
3. Is there a wrap or blanket around the exhaust pipe in the area of the front O2 sensor?
    - a. YES>>>Proceed to the next step.
    - b. NO>>>Proceed to the Repair Procedure.
  4. Was the wrap/blanket installed properly and is not damaged or torn/tattered?
    - a. YES>>>This bulletin will not address the symptom/condition. Follow the diagnostic information provided in DealerCONNECT>TechCONNECT>Service Info>Group 28 DTC Based Diagnostics>Module, Engine control (ECM), 6.7L>Standard Procedure>PRE-DIAGNOSTIC TROUBLE SHOOTING PROCEDURE, 6.7L or DealerCONNECT>TechCONNECT>Service Info>Group 29 Non-DTC Diagnostics>Drivability - Diesel, 6.7L>Diagnosis and Testing>PRE-DIAGNOSTIC TROUBLE SHOOTING PROCEDURE, 6.7L.
    - b. NO>>>Proceed to the Repair Procedure.\*\*

1. Raise the vehicle on a hoist.
2. If the vehicle is already equipped with a wrap or blanket but this bulletin is being performed because they are damaged, remove the damaged wrap or blanket from the exhaust pipe.
3. Remove both upstream and downstream Oxygen (O2) sensors.
4. Remove the exhaust pipe. Refer to the procedures identified in DealerCONNECT>TechCONNECT>Service Info>11 - Exhaust System>PIPE, Exhaust>Removal>6.7L DIESEL for additional information.
5. Install heat shield (p/n 68102274AA). Refer to the procedures identified in the Instruction Sheet (p/n K6855747) for additional information.

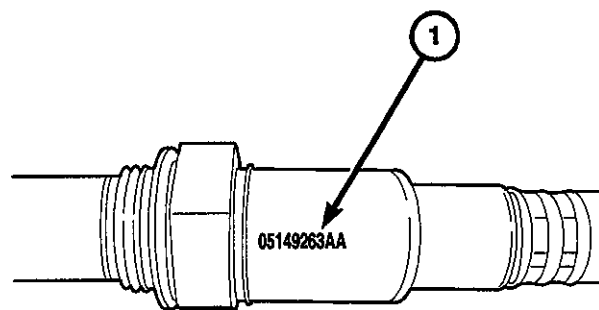
**Fig. 2 O2 SENSOR PART NUMBER LOCATION**

6. Install the exhaust pipe. Refer to the procedures identified in DealerCONNECT>TechCONNECT>Service Info>11 - Exhaust System>PIPE, Exhaust>Installation>6.7L DIESEL for additional information.
7. Inspect both O2 sensors to ensure that the latest sensors are installed in the vehicle. O2 sensors that have p/n 05149263AA (or later) scribed on the sensor, (Fig. 2) are the newer style sensor. If it is difficult to read the part number, the newer style sensor can easily be identified by the soot shield design on the sensor, (Fig. 3).

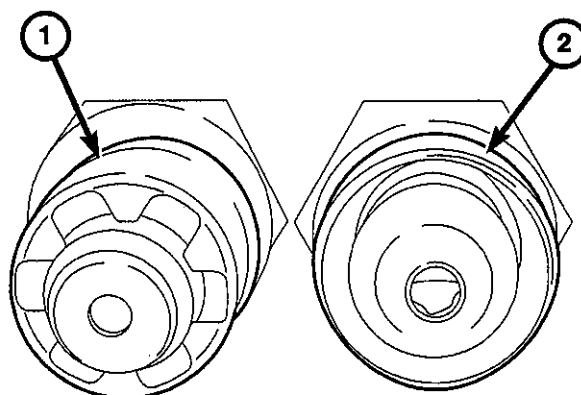
**Fig. 3 O2 SENSOR OLD VERSUS NEW**

1 - EARLY STYLE SOOT SHIELD (OLD SENSOR)

2 - NEW STYLE SOOT SHIELD (NEW SENSOR)

8. If the oxygen sensor is not scribed with p/n 05149263AA or newer or if the soot shield appears as the older style soot shield (as seen in (Fig. 3)), replace the oxygen sensors with p/n 05149263AA. If the oxygen sensors are to be reused, clean the O2 sensor using shop air only. **Do not use any solvents or cleaners when cleaning the O2 sensor.** Torque to 41 N•m (30 ft. lbs). Connect wiring to both of the Oxygen (O2) sensors.
