**NUMBER:** 25-001-13

**GROUP:** Emissions Control

**DATE:** January 25, 2013

MIL Illumination Due to P2000, P2A00 and/or P2A01

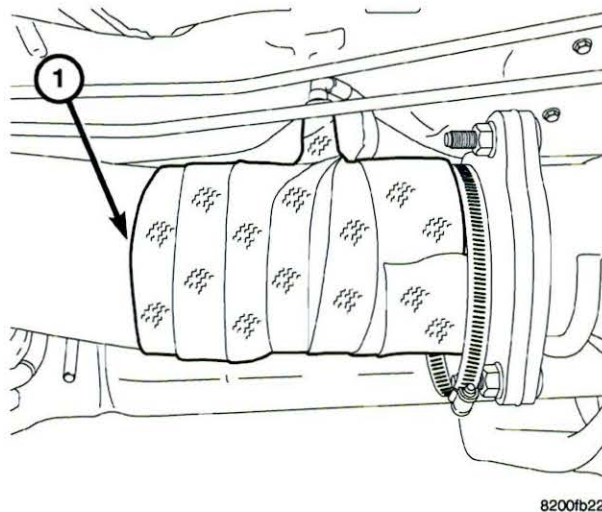
**Fig. 1 PROPER WRAP INSTALLATION**

**NOTE:** If the vehicle is equipped with an O2 sensor wrap, verify proper O2 sensor wrap installation, (**Fig. 1**). If the O2 sensor wrap has been installed properly and is not damaged or if the vehicle is equipped with an O2 sensor blanket and is not damaged, this bulletin will not address the symptom/condition. Follow the diagnostic information provided in DealerCONNECT>TechCONNECT>Service Info>Group 28 DTC Based Diagnostics>Module, Engine control (ECM), 6.7L>Standard Procedure>PRE-DIAGNOSTIC TROUBLE SHOOTING PROCEDURE, 6.7L or DealerCONNECT>TechCONNECT>Service Info>Group 29 Non-DTC Diagnostics>Drivability - Diesel, 6.7L>Diagnosis and Testing>PRE-DIAGNOSTIC TROUBLE SHOOTING PROCEDURE, 6.7L.

1 - O2 SENSOR WRAP

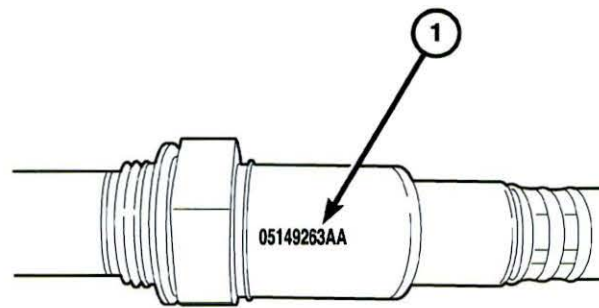
**Fig. 2 O2 SENSOR PART NUMBER LOCATION**

7. Inspect both O2 sensors to ensure that the latest sensors are installed in the vehicle. O2 sensors that have p/n 05149263AA (or later) scribed on the sensor, (Fig. 2) are the newer style sensor. If it is difficult to read the part number, the newer style sensor can easily be identified by the soot shield design on the sensor, (Fig. 3).

1 - O2 SENSOR PART NUMBER

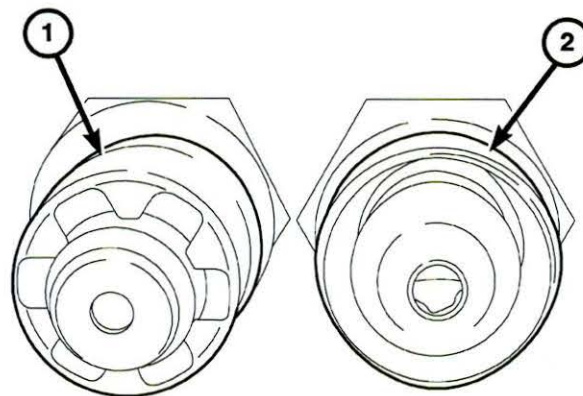
**Fig. 3 O2 SENSOR OLD VERSUS NEW**

1 - EARLY STYLE SOOT SHIELD (OLD SENSOR)

2 - NEW STYLE SOOT SHIELD (NEW SENSOR)

8. If the oxygen sensor is not scribed with p/n 05149263AA or newer or if the soot shield appears as the older style soot shield (as seen in (Fig. 3)), replace the oxygen sensors with p/n 05149263AA. If the oxygen sensors are to be reused, clean the O2 sensor using shop air only. **Do not use any solvents or cleaners when cleaning the O2 sensor.** Torque to 41 N•m (30 ft. lbs). Connect wiring to both of the Oxygen (O2) sensors.
