**NUMBER:** 25-003-13

**GROUP:** Emissions Control

**DATE:** February 28, 2013

Malfunction Indicator Lamp Illumination Due To Oxygen Sensor

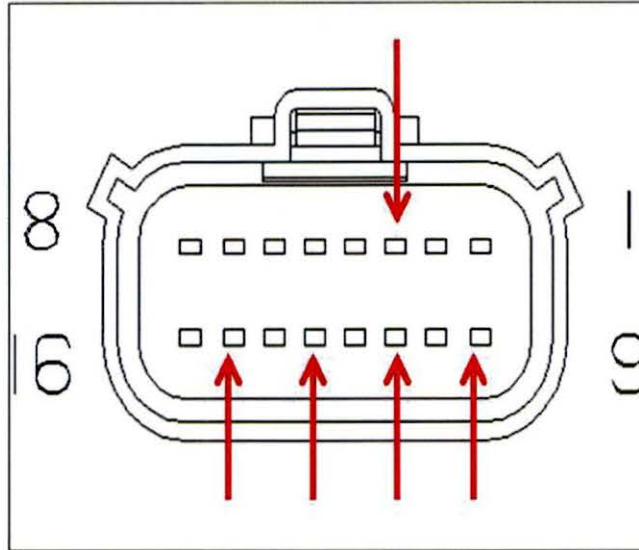
**Fig. 6 TERMINALS TO BE REPLACED**

This bulletin involves **inspecting for the part number of the transmission harness and based on the part number suffix, determining if the Oxygen Sensor Module Connector requires repair.** Some model year 2011 harness' were built with tin plated terminals in 5 of the connector cavities that should have been gold plated. Based on the transmission harness part number, the terminals will be replaced as required.

Replace Terminals Indicated By Red Arrows

8. Replace terminals #3, 9, 11, 13 & 15 (one at a time) as called out with RED ARROWS in (Fig. 6) with the gold terminal / pigtail included in Wire Repair Kit, p/n 68203454AA. The pigtail splice points should be staggered to eliminate bulk in the harness;

- a. Cut each wire, (one at a time) in a staggered manner.
  - b. Slide heat shrink tube on wire prior to splicing. Strip insulation on each wire and crimp together using band clamp **BEFORE SOLDERING** using Mopar splice band tool, p/n 05019912AA (or equivalent) then solder the crimped connection and heat shrink each wire individually.
