NUMBER: 25-004-13

DATE: September 12, 2013

I/M Readiness Check Continues To Indicate OBD System Is Not Ready For I/M Testing (X51 Lifetime Warranty Extension)

2005 - 2006 (TJ) Wrangler

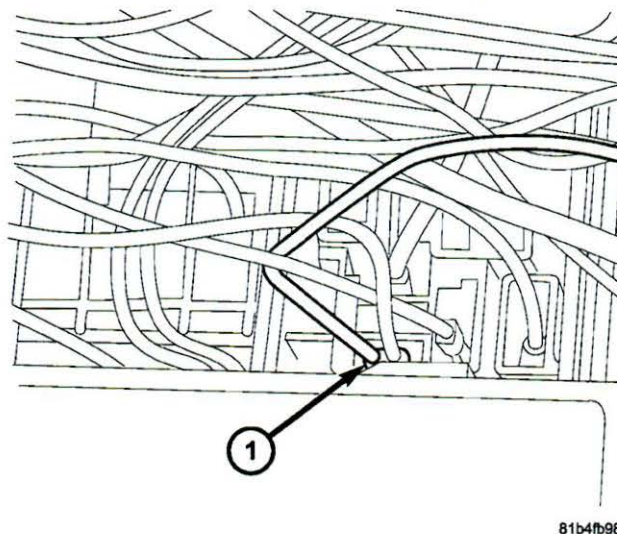
Fig. 1 TWO 20 GA. PK WT WIRES IN CAVITY A13

1 - TWO 20 GA. PK/WT WIRES - AT PDC CAVITY A13 (FOR ASD RELAY PIN 85)

1. Remove and isolate the positive and negative battery cables from the battery.
2. Remove the Power Distribution Center (PDC) cover from the PDC.
3. Locate the ASD (Auto Shut Down) and the Fuel Pump relays in the PDC.
4. Remove the two nuts used to secure the positive battery cable to the PDC. Remove the positive battery cable from the PDC.
5. Remove the PDC from its bracket and remove the cover from the bottom of the PDC to expose the underside wiring.
6. Locate the terminal end in PDC cavity A13 that connects to the ASD relay pin 85. Two 20 gauge wires, each of PK/WT color, are crimped to this terminal end (Fig. 1).

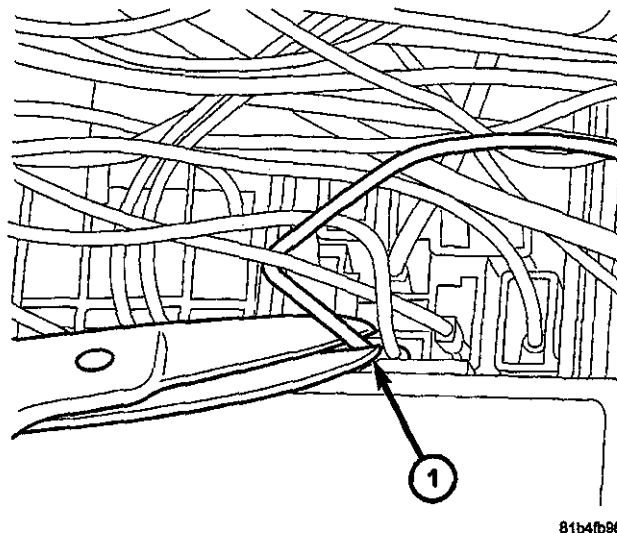
Fig. 2 CUT ASD 20 GA. PK WT TO FUEL PUMP

1 - CUT PDC CAVITY A13 PKWT WIRE THAT GOES TO THE FUEL PUMP RELAY CLOSE TO TERMINAL

7. At PDC cavity A13 (ASD), locate the one PK/WT wire that connects to the fuel pump relay terminal.
8. Cut the PK/WT wire, that connects to the fuel pump relay, as close to the PDC cavity A13 terminal as possible (Fig. 2).

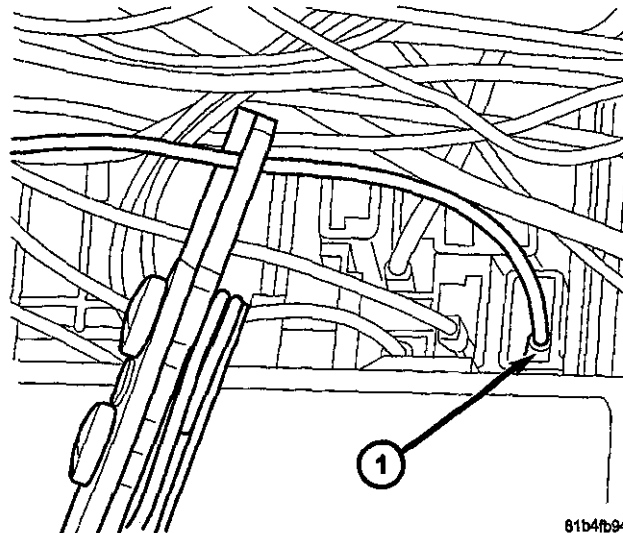
Fig. 3 CUT ASD 18 GA. RD YL WIRE IN CAVITY A15

1 - CUT PDC CAVITY A15 18 GA. RD/YL WIRE THAT GOES TO ASD RELAY PIN 30 TWO INCHES FROM TERMINAL

12. Locate the RD/YL 18 gauge wire connected to the terminal end in PDC cavity A15. This wire connects the ASD relay pin 30 to fuse #9 (ASD power) in the PDC.
13. Cut this wire approximately 2 inches from the PDC cavity A15 terminal (ASD relay pin 30) (Fig. 3).

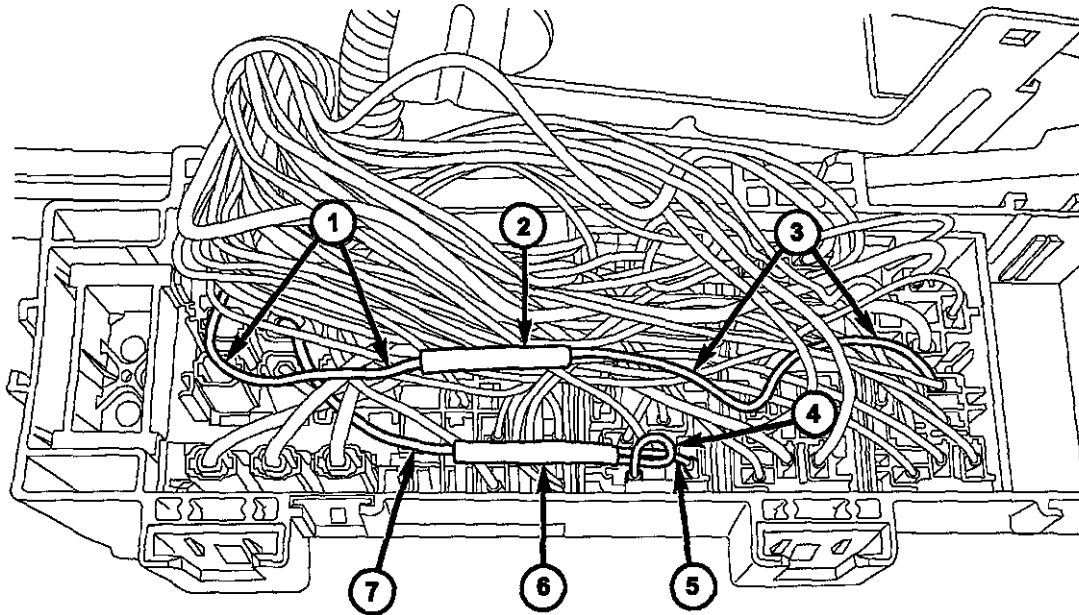
Fig. 4 COMPLETED WIRE SPLICES

- 1 - 20 gauge PK/WT wire from wire harness bundle with convolute
- 2 - Splice repair (2 wires)
- 3 - 20 gauge PK/WT wire from fuel pump relay
- 4 - 20 gauge PK/WT wire from PDC cavity A13 for ASD relay pin 85
- 5 - 18 gauge RD/YL wire from PDC cavity A15 for ASD relay pin 30
- 6 - Splice Repair (3 wires)
- 7 - 18 gauge RD/YL wire from PDC fuse #9 for ASD power

-
14. Strip approximately 0.25 inches of insulation from both ends of the RD/YL wire cut in Step #13.
 15. Splice the two RD/YL wires to the one remaining PK/WT wire (2 inch lead at A13) together (Fig. 4). **Be sure to slide shrink tube over wire before crimping.** Splice the wires with kit p/n 05018395AA.
 16. After both splices are complete, solder crimp splices with non-acid core solder.
 17. Slide shrink tube over soldered splices and shrink with a heat gun until sealant is visible on both ends of the splice (Fig. 4).
