NUMBER: 25-005-13 REV. A

I/M Readiness Check Continues To Indicate OBD System Is Not Ready For I/M Testing (X51 Lifetime Warranty Extension)

This bulletin involves modifying wiring in the Power Distribution Center (PDC).

2005 - 2006 (TJ) Wrangler

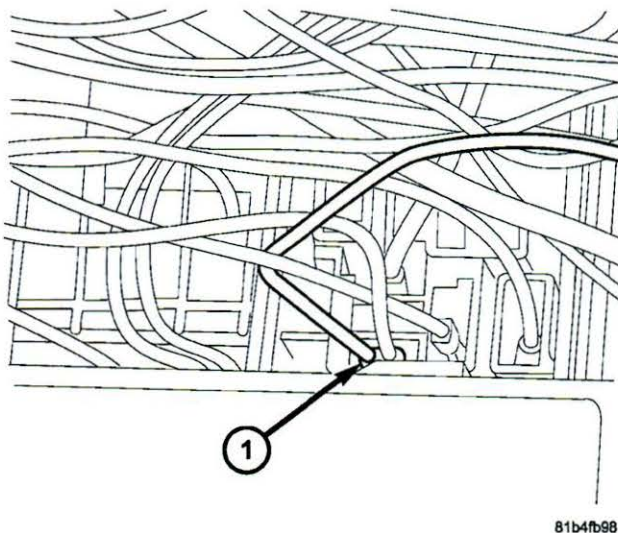
Fig. 1 TWO 20 GA. PK WT WIRES IN CAVITY A13

1 - TWO 20 GA. PK/WT WIRES - AT PDC CAVITY A13 (FOR ASD RELAY PIN 85)

1. Remove and isolate the positive and negative battery cables from the battery.
2. Remove the Power Distribution Center (PDC) cover from the PDC.
3. Locate the ASD (Auto Shut Down) and the Fuel Pump relays in the PDC.
4. Remove the two nuts used to secure the positive battery cable to the PDC. Remove the positive battery cable from the PDC.
5. Remove the PDC from its bracket and remove the cover from the bottom of the PDC to expose the underside wiring.
6. Locate the terminal end in PDC cavity A13 that connects to the ASD relay pin 85. Two 20 gauge wires, each of PK/WT color, are crimped to this terminal end (Fig. 1).

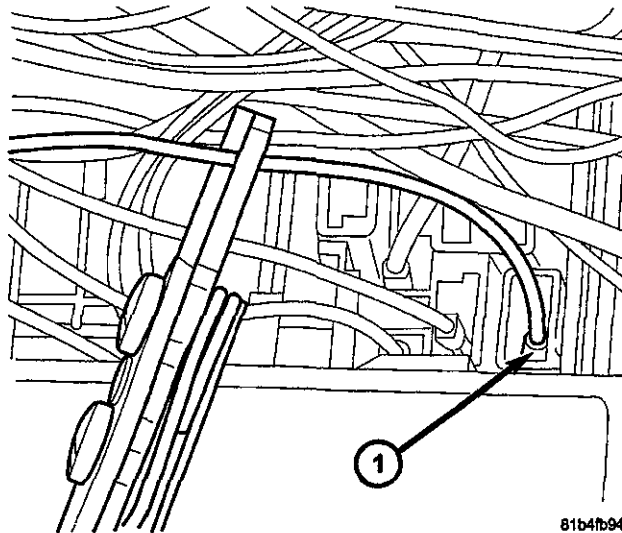
Fig. 3 CUT ASD 18 GA. RD YL WIRE IN CAVITY A15

1 - CUT PDC CAVITY A15 18 GA. RD/YL WIRE THAT GOES TO ASD RELAY PIN 30 TWO INCHES FROM TERMINAL

12. Locate the RD/YL 18 gauge wire connected to the terminal end in PDC cavity A15. This wire connects the ASD relay pin 30 to fuse #9 (ASD power) in the PDC.
13. Cut this wire approximately 2 inches from the PDC cavity A15 terminal (ASD relay pin 30) (Fig. 3).

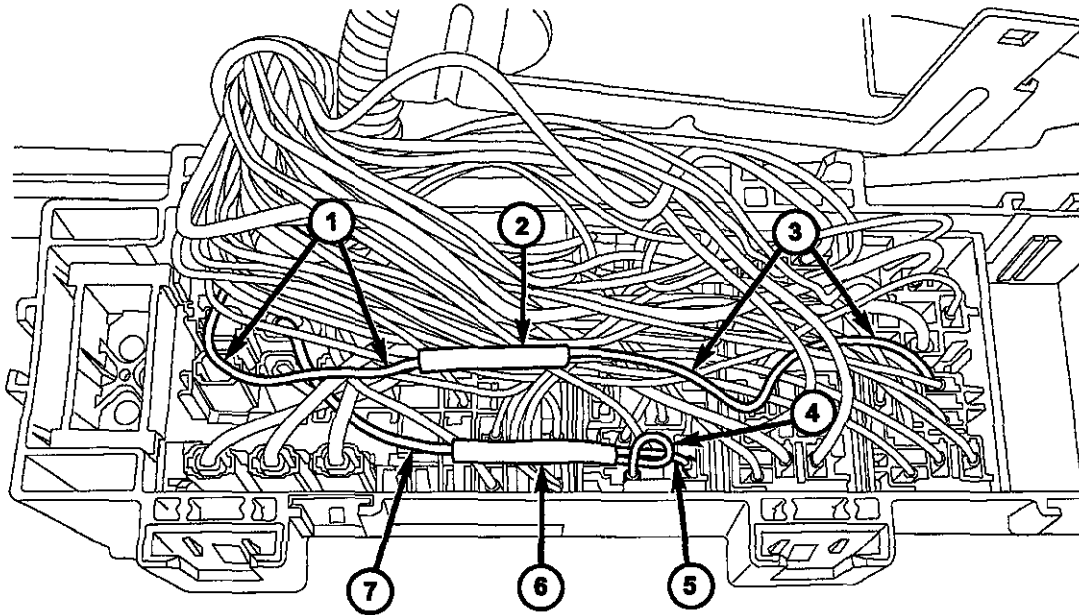
Fig. 4 COMPLETED WIRE SPLICES

- 1 - 20 gauge PK/WT wire from wire harness bundle with convolute
- 2 - Splice repair (2 wires)
- 3 - 20 gauge PK/WT wire from fuel pump relay
- 4 - 20 gauge PK/WT wire from PDC cavity A13 for ASD relay pin 85
- 5 - 18 gauge RD/YL wire from PDC cavity A15 for ASD relay pin 30
- 6 - Splice Repair (3 wires)
- 7 - 18 gauge RD/YL wire from PDC fuse #9 for ASD power

-
14. Strip approximately 0.25 inches of insulation from both ends of the RD/YL wire cut in Step #13.
 15. Splice the two RD/YL wires to the one remaining PK/WT wire (2 inch lead at A13) together (Fig. 4). **Be sure to slide shrink tube over wire before crimping.** Splice the wires with kit p/n 05018395AA.
 16. After both splices are complete, solder crimp splices with non-acid core solder.
 17. Slide shrink tube over soldered splices and shrink with a heat gun until sealant is visible on both ends of the splice (Fig. 4).
