NUMBER: 25-005-13
GROUP: Emissions Control
DATE: September 12, 2013

I/M Readiness Check Continues To Indicate OBD System Is Not Ready For I/M Testing (X51 Lifetime Warranty Extension)

2005 - 2006 (TJ) Wrangler

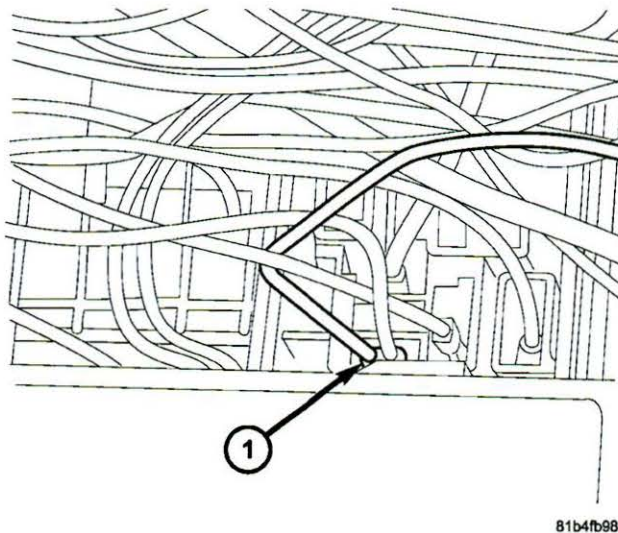
Fig. 1 TWO 20 GA. PK WT WIRES IN CAVITY A13

1 - TWO 20 GA. PK/WT WIRES - AT PDC CAVITY A13 (FOR ASD RELAY PIN 85)

1. Remove and isolate the positive and negative battery cables from the battery.
2. Remove the Power Distribution Center (PDC) cover from the PDC.
3. Locate the ASD (Auto Shut Down) and the Fuel Pump relays in the PDC.
4. Remove the two nuts used to secure the positive battery cable to the PDC. Remove the positive battery cable from the PDC.
5. Remove the PDC from its bracket and remove the cover from the bottom of the PDC to expose the underside wiring.
6. Locate the terminal end in PDC cavity A13 that connects to the ASD relay pin 85. Two 20 gauge wires, each of PK/WT color, are crimped to this terminal end (Fig. 1).

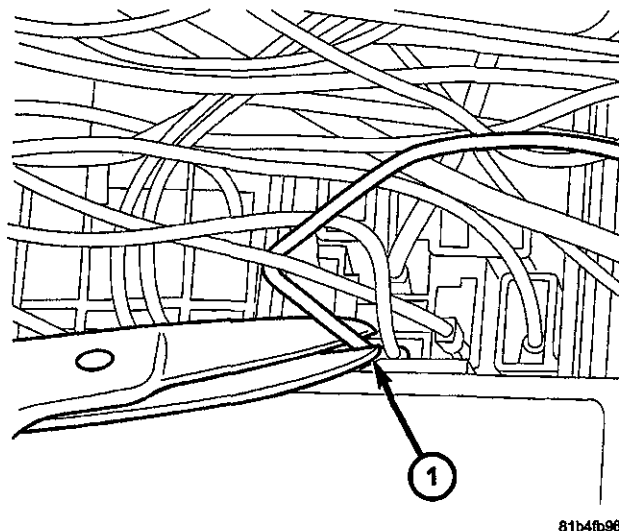
Fig. 2 CUT ASD 20 GA. PK WT TO FUEL PUMP

1 - CUT PDC CAVITY A13 PK/WT WIRE THAT GOES TO THE FUEL PUMP RELAY CLOSE TO TERMINAL

7. At PDC cavity A13 (ASD), locate the one PK/WT wire that connects to the fuel pump relay terminal.
8. Cut the PK/WT wire, that connects to the fuel pump relay, as close to the PDC cavity A13 terminal as possible (Fig. 2).

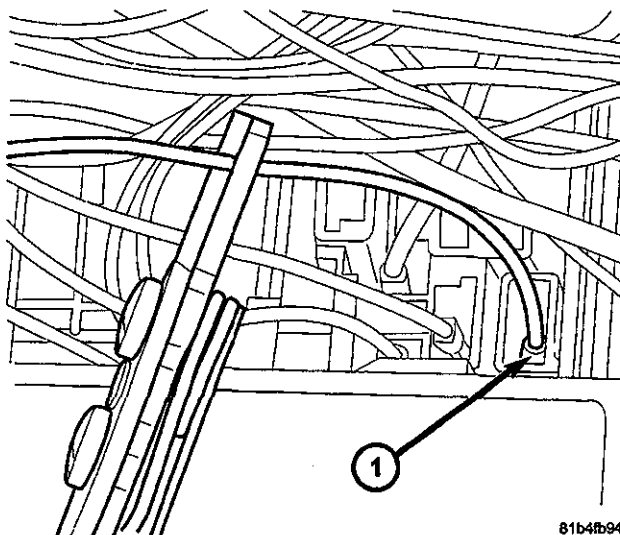
Fig. 3 CUT ASD 18 GA. RD YL WIRE IN CAVITY A15

1 - CUT PDC CAVITY A15 18 GA. RD/YL WIRE THAT GOES TO ASD RELAY PIN 30 TWO INCHES FROM TERMINAL

12. Locate the RD/YL 18 gauge wire connected to the terminal end in PDC cavity A15. This wire connects the ASD relay pin 30 to fuse #9 (ASD power) in the PDC.
13. Cut this wire approximately 2 inches from the PDC cavity A15 terminal (ASD relay pin 30) (Fig. 3).

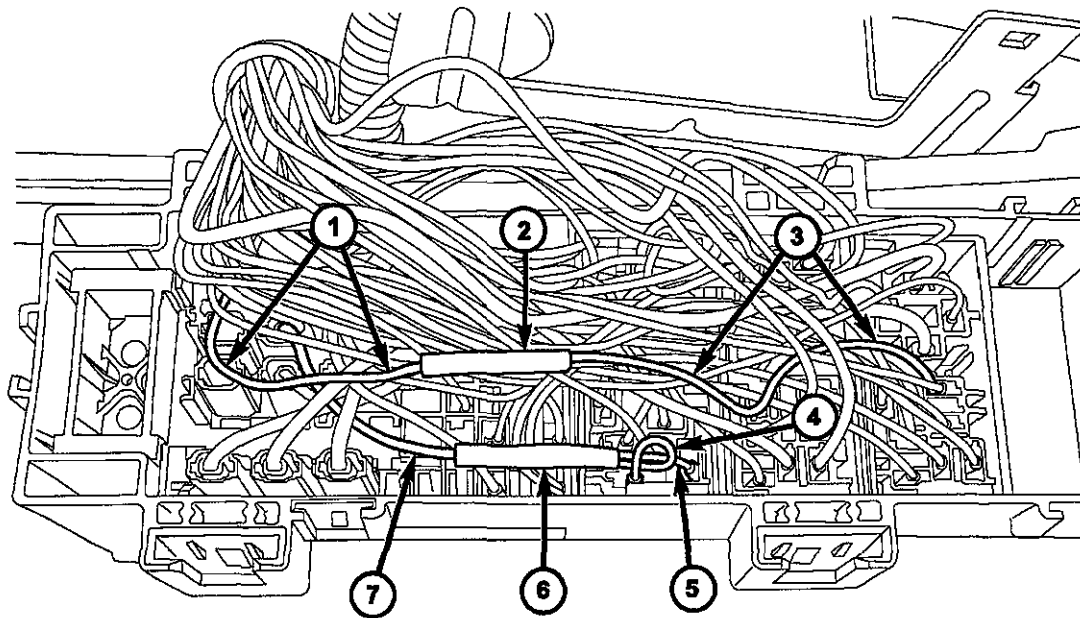
Fig. 4 COMPLETED WIRE SPLICES

- 1 - 20 gauge PK/WT wire from wire harness bundle with convolute
- 2 - Splice repair (2 wires)
- 3 - 20 gauge PK/WT wire from fuel pump relay
- 4 - 20 gauge PK/WT wire from PDC cavity A13 for ASD relay pin 85
- 5 - 18 gauge RD/YL wire from PDC cavity A15 for ASD relay pin 30
- 6 - Splice Repair (3 wires)
- 7 - 18 gauge RD/YL wire from PDC fuse #9 for ASD power

-
14. Strip approximately 0.25 inches of insulation from both ends of the RD/YL wire cut in Step #13.
 15. Splice the two RD/YL wires to the one remaining PK/WT wire (2 inch lead at A13) together (Fig. 4). **Be sure to slide shrink tube over wire before crimping.** Splice the wires with kit p/n 05018395AA.
 16. After both splices are complete, solder crimp splices with non-acid core solder.
 17. Slide shrink tube over soldered splices and shrink with a heat gun until sealant is visible on both ends of the splice (Fig. 4).
