TECHNICAL BULLETIN  
 UPS4812-6bNAS2  
 31 MAY 2013

Update Prior to Sale: Front Sub Frame Bolts Incorrectly Torqued

**XF (X250)**  
**Model Year:** 2012-2013  
**VIN:** S60251-S62610

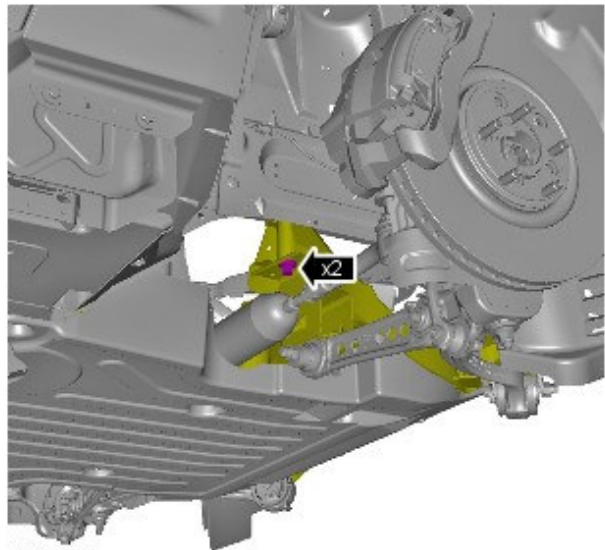
**NOTE: Right-hand shown; left-hand similar.**

Remove and discard the front subframe right-rear bolt.

3. Install a new front subframe right-rear bolt.
  - Tighten the new bolt to 80Nm + 240°
4. Remove and discard the front subframe left-rear bolt.
5. Install a new front subframe left-rear bolt.
  - Tighten the new bolt to 80Nm + 240°

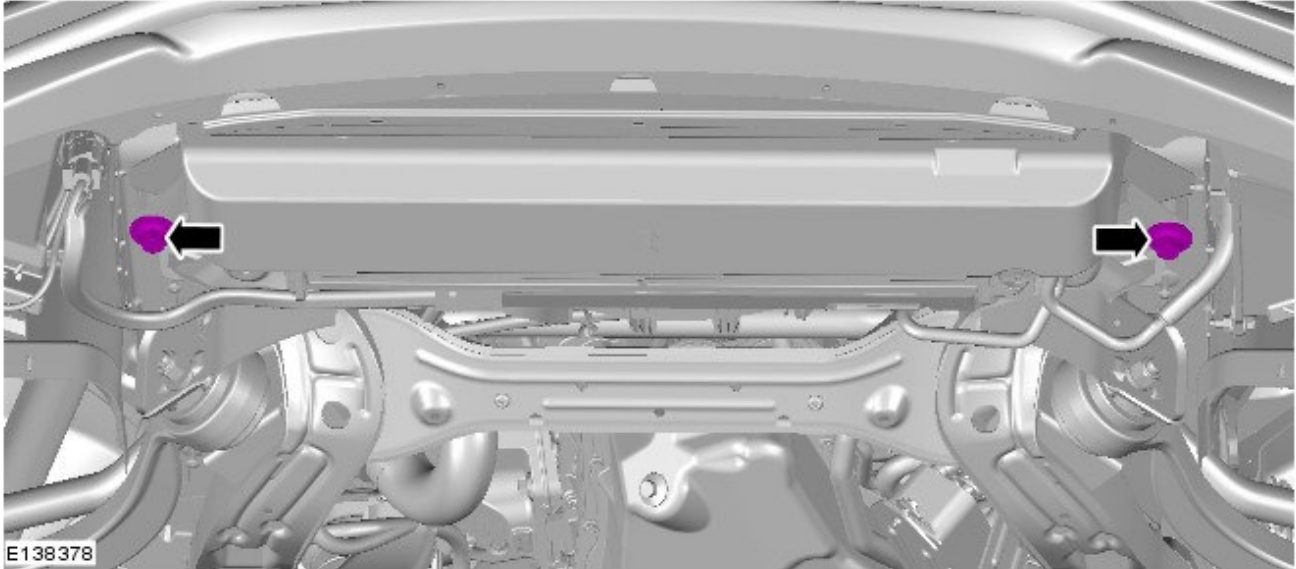
**NOTE: Do not loosen / remove the bolts.**

With a torque wrench set to 250Nm (185 lbf ft), over-check the torque of the front subframe right-front and left-front bolts.
