Service Bulletin

Bulletin No.: PIC5836B

Subject: Rattle Or Buzz Noise From Rear Speaker Or Speakers Worse With High Bass Levels

Models: 2013 Cadillac ATS

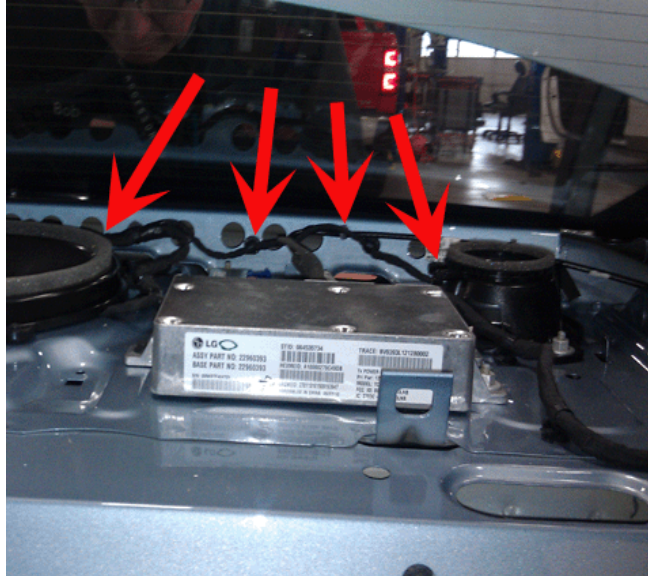
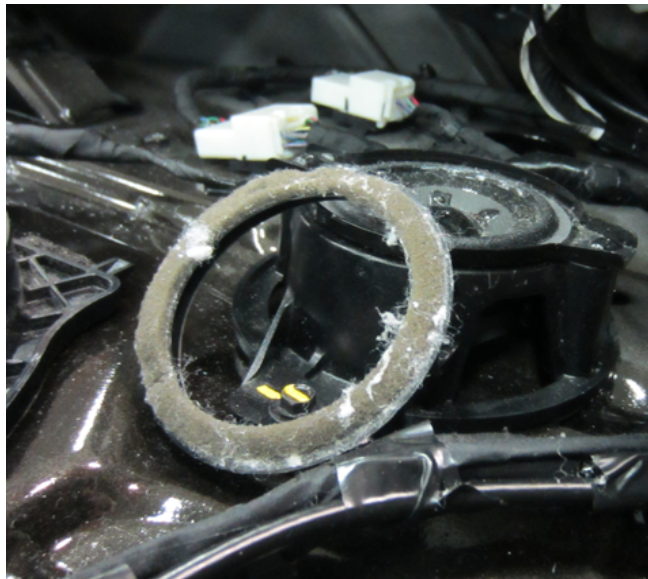
1. Improper speaker mounting or loose trim, wiring harnesses, or other parts may cause an audible buzz or distortion.
2. Rattle or buzz from the OnStar module.
3. Seat belt retractor buzz - center seat belt retractor bolt may be contacting decklid torque rod inside trunk causing metallic rattle.
4. Child tether cover may be loose in package shelf trim.
5. Package shelf trim and / or trunk upper trim plastic Christmas tree fasteners may buzz to shelf at attachment holes.
6. Leading edge of package shelf, behind rear seat back.
7. Package shelf "J" hooks loose.

1. Inspect the rear speaker and the surrounding interior trim for proper and secure mounting. If the speaker trim has come loose, replace the speaker. If surrounding interior trim is found to be loose or improperly secured, correctly secure the item and add foam to insulate items as needed. Add foam to the subwoofer speaker connector to prevent contact to the under shelf trim from making contact. Use 1/2" by 5/16" of Kent Adhesive Backed Shim Stock (foam) p/n P40125 or equivalent.
