Service Bulletin

Bulletin No.: PIC5836A

Subject: Rattle Or Buzz Noise From Rear Speaker Or Speakers Worse With High Bass Levels

Models: 2013 Cadillac ATS

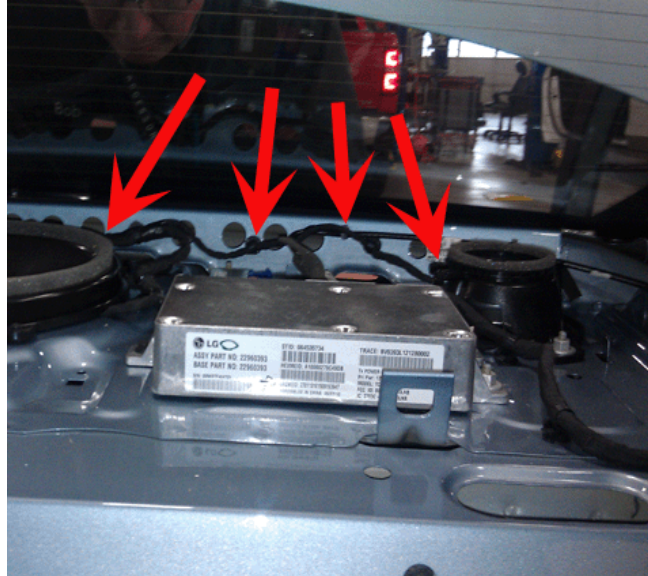
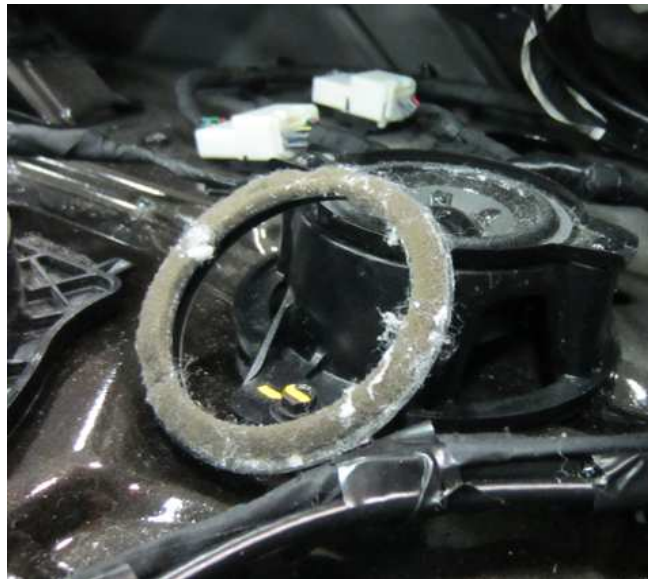
The rear speaker(s) generally is NOT the cause of this issue. Possible causes include:

1. Inspect the rear speaker and the surrounding interior trim for proper and secure mounting. If the speaker trim has come loose, replace the speaker. If surrounding interior trim is found to be loose or improperly secured, correctly secure the item and add foam to insulate items as needed. Add foam to the subwoofer speaker connector to prevent contact to the under shelf trim from making contact. Use 1/2" by 5/16" of Kent Adhesive Backed Shim Stock (foam) P/N P40125 or equivalent.
