# Service Bulletin

Bulletin No.: PIC5835

**Subject:** Front Strut Replacement On Former Police Vehicles Now Out Of Service

**Models:** 2006 - 2011 Impala Former Police Vehicles  
with RPO 9C1 or 9C3

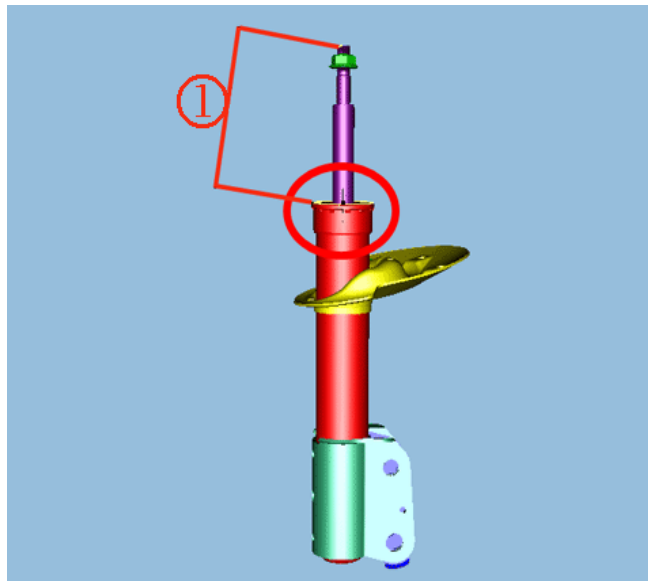
3339233

1. GM P/N 19257874 - 154.44 mm from top of rod to striker plate (Note: smaller strut cap)
2. GM P/N 22796874 - 130.71 mm from top of rod to striker plate (Note: larger strut cap)

Refer to pictures below to determine which design strut is installed on the vehicle. If changing from one design to another, the Jounce Bumpers will need replacement as well.
