Service Bulletin

Bulletin No.: PIC5834

Subject: Squeak Noise During Clutch Apply

Models: 2013 Buick Verano
with Manual Transmission (RPO MYJ)

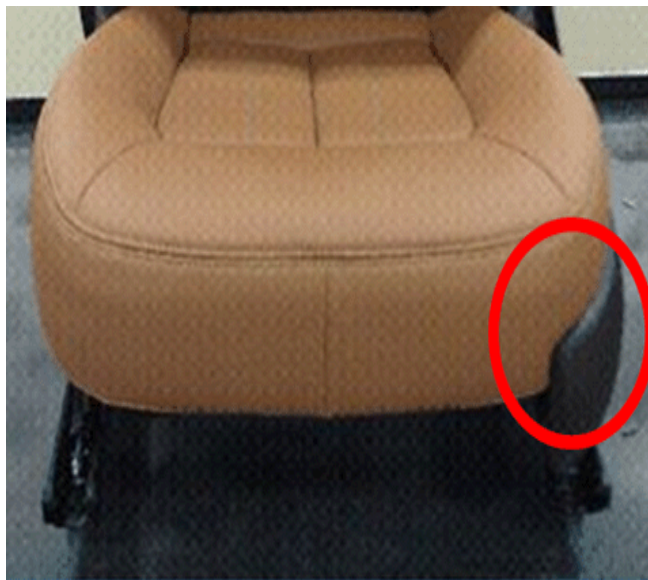
3341029

A customer may complain about a squeak, scrape, or rub-type noise coming from the seat area during a clutch pedal apply. This condition may be caused by the seat cover/material contacting the plastic seat trim cover on the outboard side of the vehicle during clutch apply. Seating position and driver may influence this condition making it difficult to diagnose.

Apply anti-itch tape between the seat cover and outboard trim panel. Use a clear Mylar or ultra-high molecular weight tape (obtained from local supplier or via internet search).
