Technical Service Bulletin

01 MIL on, DTC(s) faults P2452, P2453, P2454, P2456, and/or P2002 are stored in the ECM fault memory

01 13 00 2030292/3 May 20, 2013. Supersedes Technical Service Bulletin Group 26 number 12-14 dated August 31, 2012 for reasons listed below.

Model(s)	Year	VIN Range	Vehicle-Specific Equipment
Q7 TDI	2009-2011	All	All in North American market

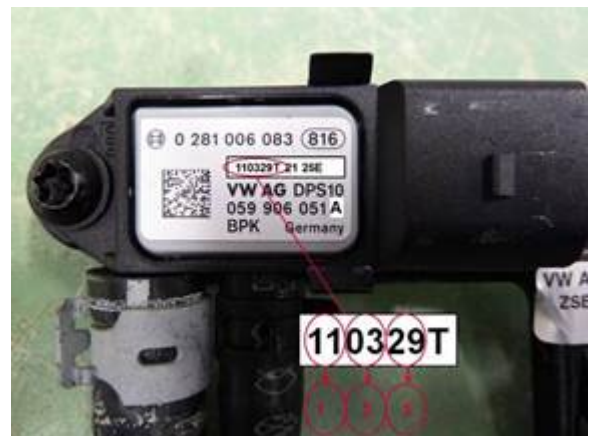
Moisture ingress due to inadequate internal sealing of some differential pressure sensors (G505) causes electronic failure of the sensors. Part analysis shows that this condition only affects parts that were produced on or before March 29, 2011.

1. Confirm that one or more of the DTCs listed in the *Condition* section of this bulletin is stored in the ECM fault memory.
2. Confirm that the date code on the sensor is 110329 (year, month, day) or earlier (Figure 1).

Figure 1. Date code on sensor in year, month, day format (example shows March 29, 2011).

3. Follow Guided Fault Finding and replace the differential pressure sensor (**059906051A**), if instructed. Follow instructions in ElsaWeb Repair Manual, Group 23.
