Technical Service Bulletin

01 MIL on (P1545, P0121, P0123, P0221 or P0222 stored in ECM)

01 13 76 2018260/7 March 14, 2013. Supersedes Technical Service Bulletin Group 01 number 13-70 dated February 22, 2013 for reasons listed below.

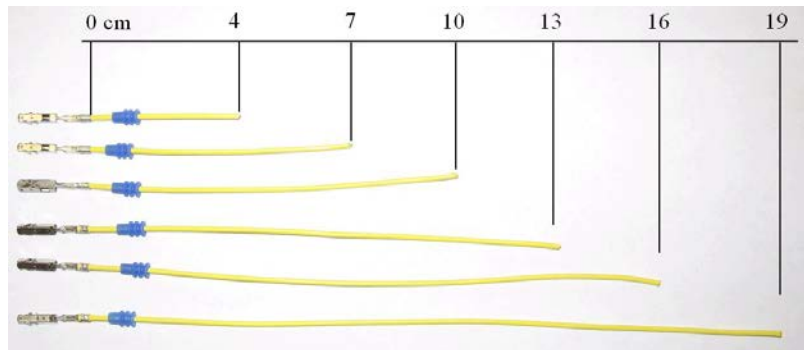
Figure 1. Correctly preassembled wires and seals.

3. Lengthen wires and preassemble seals as shown (Figure 1).

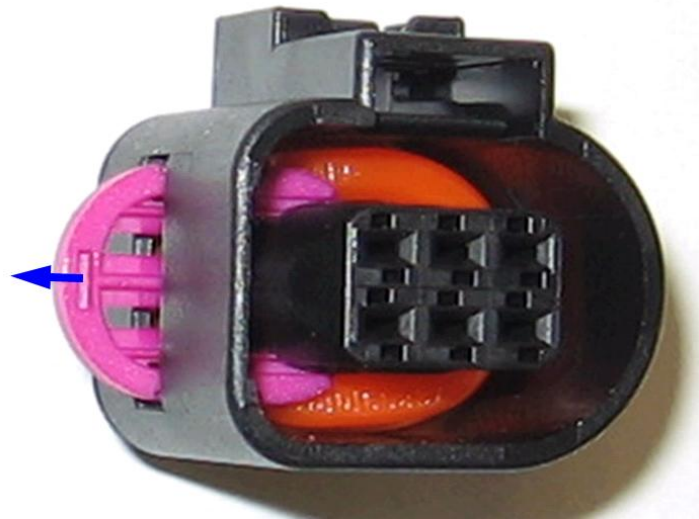
Figure 2. The slot to be used to remove the pink lock.

4. On the new housing, remove pink lock with small flathead screwdriver, using the slot on the pink lock (Figure 2).

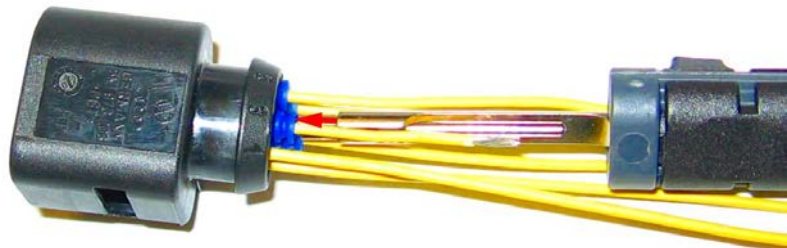
Figure 3. The single wire seal, slid as far as the stop.

5. Insert all terminals into housing until they audibly click.
6. Reinstall pink lock.
7. Using the appropriate assembly tool, slide the single wire seal up the repair wire until it contacts the housing. Continue to slide the single wire seal into the housing as far as the stop (Figure 3).
