Technical Service Bulletin

01 MIL on, (DTCs P047F, P0477, P048A, P048B, P048C, P0401)

01 13 77 2033356/1 March 15, 2013.

| Model(s) | Year | VIN Range | Vehicle-Specific Equipment |
|---|---|---|---|
| A3 TDI | 2010-2012 | All | Exhaust flap |

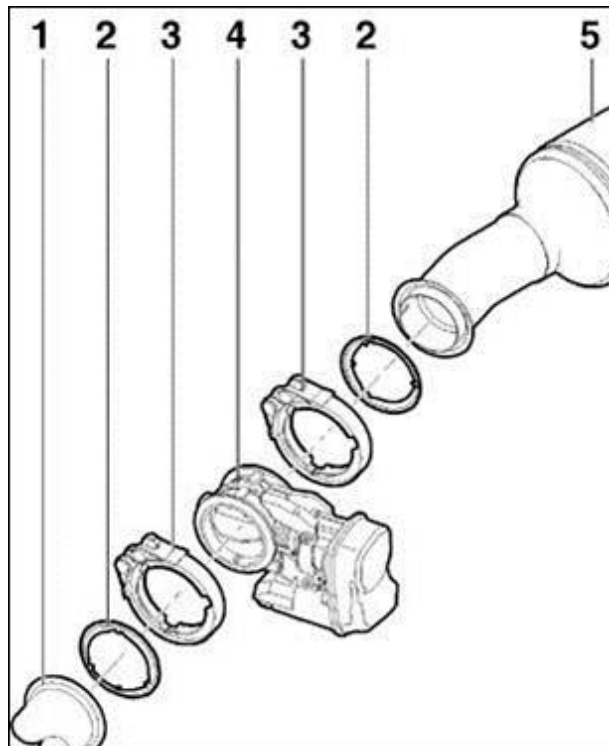
Figure 1. Exhaust flap

Water and road salt can corrode the exhaust flap shaft causing it to stick in open / closed position.

1. If one or more of the above faults are stored in the ECM fault memory, remove the exhaust flap to check for a sticking condition (Figure 1, 4)

2. If the flap cannot be moved or does not move freely, the flap must be replaced.
