Technical Service Bulletin

01 MIL on, no start or rough running (DTC P0087 - Rail fuel pressure too low or DTC P0088 - Rail fuel pressure too high)

01 13 79 2023360/3 March 20, 2013. Supersedes Technical Service Bulletin Group 01 number 11-18 dated January 25, 2011 for reasons listed below.

Model(s)	Year	VIN Range	Vehicle-Specific Equipment
А3	2010	All	2.0 TDI clean diesel Engine
Audi Q7	2009 – 2010	All	3.0 TDI clean diesel Engine

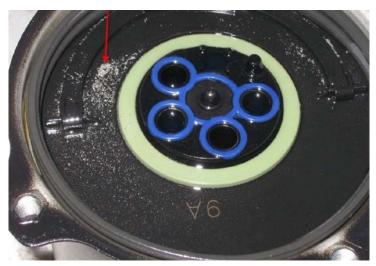
Figure 1. Example of metal shavings and debris on top of fuel filter. Some shavings can be picked up with a magnet.

If there is any indication of fuel contamination, metal shavings/debris, or rust inside the fuel filter housing (Figures 1 and 2), call the Technical Assistance Center (TAC) and open a ticket before attempting any repair.

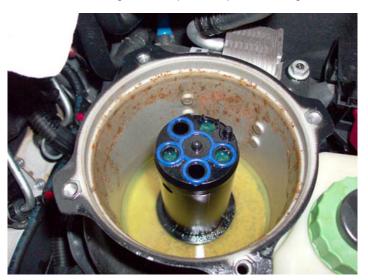
Figure 2. Example of rust in fuel system caused by water contamination.

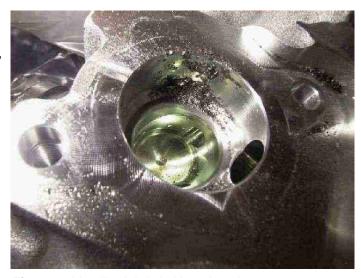
Figure 3. Metallic debris in N290 housing.

If there is any indication of fuel contamination, metal shavings/debris, or rust inside the N290 valve (Figures 3 and 4), call the Technical Assistance Center (TAC) and open a ticket before attempting any repair.

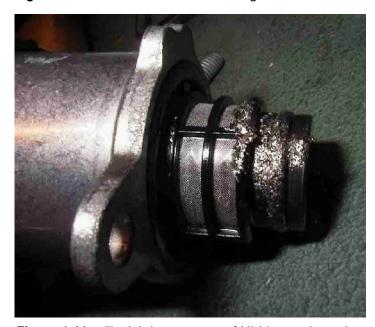
Figure 4. Metallic debris on screen of N290 metering valve.

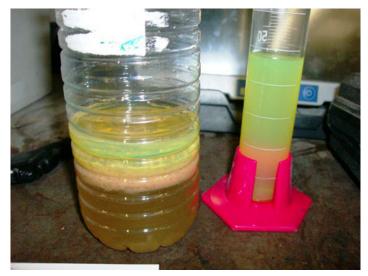
Figure 5. Fuel in the left container is contaminated.

3. If there is any evidence of fuel contamination, request that the customer produce any possible record of their last fuel purchase.
