Technical Service Bulletin

19 Coolant warning light or coolant loss - R8 4.2 FSI

19 13 37 2026109/2 May 13, 2013. Supersedes Technical Service Bulletin Group 19 number 11-23 dated April 14, 2011 for reasons listed below.

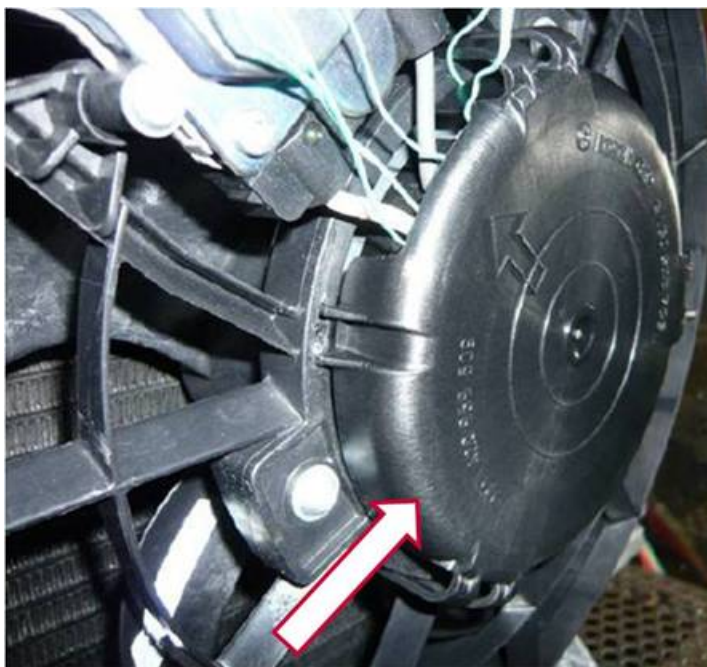
The left and/or right side radiator cooling fans may be inoperative due to corrosion caused by water ingress into the fan motors or into the fan control units. As a result, coolant temperatures may exceed the permissible value, leading to increased system pressure and potential coolant loss from the system. Indication of coolant loss may be noticed coming from the coolant reservoir.

Figure 1. Splash guard aligned with fan control unit.

A splash guard was installed on the cooling fan to protect the fan motor and the fan control unit (Figure 1).

1. Remove the front vehicle underbody cover. Refer to *Body Exterior >>Rep. Gr.66>>Removal and Installation*.
2. Check the both fans for stiffness or rough running. If necessary, replace one or both auxiliary cooling fans (if applicable).
3. Install the two splash guards.

Tip: The splash guard must be fitted with the arrow on the splash guard aligned with fan control unit.
