# Technical Service Bulletin

## 20 3.0 TFSI: noises from tank

20 14 30 2035591/1 December 13, 2013.

Model(s)	Year	VIN Range	Vehicle-Specific Equipment
Q7	2011 - 2014	000000 - 013967	3.0T

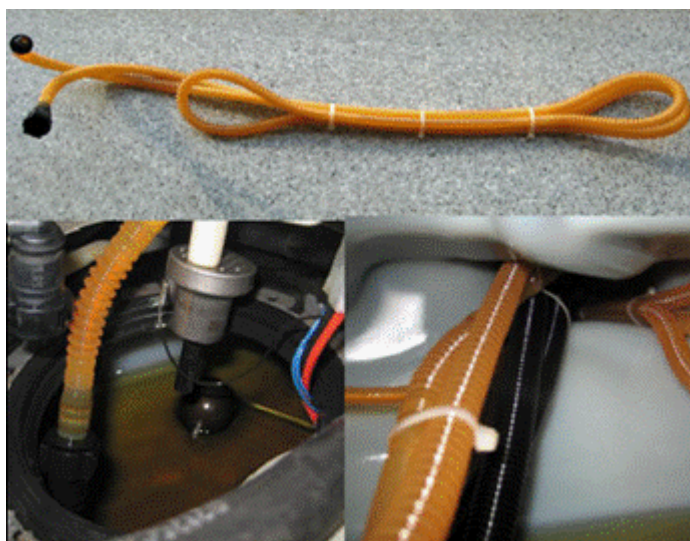
Normal fuel system pulsation can cause slight vibrations in the pressure regulator on the flange located on the right side of the fuel tank. This pulsation also causes the long, curved fuel lines (Figure 1) to vibrate and make a jarring noise in the tank.

*Figure 1. The long, curved fuel lines that run across the fuel tank from right to left.*

Long, curved fuel lines fastened with a tie wrap.

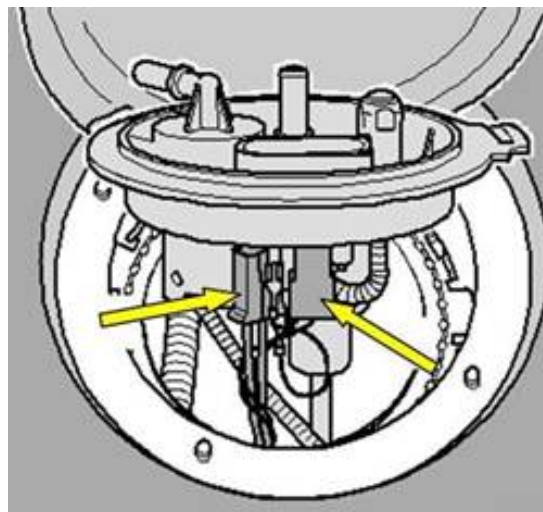
**Figure 2.** Two electrical connectors on the right locking flange to be disconnected.

1. Open the flange lock on the right side of the fuel tank according to the instructions in *Repair Manual >> Engine >> Fuel Supply System >> 20 Fuel Supply >> Removal and Installation*.
2. Slightly pull the right locking flange with seal out of the fuel tank.
3. Disconnect two electrical connectors on the underside of the right locking flange (Figure 2).

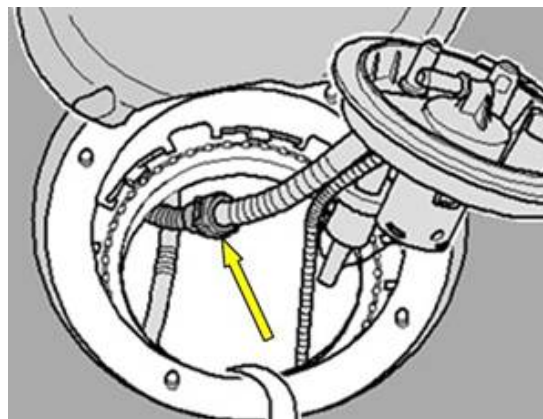
**Figure 3.** Fuel line connected to the locking flange.

4. Disconnect fuel line (Figure 3) by pressing release button.

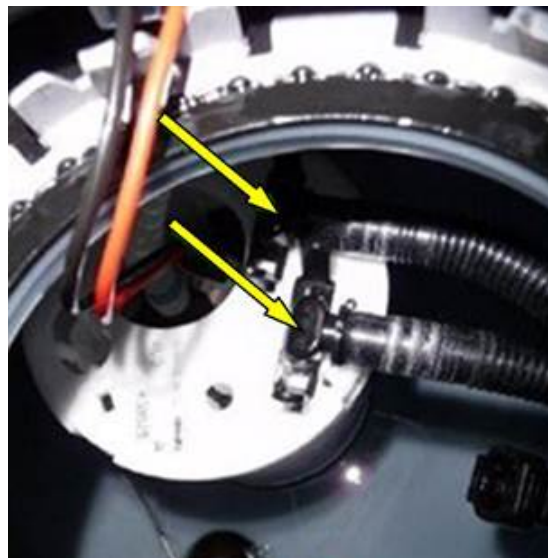
*Figure 4. Black corrugated lines leading from the suction jets to be moved.*

5. Disconnect the two black corrugated lines leading from the suction jets and move them to the left in order to create space for working on other fuel lines (Figure 4).

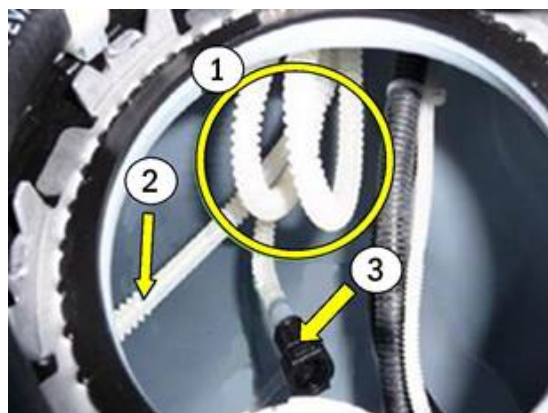
*Figure 5. Curved fuel lines (1), fuel supply pipe (2), and fuel line.*

6. Pull the curved fuel lines (Figure 5) as far to the right of the vehicle as possible without using force.

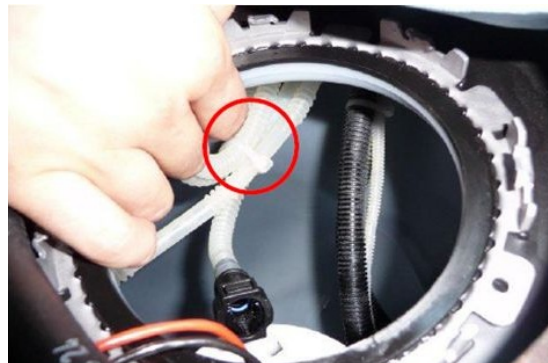
*Figure 6. Curved fuel lines, fuels supply pipe, and fuel line tied together with tire wrap.*

7. Tie the curved fuel lines, fuels supply pipe, and fuel line together with a tire wrap (Figure 6).

The tire wrap must be close to the lower section of the curve of the curved fuel lines to prevent any contact with the suction jet pipes.

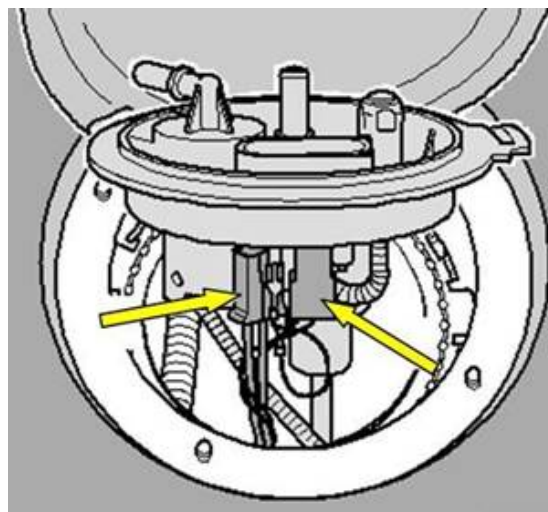
*Figure 7. Two electrical connectors on the right locking flange to be reconnected.*

8. Refit the two black corrugated lines leading from the suction jets. Reconnect the rest of the lines and reconnect the two electric connectors to the flange.

Reinstall the flange according to the instructions in Elsa, and ensure that the flange seal is positioned correctly.
