**HYUNDAI**NEW THINKING.
NEW POSSIBILITIES.**Technical Service Bulletin**

GROUP	NUMBER
AUTOMATIC TRANSMISSION	13-AT-013
DATE	MODEL
JULY 2013	Tucson (LM), Santa Fe (CM/AN/NC), Sonata (YF/YF HEV), Elantra (UD/MD/GD/JK), Accent (RB), Azera (TG/HG), Veloster (FS)

SUBJECT:	AUTOMATIC TRANSAXLE (6-SPEED) INHIBITOR SWITCH DTC P0705, P0706, P0707 & P0708
-----------------	---

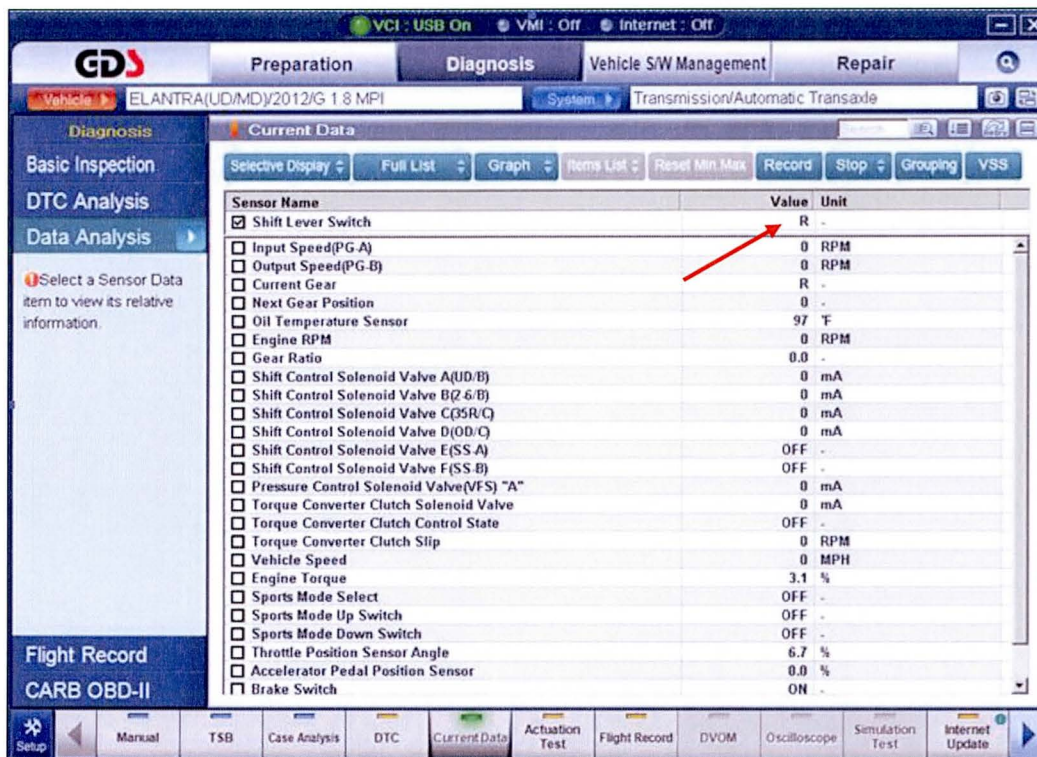
1. Turn the ignition key to the ON position or push the Start/Stop Button two times.
2. Using a GDS, check for DTC in the “Automatic Transaxle” menu. **Record the DTC and description.** Delete the DTC.
3. Select the following parameters. Move the shift lever through all gears and monitor the sensors.
 - Vehicle and A/T menu.
 - “Current Data”
 - Shift Lever Switch.
