Technical Service Bulletin

37 Harsh downshifts when braking or harsh 1-2 upshift under acceleration

37 13 84 2029305/7 January 31, 2013. Supersedes Technical Service Bulletin Group 37 number 13-79 dated January 8, 2013 for reasons listed below.

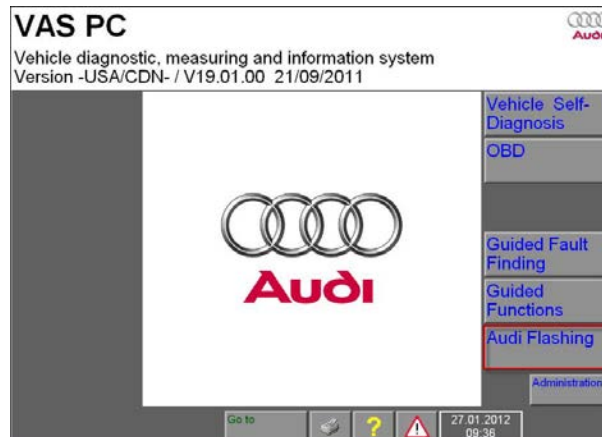
Figure 2. Audi Flashing.

- Turn off any appliances with high electromagnetic radiation (such as mobile phones).
 - If communication with a module cannot be properly established, appropriate repairs must be made before attempting SVM. If the tester cannot communicate with a module, the tester cannot flash software onto the module.
5. Enter the SVM code into the User Test Plan by selecting the **Audi Flashing** option at the main tester screen, unless otherwise directed by the TSB or TAC Helpline.
