Technical Service Bulletin

63 Repairs on rear bumper

63 13 05 2035502/1 October 7, 2013.

Model(s)	Year	VIN Range	Vehicle-Specific Equipment
A6	2013	CN168080 – CN168080	Custom shielding

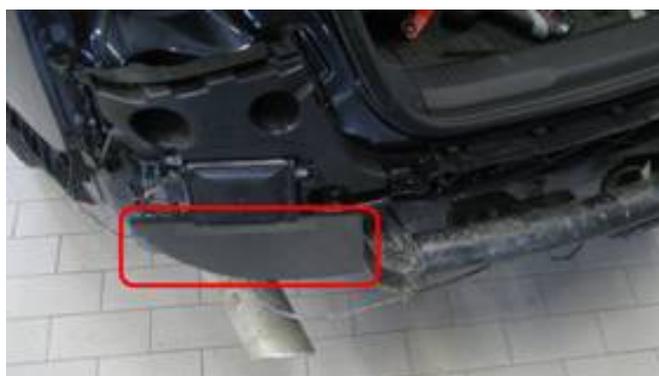
- This bulletin is informational only for repairs made to the rear bumper.
- Under the rear bumper cover, two shields are fitted below the Lane Change Assistance control units (Figure 1 and Figure 2).
- The shields are in place to prevent unwanted reflections from special aftermarket accessories fitted on this vehicle. These reflections can interfere with the function of the Lane Change Assistance system.

Figure 1. Shield on driver side.

- Do not remove the shields from the vehicle
- If the shields have been removed for associated repairs, re-secure them to the vehicle in the same locations.
- If one or both of the shields have been damaged, contact TAC for additional assistance. Attach a picture to the TAC ticket before calling TAC.

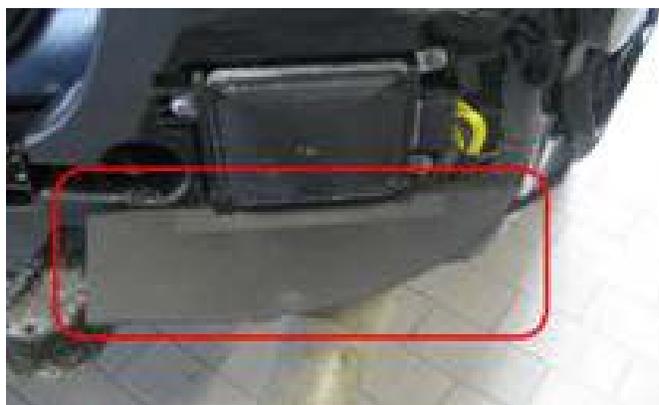
Figure 2. Shield on passenger side.
