Technical Service Bulletin

64 Noises from front door or when lowering window

64 13 26 2027837/4 June 7, 2013. Supersedes Technical Service Bulletin Group 64 number 12-25 dated November 7, 2012 for reasons listed below.

Model(s)	Year	VIN Range	Vehicle-Specific Equipment
Q5	2009-2012	All	Not Applicable

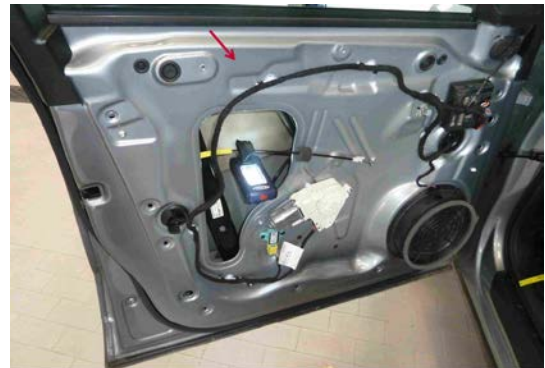
When the window is lowered, it collides with the clip that holds the window guide cable. This causes the clip to open and contact the window during operation, or to rattle when the vehicle is driven on rough roads.

Figure 1. Location of clip.

1. Remove the clip. The clip is inside the door (on the level of the red arrow) and is not visible from the outside (Figures 1 and 2).

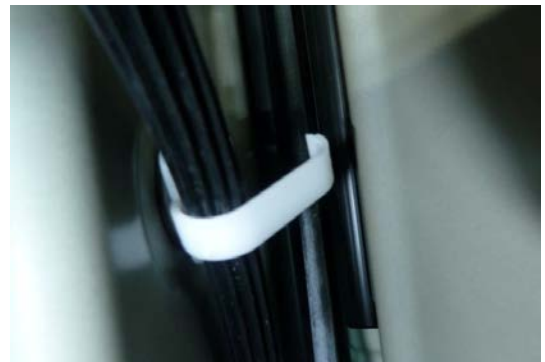
Figure 2. Clip as viewed from inside of the door panel.

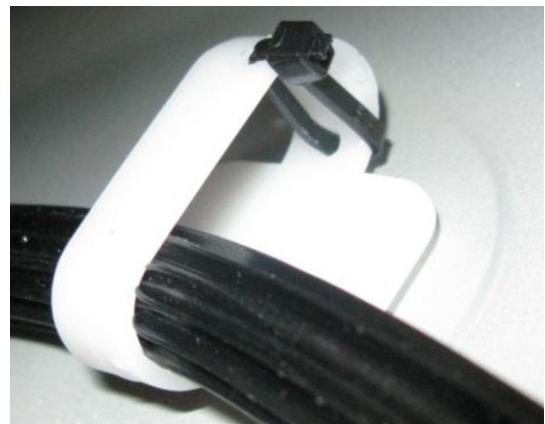
Figure 3. Clip with additional holes and zip tie.

2. Replace the clip with the parts included in the kit (see *Required Parts and Tools*). Put a zip tie through the two holes to prevent the new clip from opening. Trim the zip tie after installing it (Figure 3).

Tip: The kit includes a new clip with additional holes in it and a zip tie.
