# Technical Service Bulletin

## 61 Convertible top adjustment options

61 13 22 2015779/7 September 26, 2013. Supersedes Technical Service Bulletin Group 61 number 10-09 dated November 18, 2010 for reasons listed below.

Model(s)	Year	VIN Range	Vehicle-Specific Equipment
TT Roadster	2007 - 2015	All	Not Applicable

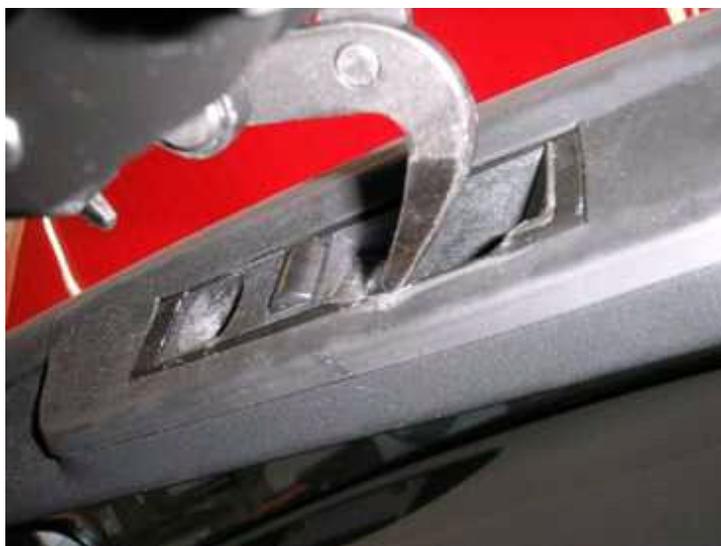
The convertible top latches (Figure 1) do not engage end plates on windshield frame. Latch hooks meet end plates too far rearward.

*Figure 1. The convertible top latch.*

If the convertible top latches match the description found in the *Condition* section of this bulletin, check the following points and adjust as necessary:

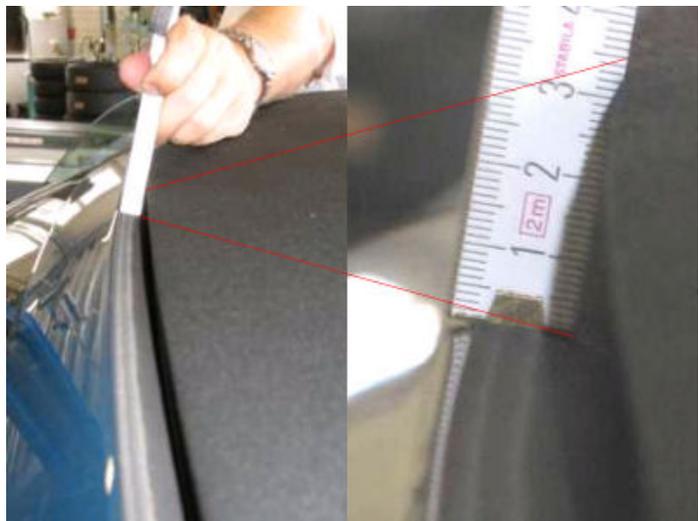
**Figure 2.** There should be 35 mm (tolerance +/- 5mm) from the windshield frame to the front edge of the roof.

- This distance should be measured after initial opening of the top, when the front latch motor V223 has stopped after unlatching, but before the hydraulic pump begins operating.
- Specification for basic setting = 35 mm (Tolerance +/- 5 mm) (Figure 2).

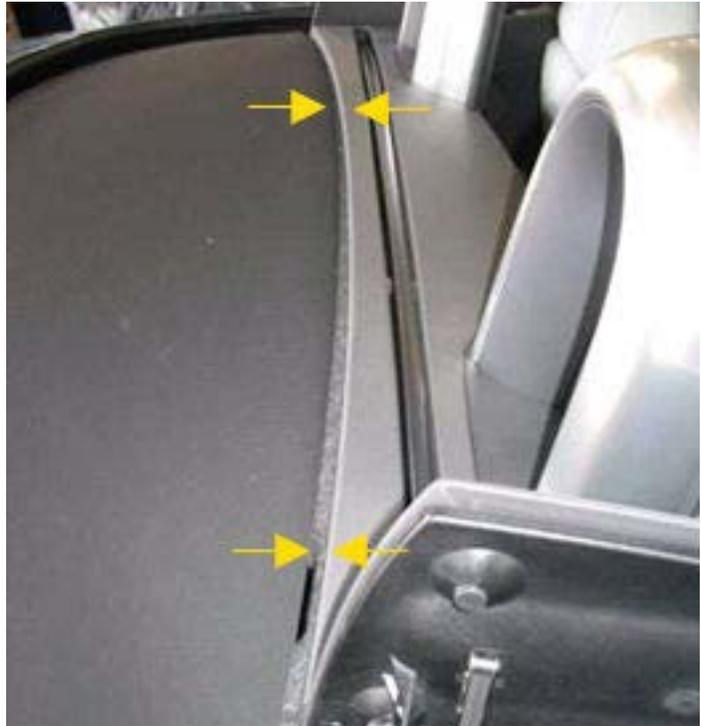
**Figure 3.** The gap on the roof panel should be the same on the left and right sides.

- This distance should be measured after the top is fully opened (Figure 3).
- There should be 4-8 mm between the roof panel and body (Figure 4).

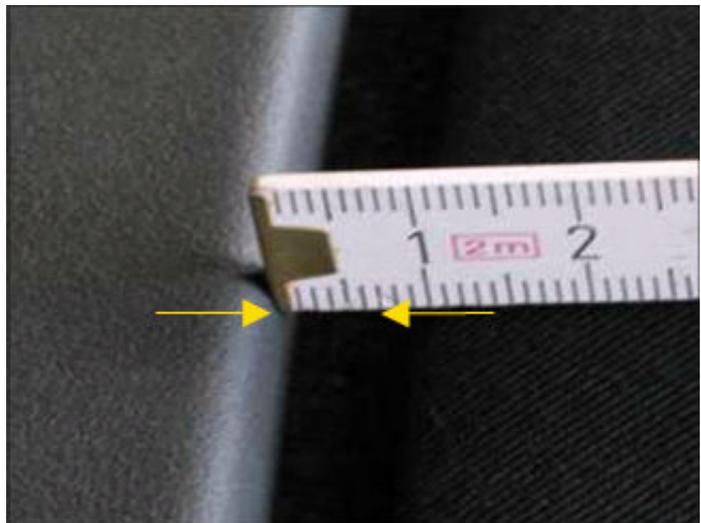
**Figure 4.** There should be 4-8 mm between the roof panel and body.

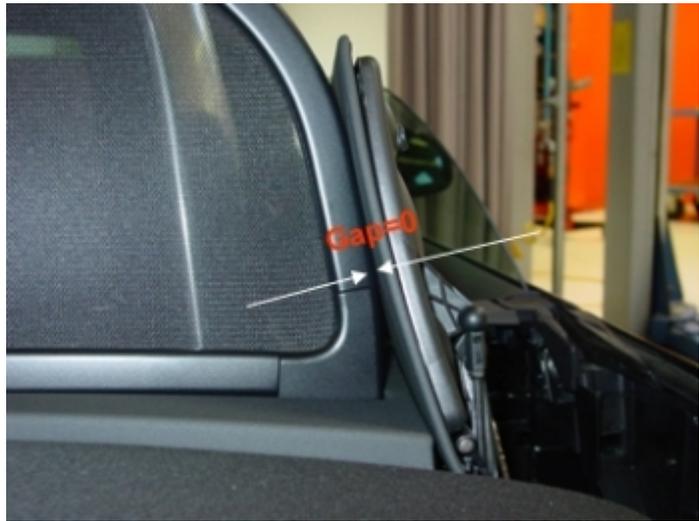
- Adjustment of the flap opening angle is critical, particularly after replacement of the flap motors. This adjustment is checked by establishing a gap of 9.6 mm between the flap and the wind deflector. If a fully-open flap is in contact with a raised wind deflector (0 mm) or less than 9.6 mm, the flap has opened over-center (Figure 5).

*Figure 5. A flap that is open over-center.*

**Note:** If the flaps open over-center, the flap motors will be damaged when closing.

- Disconnect the connecting rod at the flap end so that the flap moves independently of the motor. Avoid moving the motor arm manually. Allow the flap to rest in the up position. Locate the fine adjustment screw (Figure 6 and Figure 7).

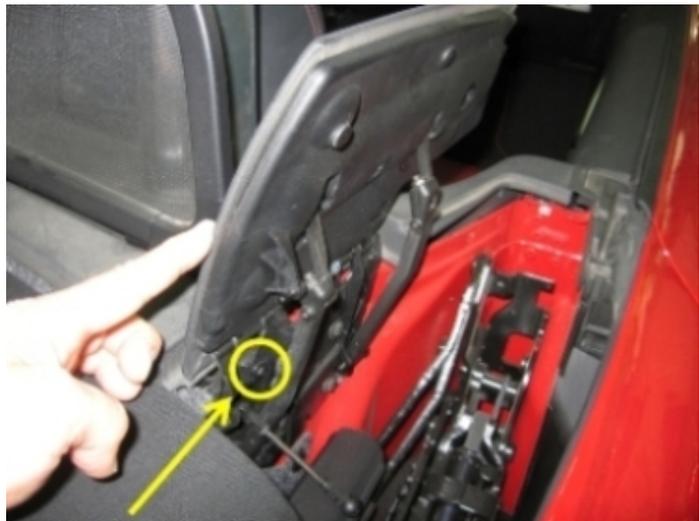
*Figure 6. Location of fine adjustment screw.*

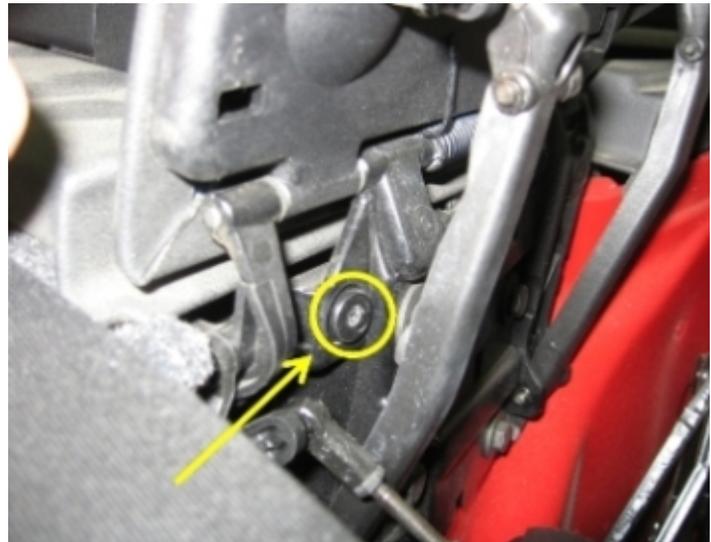
**Figure 7.** Close-up view of the fine adjustment screw.

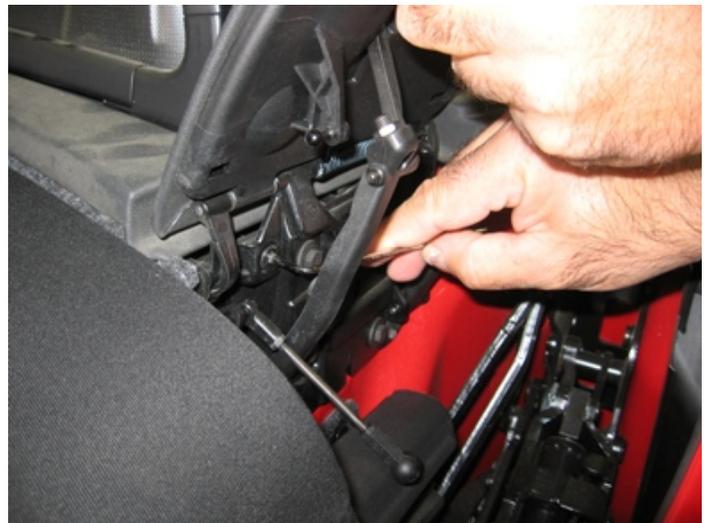
**Figure 8.** Adjustment of the fine adjustment screw.

- With the wind deflector raised, check the gap between the flap trim and the wind deflector as shown in the illustration. It should be 9.6 mm. Using a 3 mm Allen wrench, adjust the fine adjustment screw until this gap is achieved (Figure 8).

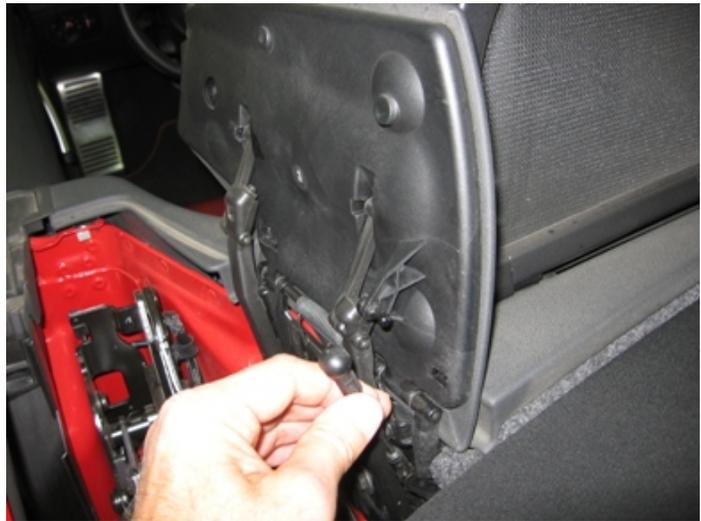
*Figure 10. Reinstalling the connecting rod.*

- Reconnect the connecting rod (Figure 10). If the basic adjustment of the connecting rod is correct and if the flap to wind deflector gap is adjusted correctly (Figure 11), the connecting rod should align with both ball connections.

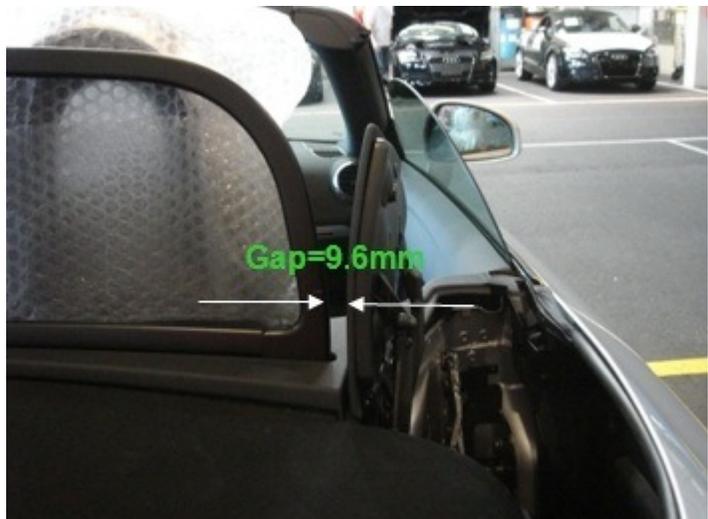
*Figure 11. Correct gap.*

- Operate the complete convertible top cycle 2 or 3 times. Recheck the flap to wind deflector gap. Readjust if necessary.

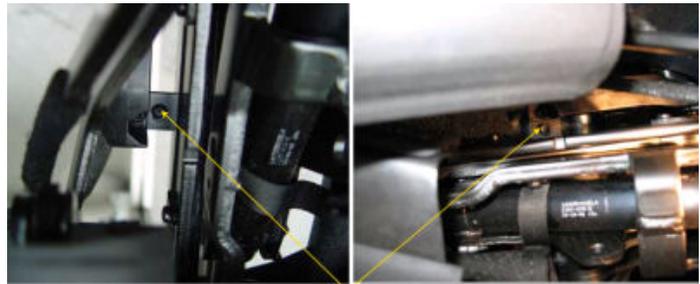
**Figure 12.** The depth screw location.

- Before the main bearing bolts are loosened, the main bearing depth screw (Figure 12) should be moved downward until it makes contact with the body (approx. 2-3 rotations).

- Moving the main bearing depth screw downward maintains the main bearing height during adjustment. Additionally, the main bearing may need to be moved forward. For this reason, the tension straps must also be loosened to allow for this movement.

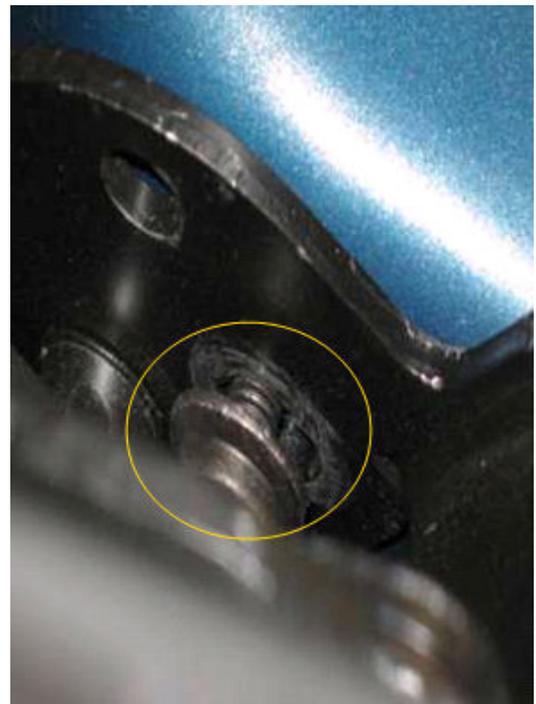
**Figure 13.** N.i.O. position of the main mounting bolt.

- Loosen mounting bolts and inspect position. The position of the main bearing mounting bolts with respect to height should be centrally located in the holes in the bearing (Figure 13 and Figure 14).

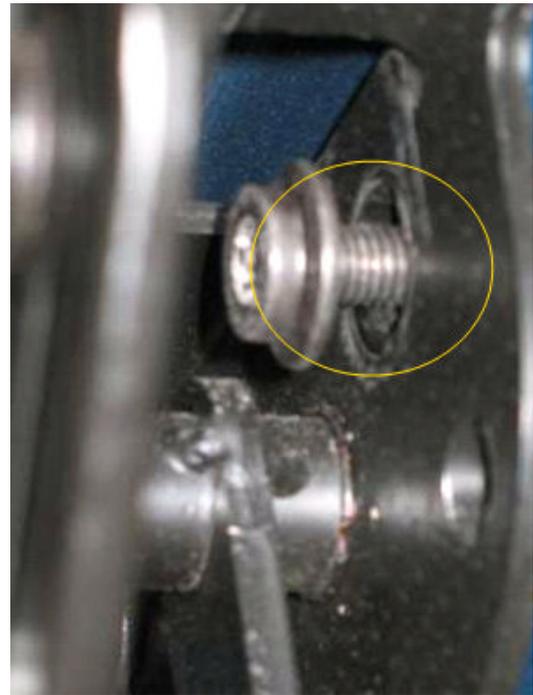
**Figure 14.** I.O. position of the main mounting bolt.

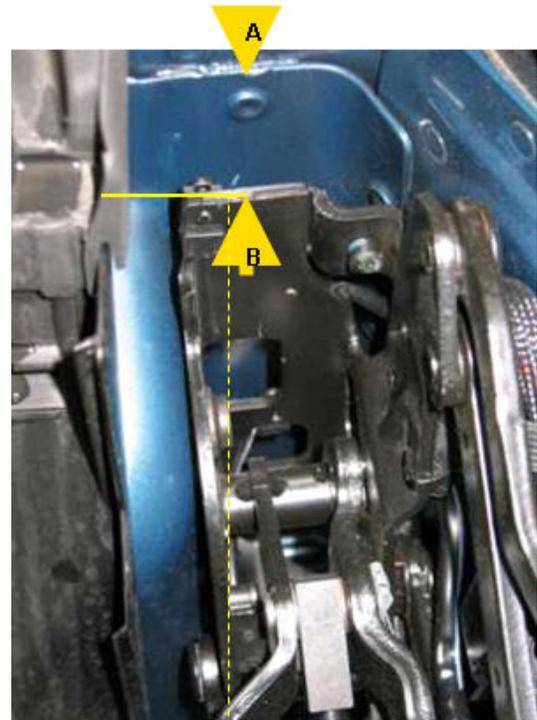
After adjustment at the main bearing is complete, the main bearing depth screw must be backed off so that there is no contact between this screw and the body. Contact will cause a creaking noise.

**Figure 15.** There should be 30 mm between the main bearing and the sheet metal at the B-pillar. This should be equal right to left and also should be measured at two points on each side (upper and lower) to maintain a perpendicular position of the main bearing. There should be 285 mm from the bottom of the body cavity to point B.

- Measuring point: main bearing to body:
  - This distance should be equal between the left and right side.
  - Specification for basic setting of distance front to rear (Figure 15, A to Figure 15, B) = 30 mm
  - Specification for basic setting of height (bottom of body cavity and point B) = 285 mm

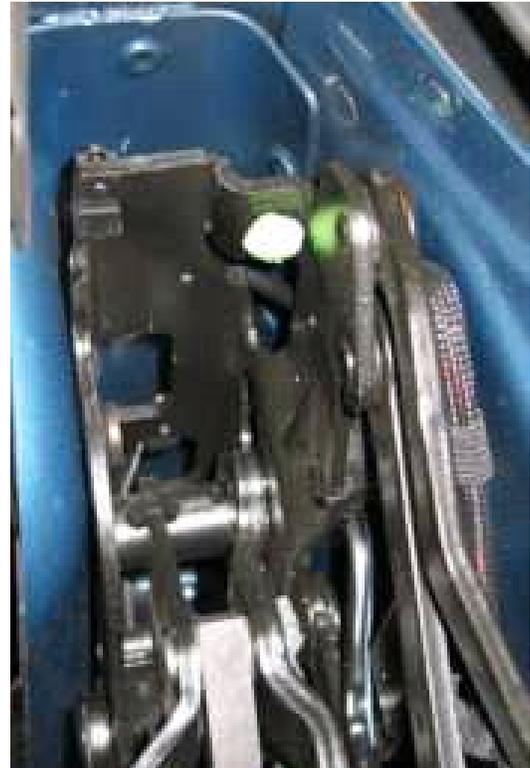
*Figure 16. The screw head, covered with Plastelin or Butyl.*

- Apply Plastelin or Butyl on the screw heads to determine if the frame travel is being limited by the screw (Figure 16). The frame may make contact with the screw but should not prevent appropriate forward movement (e.g. central engagement of the top latch hooks to the end plates) during operation.

- Cycle the top, check distance between frame and screw and adjust if necessary. It is important to note that as this screw is adjusted toward the rear the top frame travels more forward. Conversely, if the adjustment screw is moved toward the front the top travel is limited more rearward. Make adjustments only 1 full turn at a time and recheck the latch hook engagement after each top cycle.

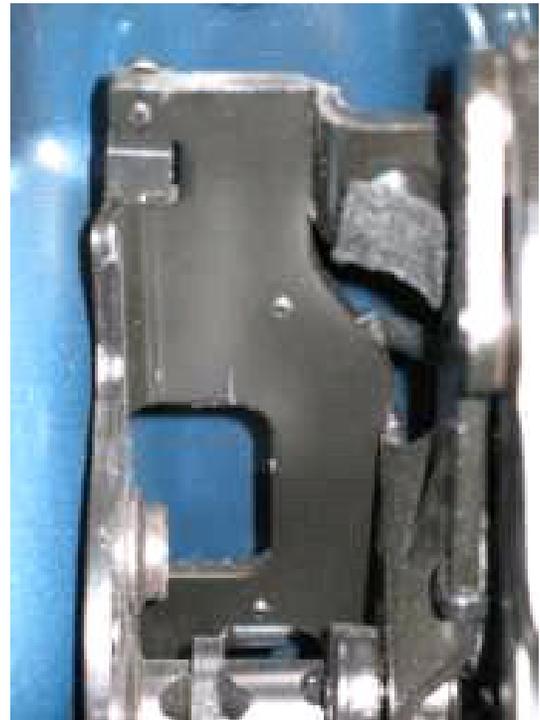
*Figure 17. The screw, covered in felt.*

- If there is no contact between the frame and the screw apply a suitable amount of Plastelin or Butyl or, as an alternative, a piece of felt to determine the gap (Figure 17).

- Adjust both sides.

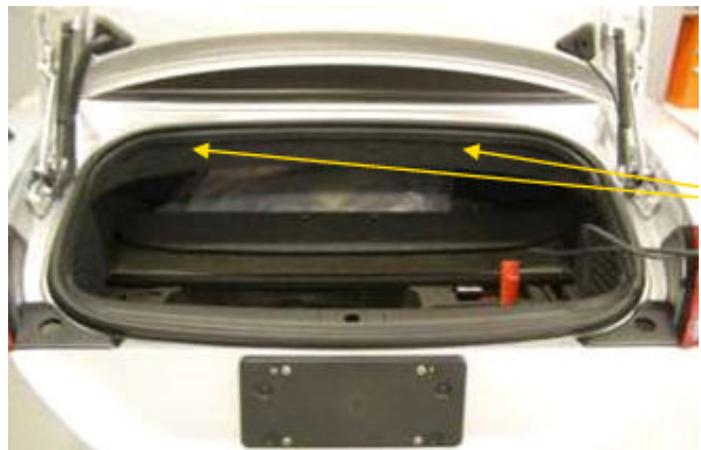
*Figure 18. The tension straps.*

- Adjust the tension straps (Figure 18). The correct amount of tension to the straps prevents the front latch hooks from hitting the end plates at the windshield frame. Correct adjustment softens the meeting of the latch hooks at the end of the closing cycle.

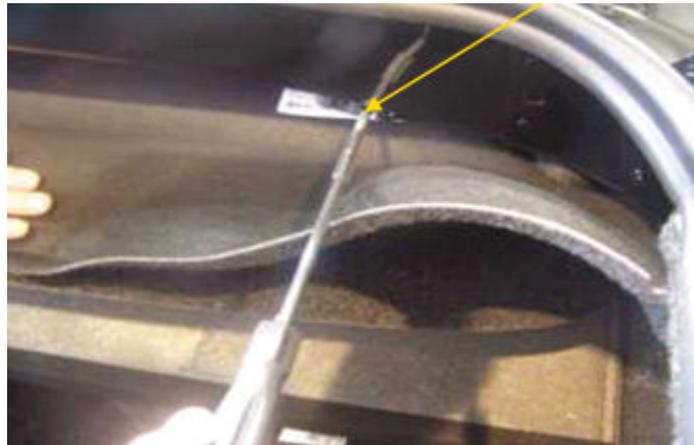
**Figure 19.** The tension straps are located behind the trunk trim.

- The adjustments are made behind the trunk trim (Figure 19 and Figure 20). Turning clockwise increases the tension and slows the drop of the front of the roof at the end of the closing cycle. Be cautious not to create too much tension. This could cause the front latch and motor to be incapable of pulling the top closed.

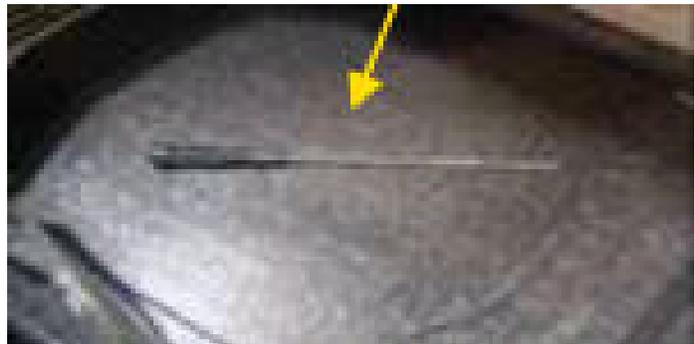
**Figure 20.** The tension straps are located behind the trunk trim.

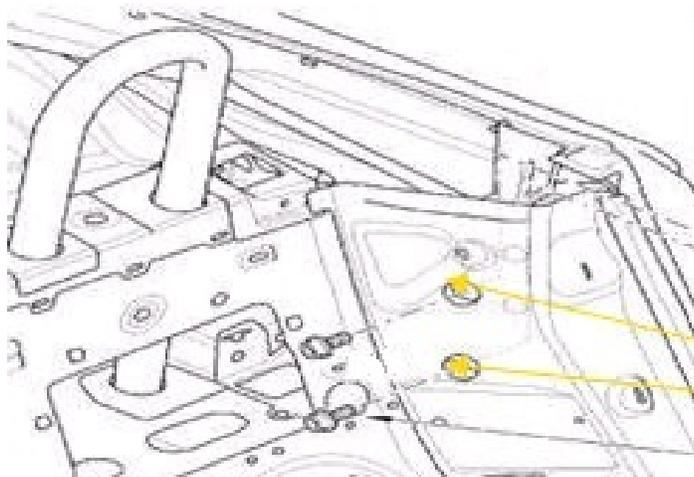
**Figure 21.** The location of the main bearing bolts.

**Tip:** The main bearing bolts (Figure 20 and Figure 21) are to be torqued to 36 Nm. After adjustment at the main bearing is complete the main bearing depth screw must be backed off such that there is no contact with the body. Any contact between this screw and the body creates a creaking noise.

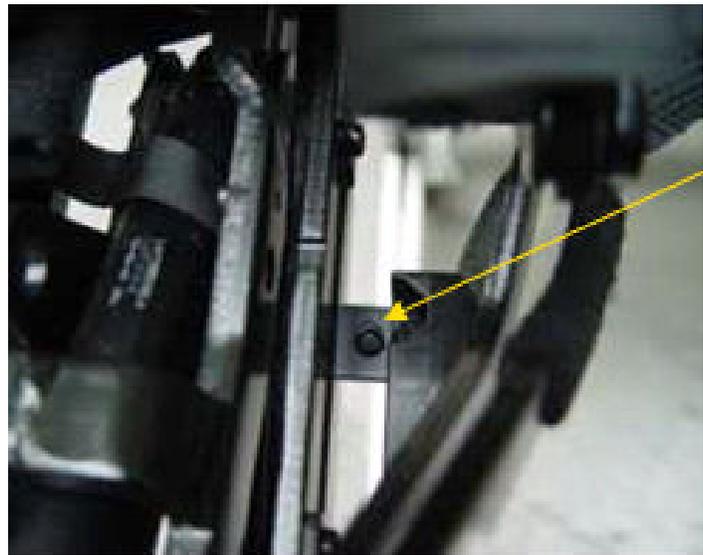
**Figure 22.** The location of the main bearing bolts.
