# Technical Service Bulletin

## 64 Noises from front door or when lowering window

64 13 31 2027837/5 December 3, 2013. Supersedes Technical Service Bulletin Group 64 number 13-26 dated June 7, 2013 for reasons listed below.

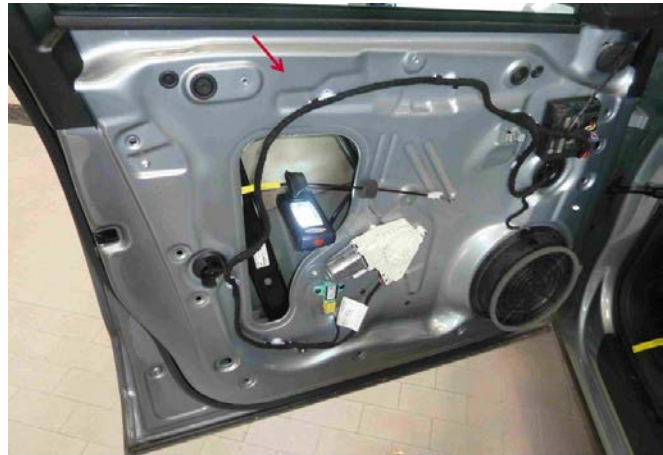
When the window is lowered, it collides with the clip that holds the window guide cable. This causes the clip to open and contact the window during operation, or to rattle when the vehicle is driven on rough roads.

*Figure 1. Location of clip.*

1. Remove the clip. The clip is inside the door (on the level of the red arrow) and is not visible from the outside (Figures 1 and 2).

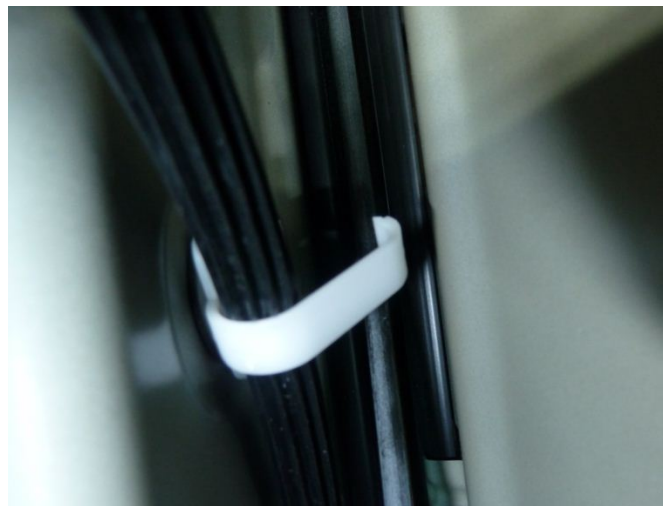
*Figure 2. Clip as viewed from inside of the door panel.*

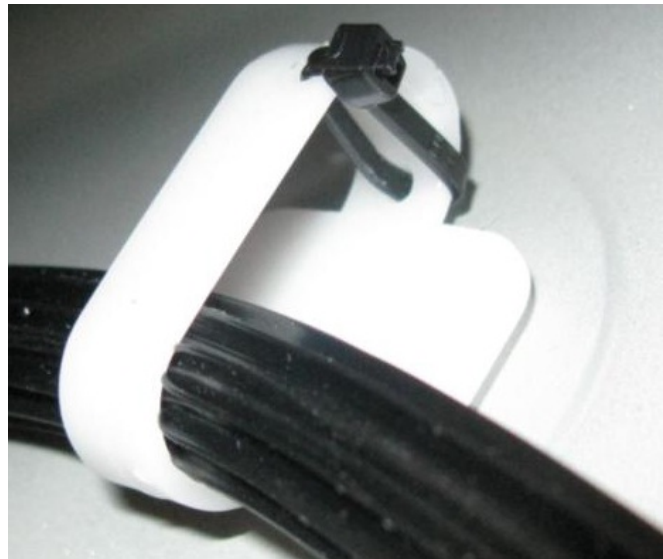
**Figure 3.** Clip with additional holes and zip tie.

2. Replace the clip with the parts included in the kit (see *Required Parts and Tools*). Put a zip tie through the two holes to prevent the new clip from opening. Trim the zip tie after installing it (Figure 3).

**Tip:** The kit includes a new clip with additional holes in it and a zip tie.
