# Technical Service Bulletin

## 66 Wind noise from exterior rear view mirror base or at lane change assist lamp

66 13 32 2029586/5 September 26, 2013. Supersedes Technical Service Bulletin Group 66 number 13-31 dated June 12, 2013 for reasons listed below.

Model(s)	Year	VIN Range	Vehicle-Specific Equipment
Q5	2010 - 2013	All	All
Q5	2014	000001 - 004821	All
Q7	2010 - 2013	All	All
Q7	2014	000001 - 009004	All

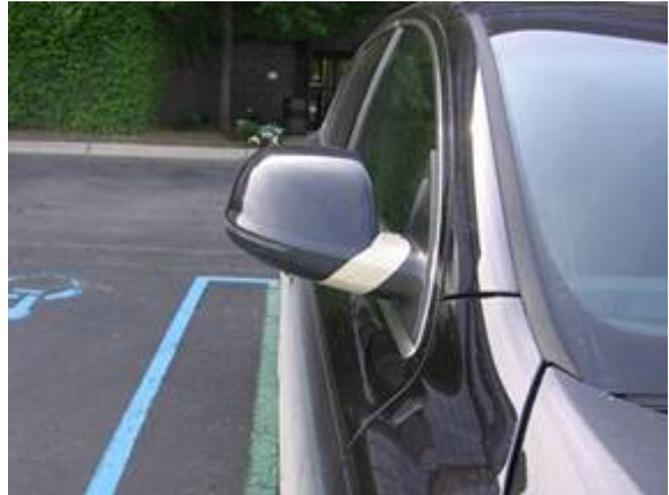
1. Apply tape to the seam at the rotation collar between the mirror mount assembly and the painted cover (Figure 1) to determine if the noise is coming from the mirror base.
  - If the mirror base is not the source of the noise, move to step 2.
  - If the mirror base is the source of the noise, replace the mirror base according to the ElsaWeb Repair manual: *Body >> Body Exterior >> 66 Exterior Equipment >> Removal and Installation >> Exterior rearview mirror >> Exterior rearview mirror.*

Figure 1. Tape applied to rotation collar seam.

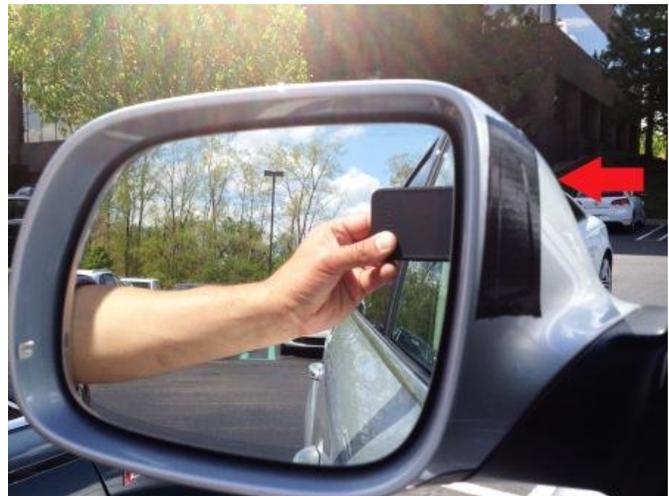
2. If the vehicle is equipped with lane change assist, remove the first piece of tape, then apply tape to cover the lane change assist marker lens (Figure 2) to determine if the lane change assist lamp is the source of the noise.
  - If the lane change assist lamp is the source of the noise, replace one or both of the lamps according to the ElsaWeb Repair manual: *Electrical System >> Electrical Equipment >> 96 Interior Lights, Switches >> Removal and Installation >> Lane Change Assistance >> Lane Change Assistance Warning Lamp in Exterior mirror.*

Figure 2. Tape applied over the lane change assist lens.
