Technical Service Bulletin

66 Wind noise from exterior rear view mirror housing at turn signal seam

66 13 33 2033517/2 September 30, 2013. Supersedes Technical Service Bulletin Group 66 number 13-27 dated April 8, 2013 for reasons listed below.

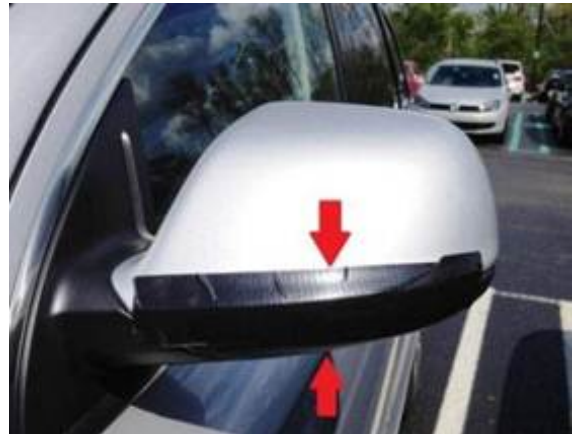
Air flows through the exterior rear view mirror housing at the seam where the turn signal lamp meets the housing. This causes a high-frequency whistling tone.

1. Confirm through diagnosis and road tests that the source of the wind noise is coming from the exterior rear view mirror housing, specifically at the area of the housing where the turn signal lamp is mounted (Figure 1).

Figure 1. Application of tape over turn signal lamp.

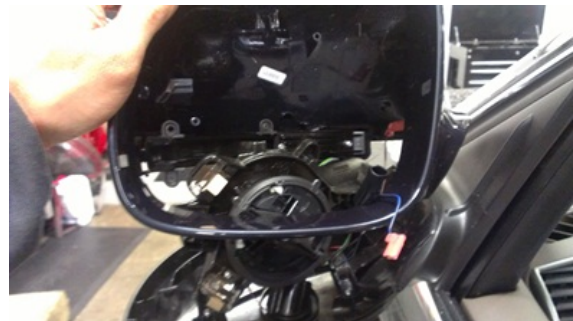
Figure 2. Removal of the mirror housing from the mirror base.

2. Should the root cause of the wind noise be from the seams at the turn signal lamp, remove the turn signal lamp from the mirror housing starting with the removal of the mirror housing from the mirror base (Figure 2).

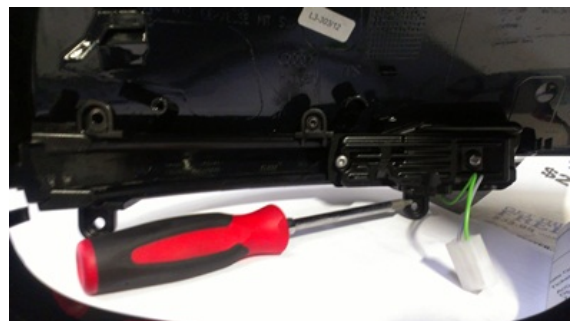
Figure 3. Removal of the turn signal lamp from the mirror housing.

3. Remove the turn signal lamp from the mirror housing (Figure 3).

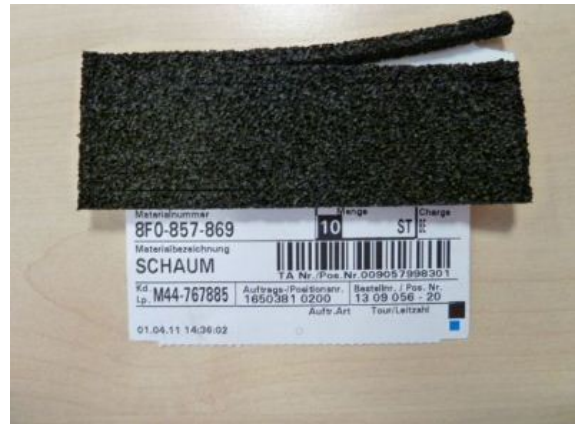
Figure 4. Sealing foam tape.

4. Insert strips of sealing foam tape **8F0857869** into the channel that surrounds the turn signal lamp (Figure 4).

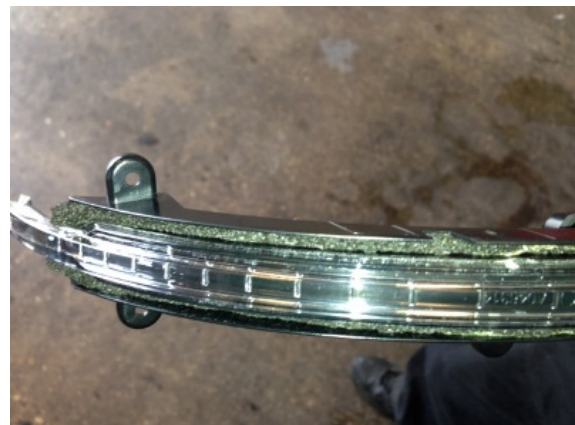
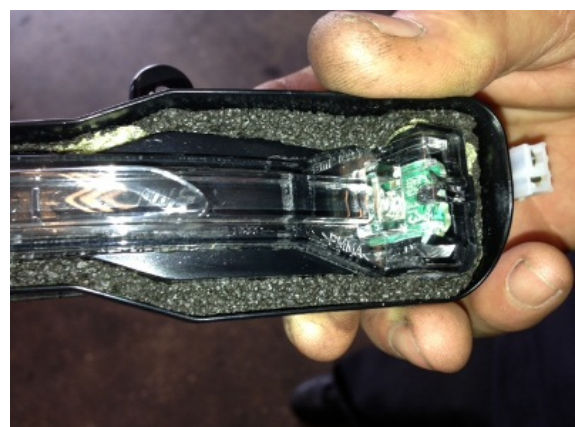
Figure 5. Turn signal lamp with sealing foam tape installed.

Figure 6. Turn signal lamp with sealing foam tape installed.

5. Leave no gaps around the perimeter of the turn signal lamp channel (Figures 5 and 6).
