# Technical Service Bulletin

## 70 Noises from the upper-center dashboard area

70 13 33 2029280/2 July 12, 2013. Supersedes Technical Service Bulletin Group 70 number 12-28 dated April 13, 2012 for reasons listed below.

Model(s)	Year	VIN Range	Vehicle-Specific Equipment
A6 / A7 (C7)	2012	000001 - 151934	All

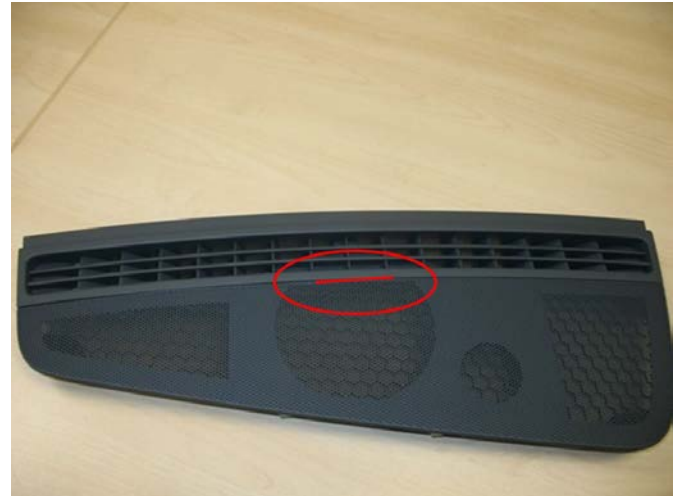
The noise can be caused by unfavorable tolerances between the instrument panel speaker and the center speaker trim. A speaker that has been incorrectly installed can make the condition worse.

Because there is no attachment to the trim carrier in the speaker cut-out, this area is the likely source of the vibration (Figure 1).

**Figure 1.** The affected area of the speaker grille, circled in red.

Replace the center defroster vent and the speaker trim. Review the steps below before proceeding:
