**SUBARU**

## SERVICE BULLETIN

**NUMBER:** 02-148-13R

**SUBJECT:** Repair Procedure for Abnormal Sound from  
 Engine Mounts

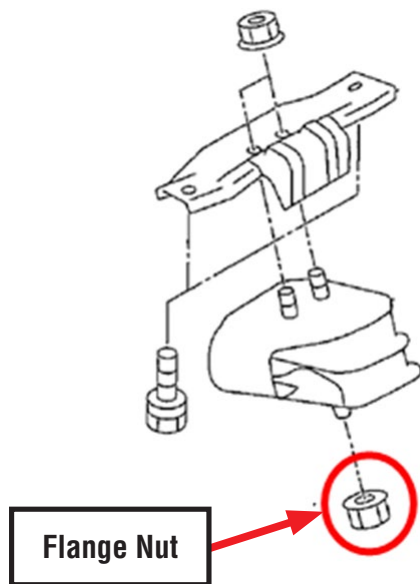
This bulletin provides a repair procedure to address customer concerns of abnormal sounds which after diagnosis, have been determined to be coming from the engine mounts. In some cases, the vehicle's usage patterns may put excessive force on the lower engine mount retaining nuts. The torque specification for these nuts has been revised accordingly.

**One-Time Use Item**  
**Torque to 60Nm (44 Ft. Lbs.)**

Confirm the customer concern is being caused by the engine mount condition as described in this bulletin. Always replace **BOTH** the left and right side flange nuts if either is found to be loose or missing. Whenever removing a flange nut, inspect the threads of the engine mount stud closely and replace the mount if any damage is found. When installing the new flange nuts, torque to 60Nm (44 Ft. Lbs).
