April 09, 2013

UPDATE – 97Z5 Engine Wiring Spacer Ring (NVLW)

Model(s)	Year	Engine Code	Trans. Code
Touareg	2013	CNRB	All
		(3.0L TDI)

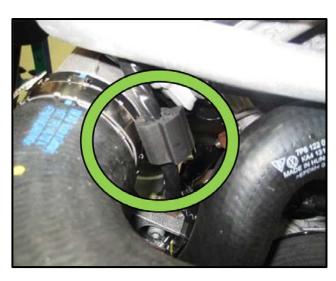
On all affected vehicles the engine harness can rest and chafe on the clip of the pressure pipe.

- Open hood and remove engine cover
- Locate engine harness in area marked <circle>.

On all affected vehicles a spacer ring must be fitted to protect the engine harness.

- If spacer ring is already installed as shown <circle>, WORK COMPLETE, otherwise Continue work procedure.
- If spacer ring is not already installed, install spacer ring part number (N 107 162 01) as shown <circle>.
- Reinstall engine cover and close hood
