# Technical Service Bulletin

## 48 Power steering warning in cluster, DTC for end stops

48 13 35 2029622/3 February 14, 2013. Supersedes Technical Service Bulletin Group 48 number 12-34 dated October 23, 2012 for reasons listed below.

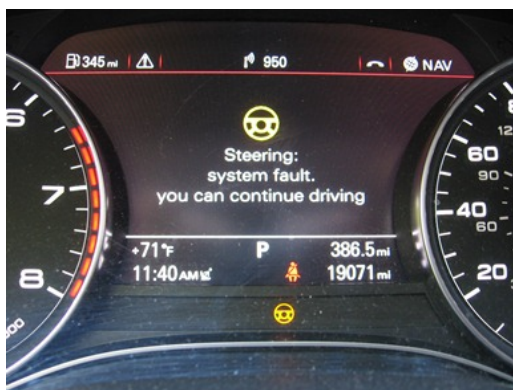
The yellow steering symbol is illuminated in the instrument cluster. **DTC C10ACFO** (steering end stops not programmed) is logged in the power steering control unit, J500 (44).

**Figure 1.** Yellow steering symbol and cluster message.

The power steering control unit, J500 (44), expects to receive a VIN message over the data bus shortly after terminal 15 is turned on. If the VIN message is not received at the expected time, the power steering control unit assumes it has been installed in a new vehicle and discards the programmed end position values.

1. Follow all instructions in the attached TSB 2011732 *00 Software Version Management (SVM), operating instructions*.
2. Update the power steering gear control module (J500) using the SVM action code as listed in the table below if necessary.
