Technical Service Bulletin

94 Headlight Flickering or Warning On in Cluster (All Xenon Headlights)

94 13 03 2029194/3 February 1, 2013. Supersedes Technical Service Bulletin Group 94 number 12-99 dated November 30, 2012 for reasons listed below.

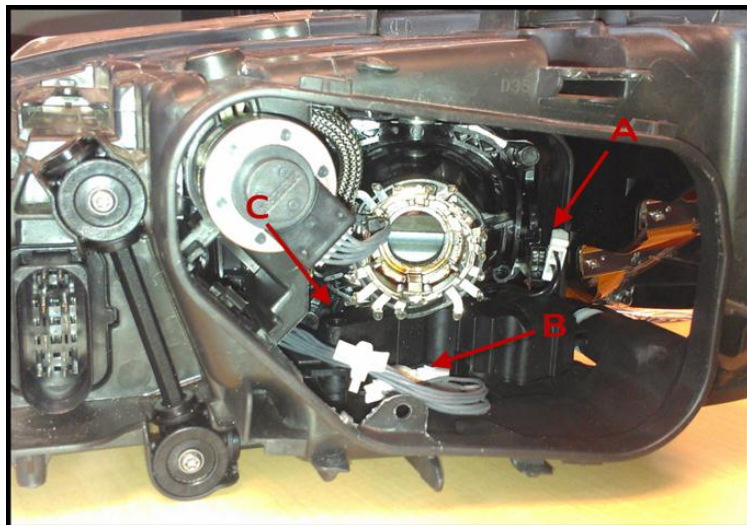
One or more of the connectors inside the headlamp housing are disconnected fully or partially from the factory.

Figure 1. Back of Tri-Xenon Headlight showing three connectors, "A", "B", "C". Bi-Xenon Headlight will only have a single "A" connector.

4. Ensure all the connectors are fully seated and locked. If a loose connector is found, skip step 5 and move to step 6.
5. If no loose connector is found and the issue still persists then the issue, is outside the scope of this TSB and the remaining steps can be skipped. A swap of headlamp components between left and right is the next logical step to narrow down the failed part of the headlamp.

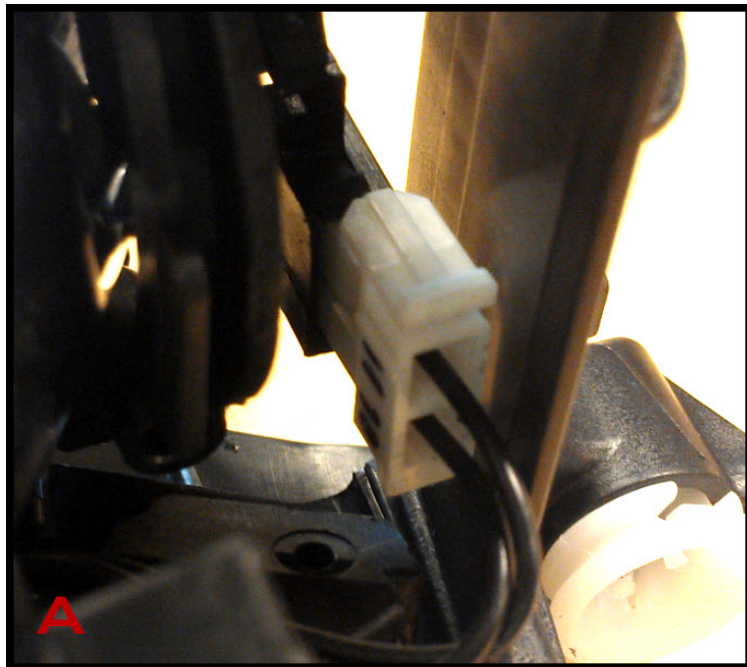
Connector "A" (Figure 2, A) can be seated but not fully engaged. When pushing on this connector the projector will swivel, thus you will need to hold the projector housing when applying pressure to the connector.

Figure 2. Connector "A" shown not fully seated.

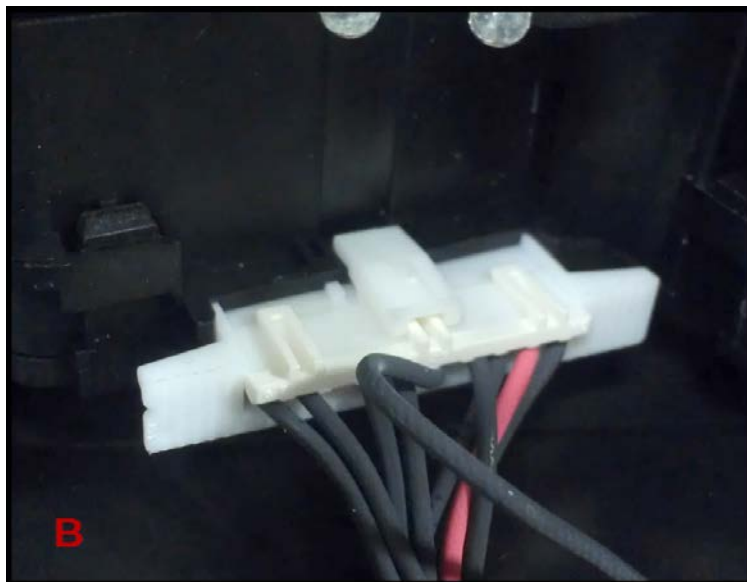
Connector "B" (Figure 3, B) can be fully locked into place but it can be rotated 5-10 degrees off center. Thus, please check to ensure the harness connector is seated parallel to the connector housing on the headlamp.

Figure 3. Connector "B" shown off center.

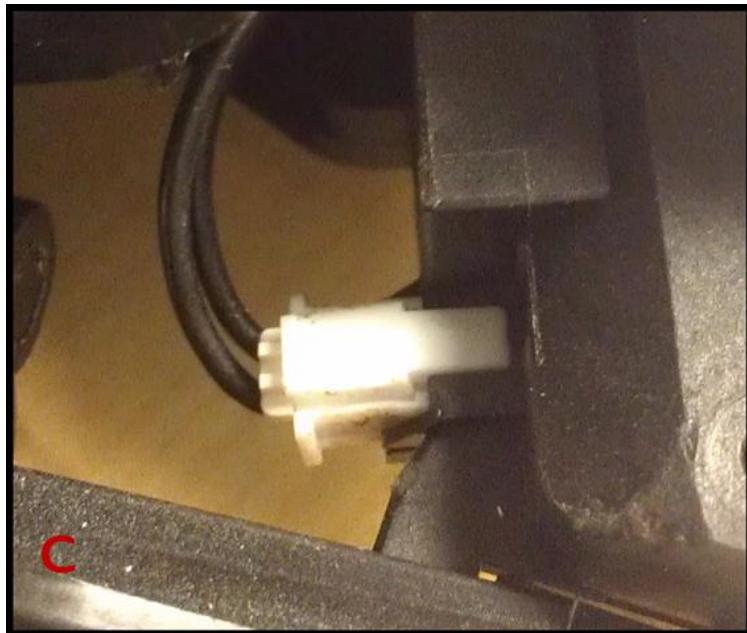
Figure 4. Connector "C" shown in the locked position.

Connector "C" (Figure 4, C) is located behind the motor mechanism, which rests below the projector lens. This is a very small two-pin connector. Take care when wiggling this connector because if it becomes fully disconnected, it is very difficult and almost impossible to reconnect without using special tools. Place your finger, or a set of small bent pliers, on this connector and pull towards yourself to fully seat the connector.
