Technical Service Bulletin

94 Daytime Running Light (DRL) inoperative

94 13 05 2032184/1 February 8, 2013.

Model(s)	Year	VIN Range	Vehicle-Specific Equipment
Q5	2013	All	Audi Xenon Plus with LED Daytime Running Lights
	2014

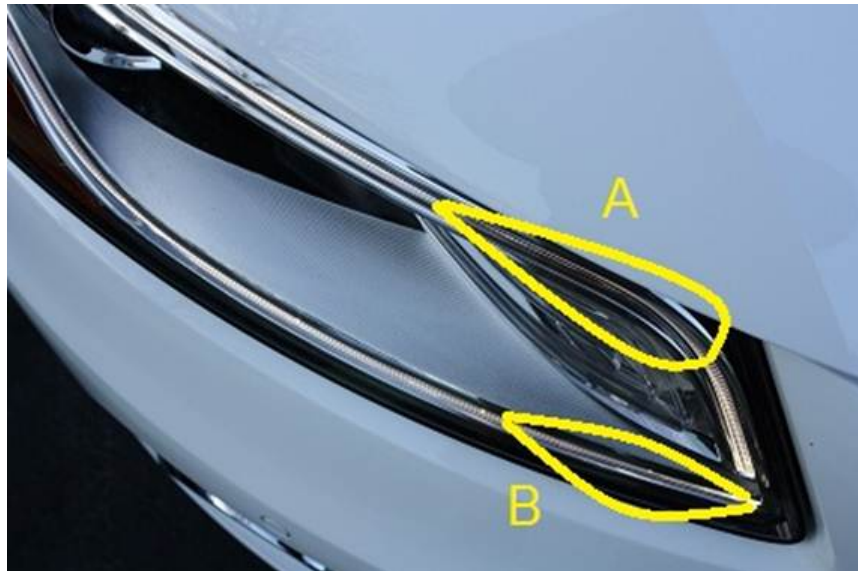
- A defect may be perceived for top-down viewing angle (Figure 3).

Figure 3. Upper light pipe perceived defect (A). Lower light pipe perceived defect (B).

Explain to the customer that the LED illumination appears differently to someone standing in front of the vehicle than it appears to oncoming traffic. The viewing angle of someone standing in front of the vehicle will give a visual effect of an LED DRL inoperative or partially-inoperative condition.

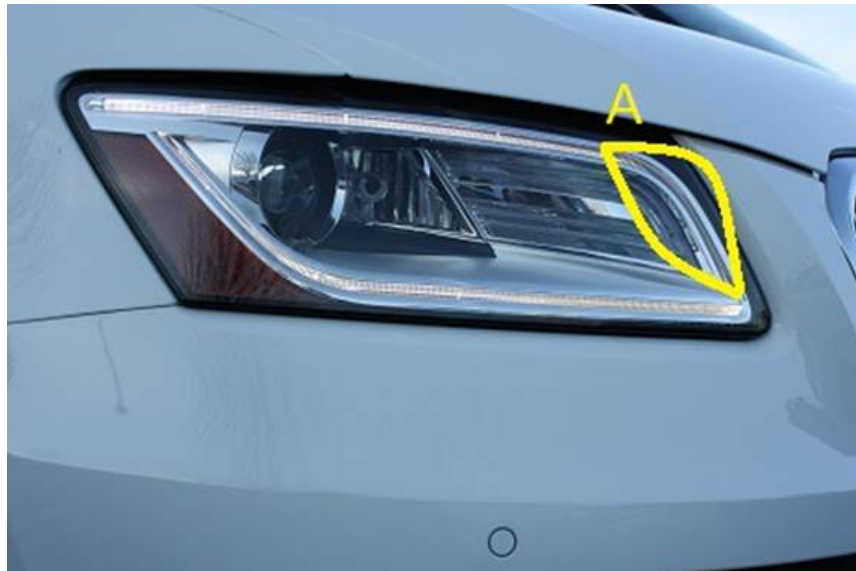
- A defect may be perceived for corner viewing angle (Figure 4).

Figure 4. Upper light pipe perceived defect (A).

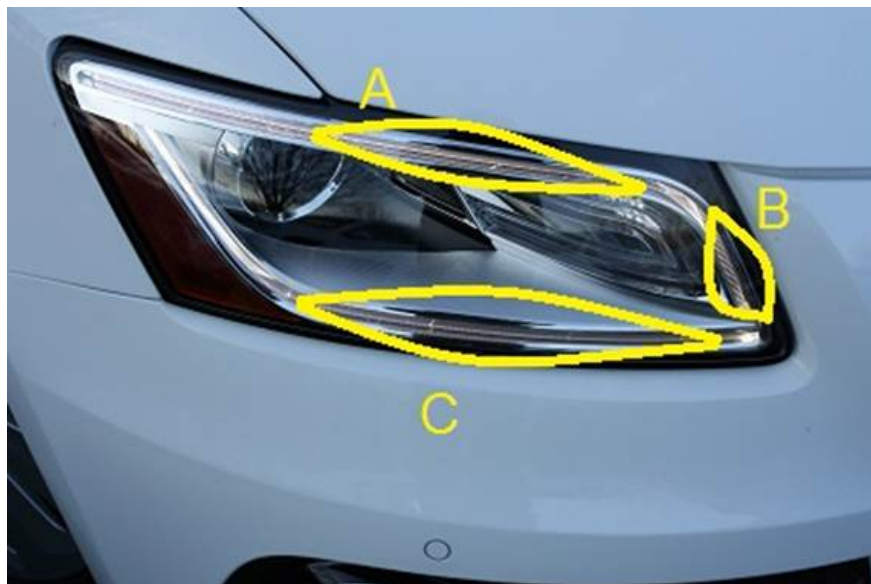
- A defect may be perceived for acute corner viewing angle (Figure 5).

Figure 5. Upper light pipe perceived defect (A, B). Lower light pipe perceived defect (C).

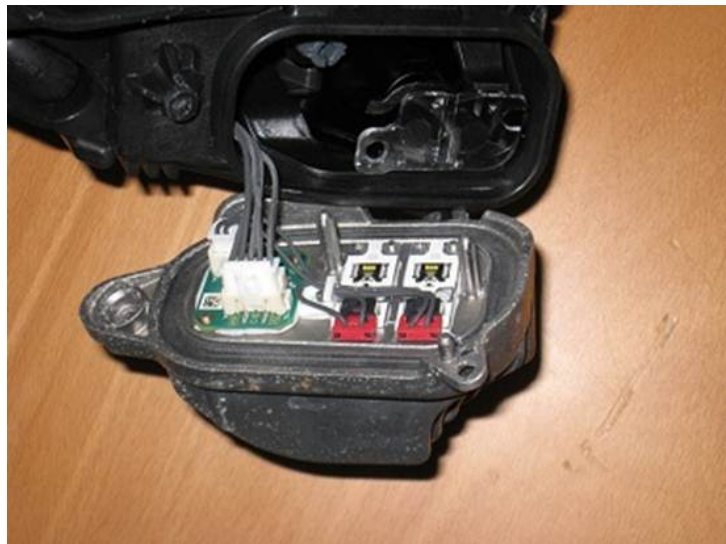
Be extra careful of red surface mount connectors. In general, a repair kit is not available for any internal headlight connectors.

Figure 6: Dual surface mount LED unit exposed.

1. With ignition off, remove DRL control module and check red connector at module. Secure it, if loose. If necessary, remove red connector and reinstall to be sure connector is engaged properly. The wire guide of the red terminal housing may impede connector engagement.
2. Turn ignition on to see if DRL is now operating to specifications. If it is not, proceed to step 3.
3. Remove headlight(s) according to repair manual. See *Repair Manual >> Electrical System >> Electrical Equipment >> 94 Exterior Lights, Switches >> Removal and Installation*.
4. With ignition off, remove LED DRL unit with heat sink from headlight housing (Figure 6).
5. With ignition off, inspect and secure all electrical connectors, if loose. Remove and secure the white connectors, even if they do not appear to be loose.

6. If the above steps do not correct the DRL operation, continue with further diagnosis on the LED control module and LED with heat sink before replacing the headlight housing; e.g., swapping modules from one headlight to another, inspect wiring, connectors, etc.
