## Field campaign

Topic	Mulsanne side view camera control module (SC12/15)
Market area	Worldwide Bentley (1WBE)
Brand	Bentley
Transaction No.	2030874/3
Campaign number	E775
Note	E775
Type	
US code

### Mulsanne

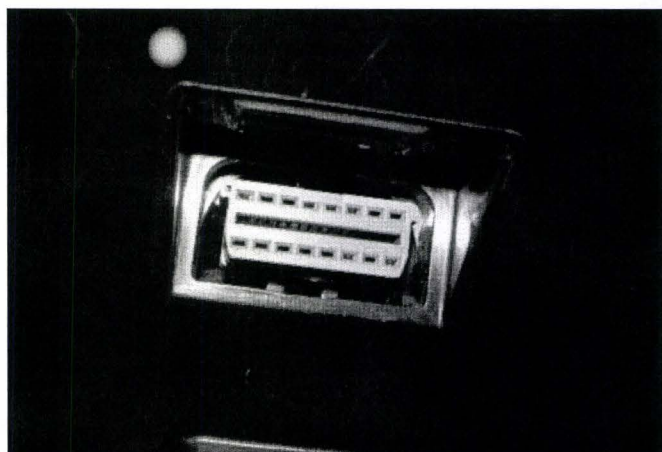
Figure 1

In January 2012 a TPI was released which instructed Dealers to remove where fitted the side view camera control module as a potential fault was identified with the original part. The latest specification side view camera control module is now available for all Bentley Mulsanne vehicles which were specified with the side view camera option. If the original module has been previously removed and replaced with the link loom as per previous instruction, a Yellow paint mark will be evident on the diagnostic plug surrounding cover as shown in Figure 1, please remove the loom and fit the replacement side view camera module as detailed within this document.

Should the vehicle still have the original side view camera module fitted or the link loom was installed at the time of production a Yellow paint mark will not be evident, if this is the case please replace the existing module or remove the link loom and replace with the latest specification part as detailed within this document.

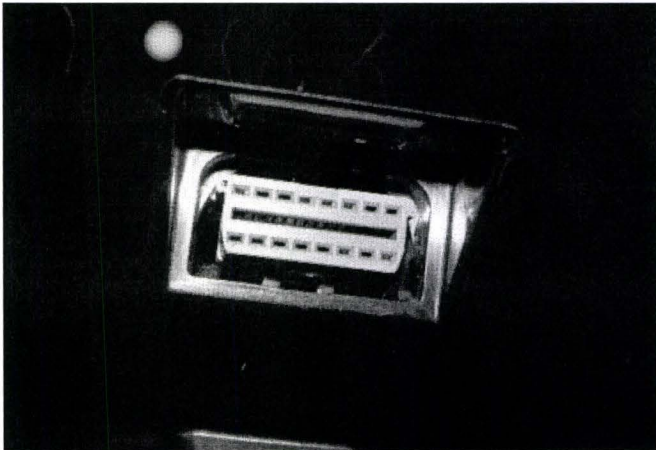
Figure 1

In January 2012 a TPI was released which instructed Dealers to remove where fitted the side view camera control module as a potential fault was identified with the original part. The latest specification side view camera control module is now available for all Bentley Mulsanne vehicles which were specified with the side view camera option. If the original module has been previously removed and replaced with the link loom as per previous instruction, a Yellow paint mark will be evident on the diagnostic plug surrounding cover as shown in Figure 1, please remove the loom and fit the replacement side view camera module as detailed within this document.

Should the vehicle still have the original side view camera module fitted or the link loom was installed at the time of production a Yellow paint mark will not be evident, if this is the case please replace the existing module or remove the link loom and replace with the latest specification part as detailed within this document.

3. Should the original side view camera control module have been previously removed and replaced with the link loom 3Y0 998 381 there should be a Yellow completion paint mark on the diagnostic plug surrounding cover (Figure 1), please carefully remove this and replace with a White paint completion mark as shown in Figure 2. If the original control module has been replaced for the latest specification part or the factory fitted loom has been replaced with the latest specification part, a White paint completion mark should also be added (Figure 2)

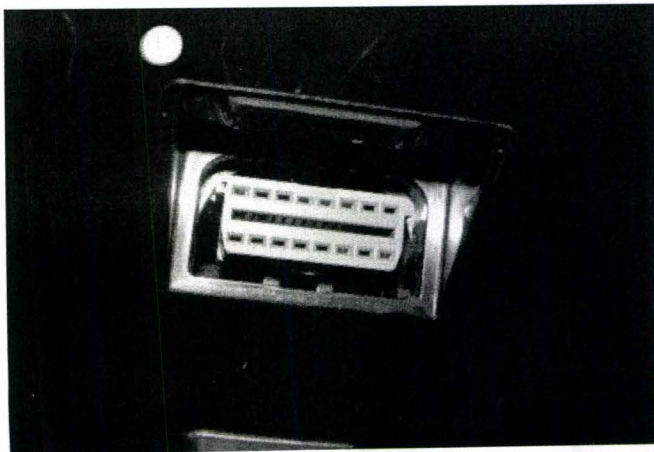
Figure 2

If the vehicle is not already listed as repaired in "Repair history" (in Elsa pro), check for the Campaign completion identification mark which is a White paint mark located above the diagnostic plug cover (Figure 2) the White mark confirms the latest specification part has been fitted, should neither be evident carry out the required work in accordance with instructions.

White paint mark on the diagnostic plug surrounding cover confirms the latest specification part has been fitted.
