## SERVICE BULLETIN

**APPLICABILITY:** 2013 MY BRZ

**NUMBER:** 12-145-13

**SUBJECT:** Condensation in Rear Combination Lamps,  
 Retaining Nut Change

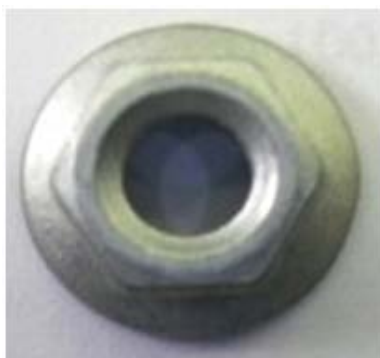
Due to a smaller diameter flange surface, the original retaining nuts may distort the rear body panel mounting and sealing surfaces for the combination lamps enough to allow moisture seepage past the seals into the combination lamps and possibly the trunk area.

Original Nut, 12mm  
 diameter flange surface

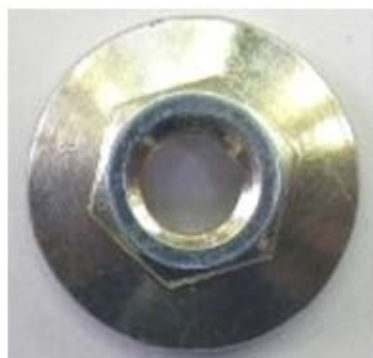
Revised Nut, 15mm  
 diameter flange surface

The revised retaining nuts with a larger diameter flange surface were incorporated into production starting with VIN D\*605847.

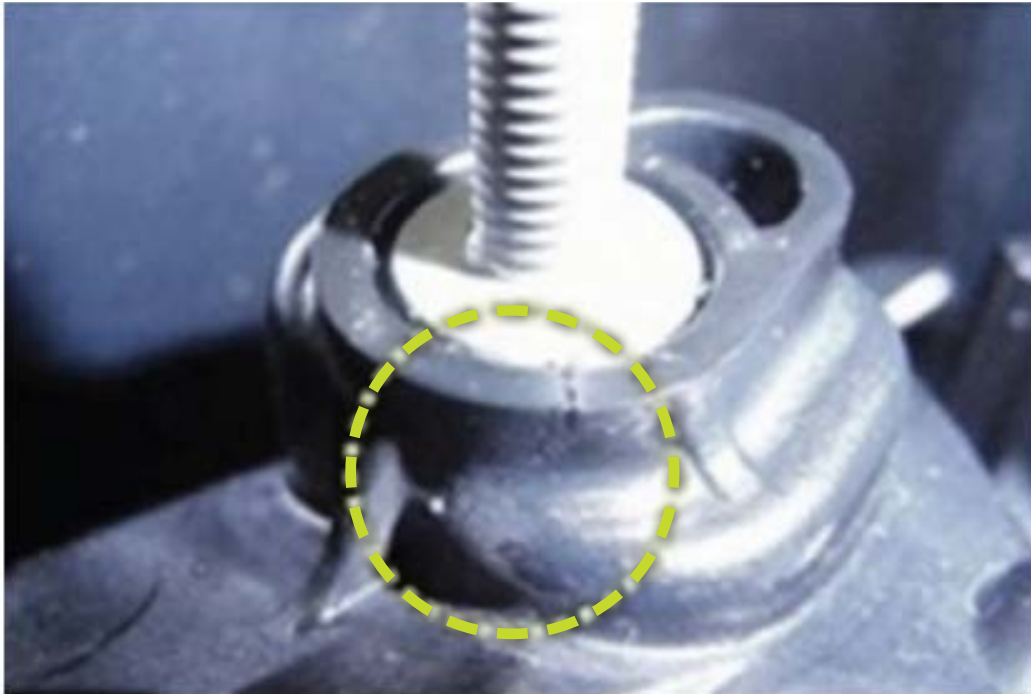
#### Example of crack

Once the combination lamps are removed, inspect their mounting stud boss areas carefully for any cracking as shown in the photo example below. Any damaged combination lamps must be replaced.

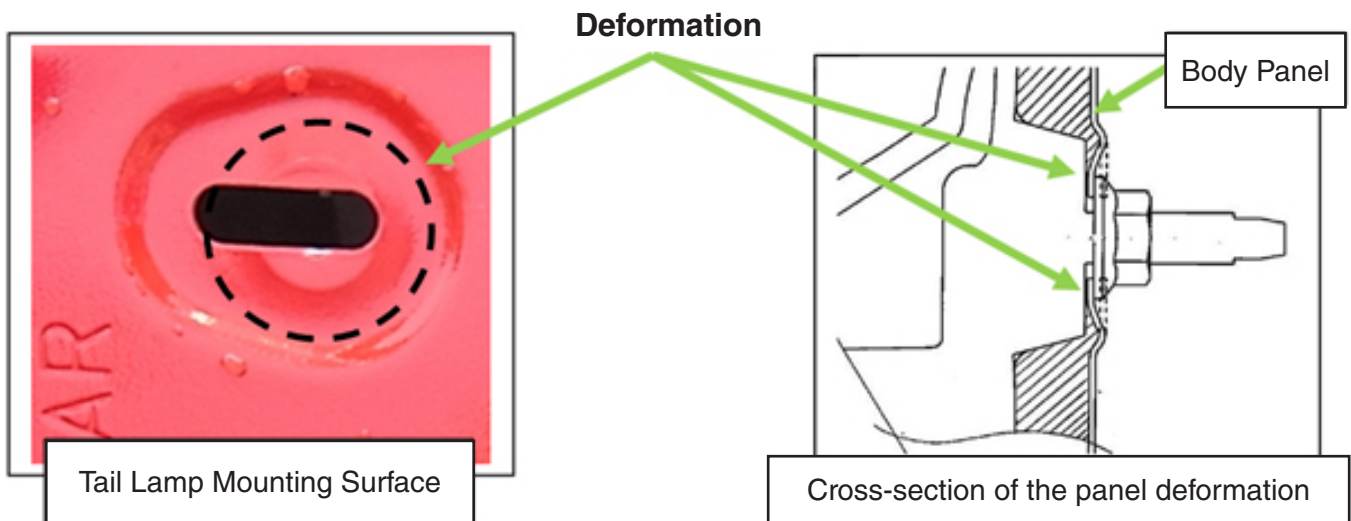
Inspect the rear body panel in the retaining nut areas for any deformation of the metal as shown in the illustrations below.

If any deformation is found, CAREFULLY straighten the affected mounting area using a small body hammer and dolly.
