Technical Service Bulletin

72 Rear center seat rattles and does not fold flat

72 13 08 2023324/2 September 10, 2013. Supersedes Technical Service Bulletin Group 72 number 10-01 dated April 23, 2010 for reasons listed below.

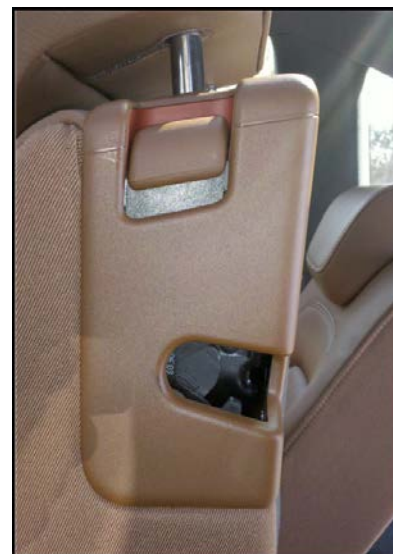
The rod between the rear center backrest latch and the release lever is detached (Figure 1). After the rod detaches and the center backrest is latched to the rear backrest on the driver's side, the center backrest cannot be folded flat independent from the driver's side rear backrest.

The loose connection inside the latching mechanism can create noises from the rear center seat when the vehicle is driven over rough roads.

Figure 1. The rear center backrest latch and release lever.

Follow the instructions below to replace both the release lever and the lock cover.

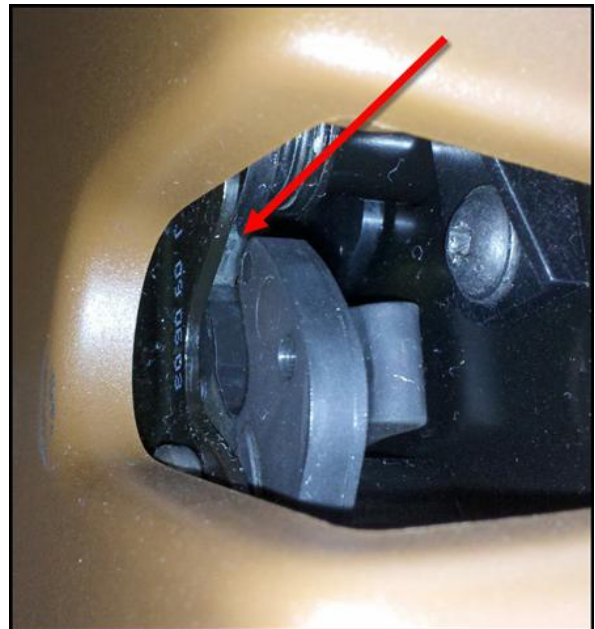
Figure 2. Arrow indicates direction to insert screwdriver. The latch is shown in the locked position.

1. Manually unlatch the center backrest from the driver's side rear backrest. To do this, insert a small, flat, regular screwdriver (with an end width of 6 mm-8 mm) into the latch to release the locking mechanism (Figure 2).

The latch concept is the same as a door latch; pressing inward will release the latch.

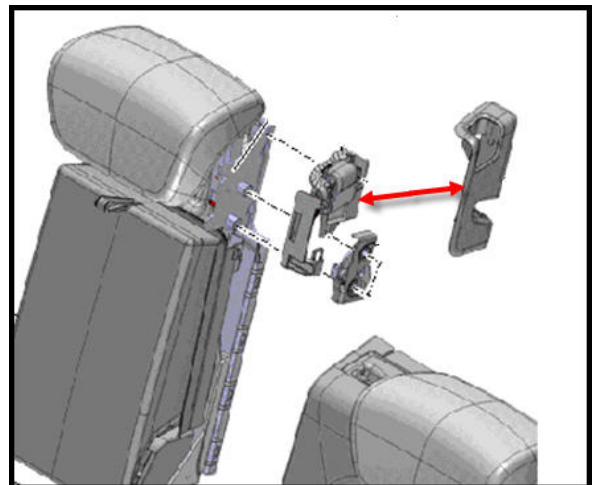
Figure 3. The release lever button and lock cover (arrows).

2. Use the repair instructions in Elsa to remove and replace the release lever button and the lock cover (Figure 3 and Figure 4).

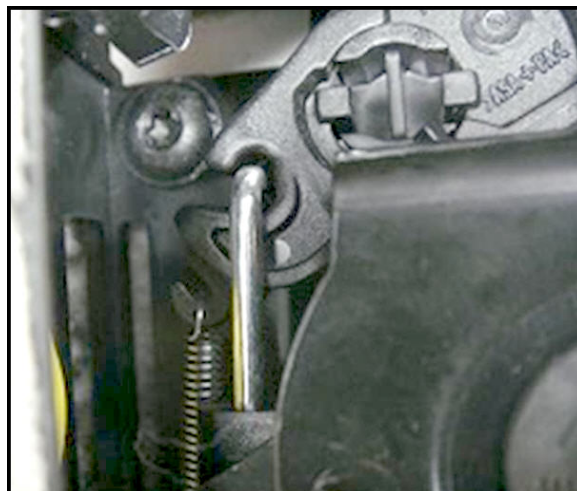
Figure 4. The optimized connection point of the release lever and the connecting rod.
