Technical Service Bulletin

72 Rattle from left rear seat back

72 13 12 2030729/4 October 21, 2013. Supersedes Technical Service Bulletin Group 72 number 13-05 dated September 5, 2013 for reasons listed below.

Model(s)	Year	VIN Range	Vehicle-Specific Equipment
Audi Q5	2009 - 2012	All	Not Applicable
Audi Q5	2013	000001 - 009164

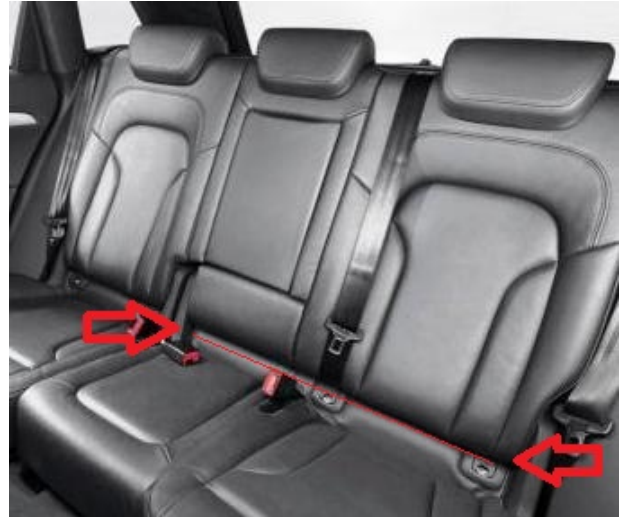
- The rattle sound may be caused from the pivot point of the torsion bar (Figure 1) within the 2/3 rear seat backrest pivot assembly.

Figure 1. Left rear seat noise area marked with red arrows.

Improved 2/3 rear seatback frame torsion bar to pivot incorporating internal plastic guides. The striker pin has also been improved to reduce the contact surface with the lock.

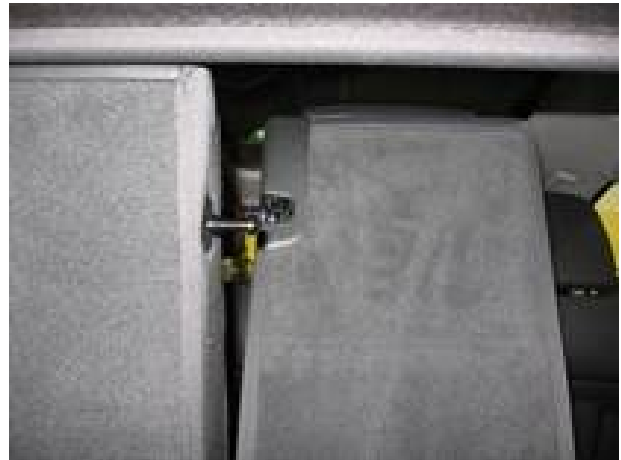
- The squeak noise may be coming from the rear seat armrest area, specifically from the contact surface between the armrest lock and the striker pin (Figure 2).

Figure 2. Armrest lock striker pin.

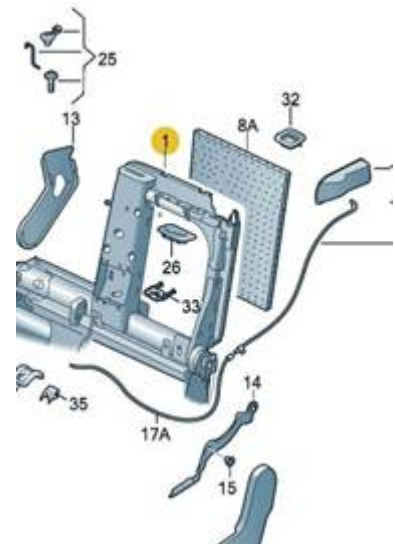
Figure 3. 2/3 seatback frame

1. Start diagnosis by performing a test drive. Sit in the right rear seat of the vehicle while a partner drives.
2. Ensure that there are no objects or passengers in the left rear seat, as the rattle is best diagnosed under these conditions.
3. If the 2/3 rear seatback is confirmed as the source of the rattle, the 2/3 rear seatback frame must be replaced, as the 2/3 rear seat backrest frame is not serviceable (Figure 3).

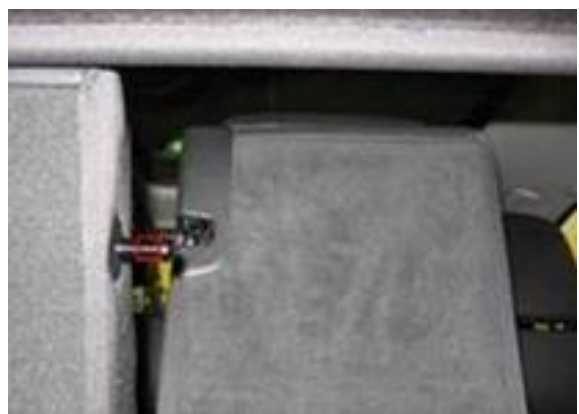
Figure 4. Area of striker pin to be lightly sanded.

1. Confirm that the source of the squeak is the armrest lock.
2. Lightly sand the contact surface of the striker pin to create a “knurled” effect (Figure 4).
