# Technical Service Bulletin

## 74 S-line front seat head restraint feed-through hole exposed in leather backrest cover

74 13 13 2018257/5 October 21, 2013. Supersedes Technical Service Bulletin Group 74 number 13-10 dated September 13, 2013 for reasons listed below.

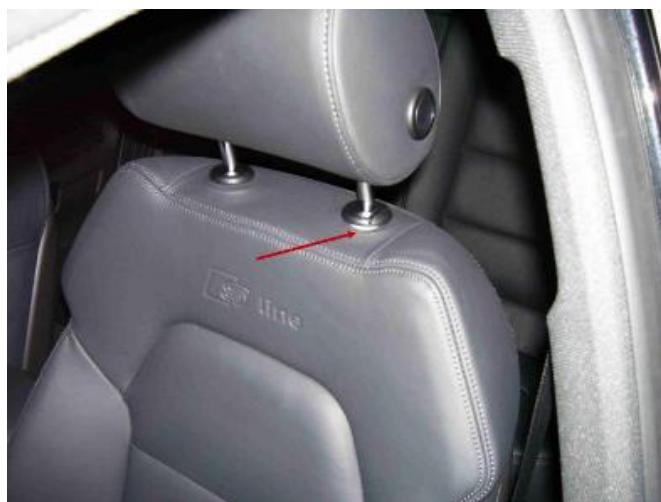
The head restraint feed-through hole is visible on the seat backrest cover.

Depending on how the customer enters the vehicle, the leather backrest cover may be pulled forward, exposing the feed-through hole for the head restraint. This condition only affects vehicles with S-line sport seats.

**Figure 1.** The head restraint feed-through hole, exposed.

Replace the front seat backrest cover.
