Technical Service Bulletin

74 Seat heating performance too low

74 13 14 2028257/8 October 21, 2013. Supersedes Technical Service Bulletin Group 74 number 13-11 dated September 13, 2013 for reasons listed below.

Model(s)	Year	VIN Range	Vehicle-Specific Equipment
Q5	2012	000000 -090179	Heated front seats

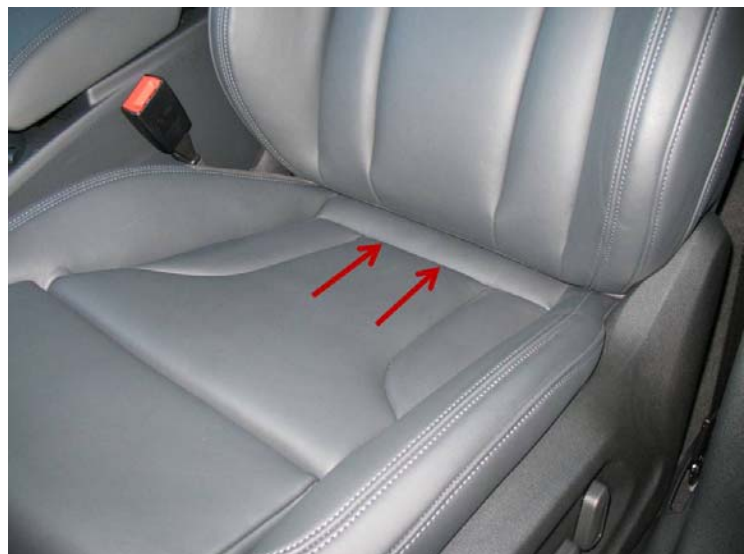
From model year 2012, an additional row of fastening features were added to improve the fit of the leather seat covers on the basic and sports seats (Figure 1).

As a consequence of this change, the temperature sensor within the seat was moved to a location that is more sensitive to heat. As a result, the control limit is reached too early and the heat is reduced before the seating surface reaches the correct temperature.

Figure 1. Arrows show area where additional fastening clips were added.

Install new software in the electronic central electrics unit (BCM1) control module, J519 (address word 09), to modify the control limit for the seat heater.
