Technical Service Bulletin

91 MMI screen carrier shudders/noisy

91 13 05 2028446/5 September 12, 2013. Supersedes Technical Service Bulletin Group 91 number 13-01 dated August 15, 2013 for reasons listed below.

Model(s)	Year	VIN Range	Vehicle-Specific Equipment
A6, A7	2012	All	Not Applicable

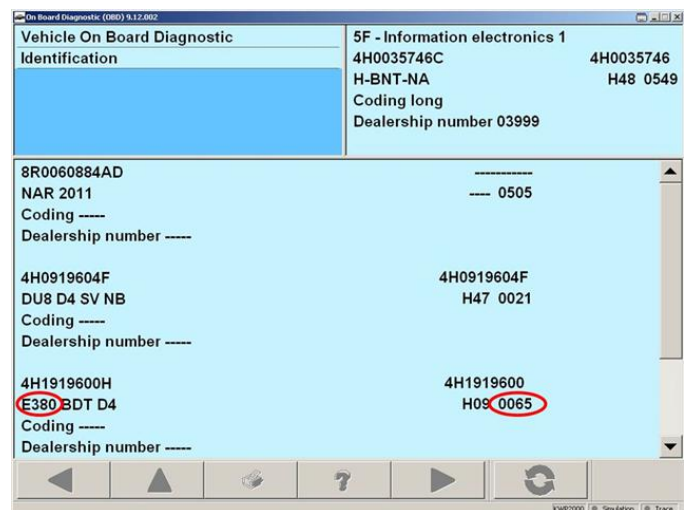
Figure 1. Location of E380 software version.

1. Replace the MMI display carrier with part number **4G8857346E** as per ELSA repair manual instructions.
2. Using GFF, determine the software level of the E380 controller. This can be accessed through *Vehicle Self-Diagnosis >> On Board Diagnostic (OBD) >> 5F- Information Electronics 1* (Figure 1). It will be the third item on the list.

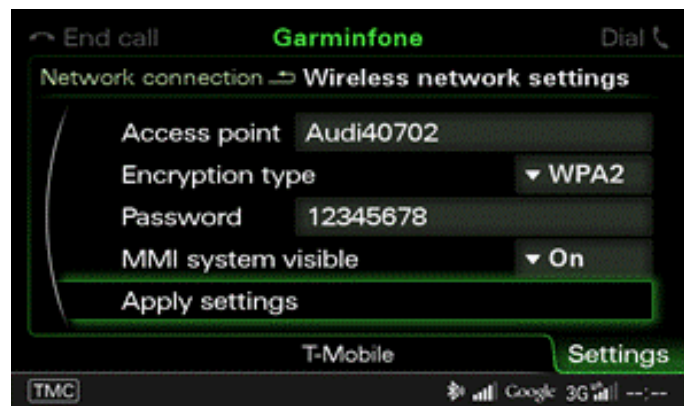
Figure 2. Wireless network settings.

3. As part of the update, wireless settings and paired devices will be deleted. All devices will need to be re-paired after the update, and all wireless settings restored to the customer's settings. To access the Wireless Network Settings on the MMI (Figure 2), press *TEL >> Settings >> Wireless network connection >> Wireless network settings*. Record all settings so they can be re-entered at the end of the procedure.

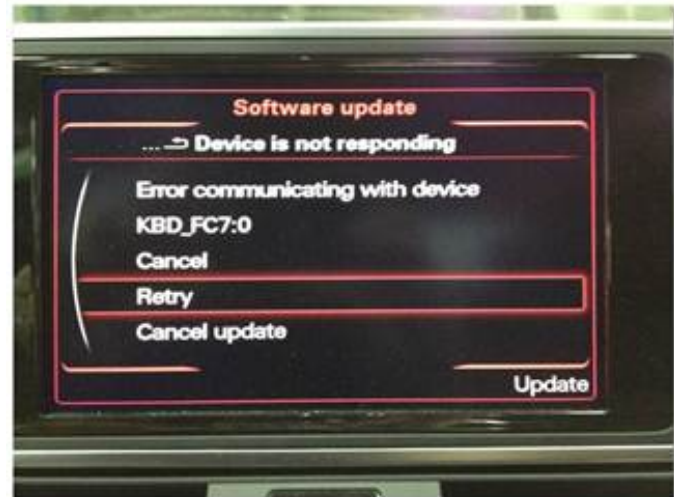
Figure 3. A device requiring a 'Cancel' selection.

Some earlier model year 2012 vehicles or vehicles equipped with Bose sound systems may experience certain modules that will not update properly during Step 16 of TSB 2028141. If this should occur, either choose 'Cancel' (Figure 3), or 'Skip device' (Figure 4), depending on the type of error. Do *not* choose 'Cancel update', as this may cause the software update to fail entirely. After the update is finished and the summary page is shown, select 'Retry' at the bottom of the list if it is available to attempt to update the modules again. If 'Retry' is greyed out, then the software update was successful, so select 'Continue' to proceed. In some cases 'Retry' may have to be repeated two or three times to get all modules to update successfully.

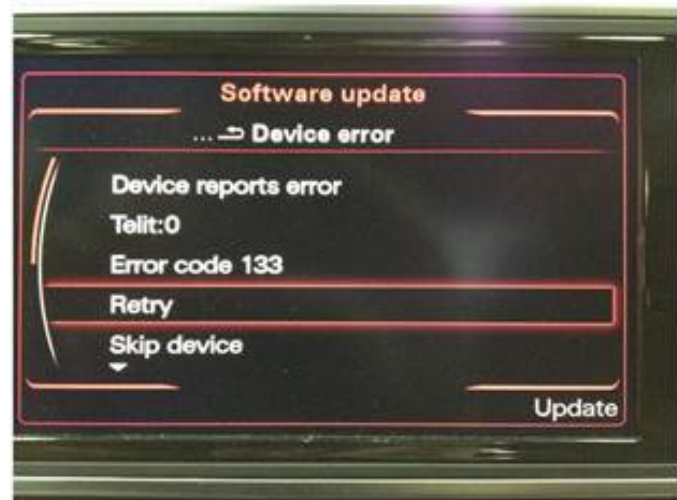
Figure 4. A device requiring a 'Skip device' selection.

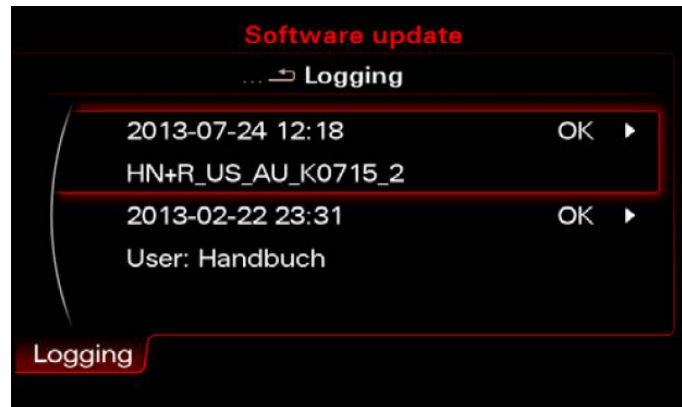
Figure 5. Software update log showing a successful software installation.

5. Verify that the software update has been completed successfully by accessing the logging page (Figure 5). To access this screen, proceed to step 8 in TSB 2028141 and press the lower left softkey. A successful update will show the date the update was performed, the software that was installed (HN+R_US_AU_K0715_X), with 'OK' listed on the right. The 'X' may be one of several different numbers. If K0715_X does not have any rows with 'OK', the update must be retried until it is successful.

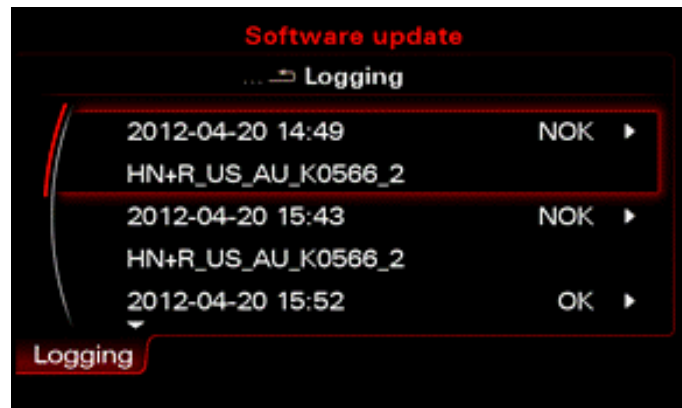
Figure 6. Software update log showing 2 failed attempts before a successful installation.

Tip: If the update must be performed two or more times due to modules not updating correctly, a screenshot of the software update log is required (Figure 6). This should be kept on-hand for warranty auditing purposes. To take a screenshot, insert an SD Card into slot 1 and press and hold the left and right arrow keys at the same time. All 4 softkeys will flash when the screenshot is taken. A screenshot should be taken of each page in the logging display.
