Technical Service Bulletin

91 MMI 3G Basic Sound system "popping" (K0250 Update)

91 13 09 2035232/1 September 25, 2013.

Model(s)	Year	VIN Range	Vehicle-Specific Equipment
A6	2011	All	MMI Basic (8DS)
Q7	2011-2013

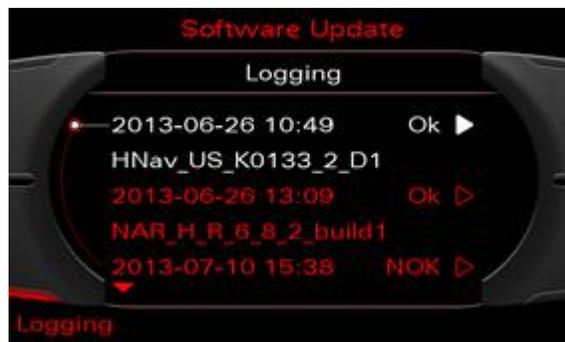
After a successful update, the screen will show the date on which the update was performed and the software that was installed (BBT_US_K0250_X_XX — The X characters will be one of several different numbers or letters). 'Ok' will be listed on the right. If K0250 does not have any rows with 'Ok', the update must be retried until it is successful.

Figure 1. Software update log showing a successful software installation. (MMI 3G High screenshot used as reference).

2. Verify that the software update has been completed successfully by accessing the Logging page (Figure 1). To access this screen, proceed to step 8 in TSB 2028141, and press the lower left softkey.

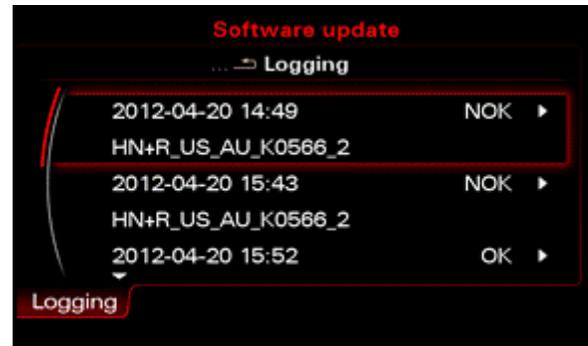
Figure 2. Software update log showing 2 failed attempts before a successful installation (MMI 3G+ screenshot used as reference).

Tip: If the update must be performed two or more times because the modules are not updating correctly, a screenshot of the software update log is required (Figure 2). This should be kept on-hand for warranty auditing purposes. To take a screenshot, insert an SD Card into slot 1 and press and hold the left and right arrow keys at the same time. All four softkeys will flash when the screenshot is taken. A screenshot should be taken of each page in the logging display.
