Technical Service Bulletin

91 MMI 3G Sound system "popping" and/or other audio issues (K0133 Update)

91 13 10 2034923/3 October 16, 2013. Supersedes Technical Service Bulletin Group 91 number 13-06 dated September 12, 2013 for reasons listed below.

Model(s)	Year	VIN Range	Vehicle-Specific Equipment
A4	2011 - 2012	All	MMI 3G
A5 / A5 Cab	2011 - 2012		
A6	2011		
Q5	2011 - 2012		
Q7	2011

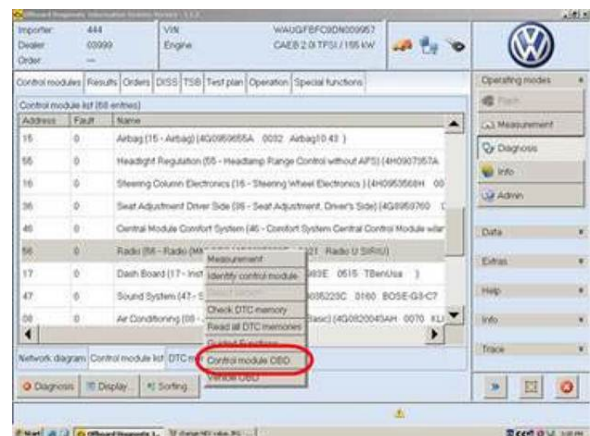
Figure 1. Radio self-diagnosis.

1. Verify the HD radio is enabled in the MMI by navigating to *Radio >> Settings*.
 - If the HD radio options are present in the MMI menu, proceed directly to Step 6.
 - If the HD radio options are not present in the MMI menu, continue with Step 2.
2. Using ODIS, right-click on 56 – *Radio* in the control module list, and select *Control Module OBD* (Figure 1).

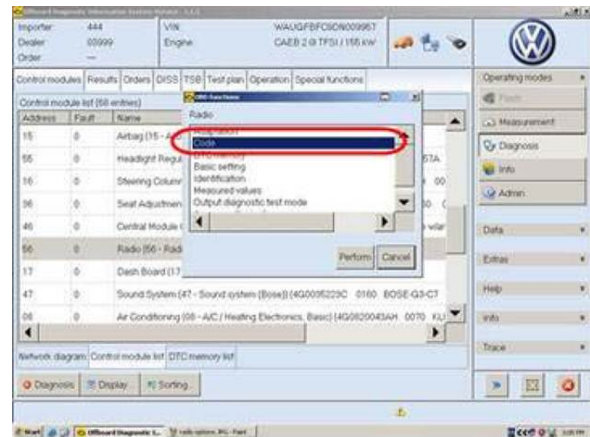
Figure 2. Code radio option.

3. Select *Code* (Figure 2).

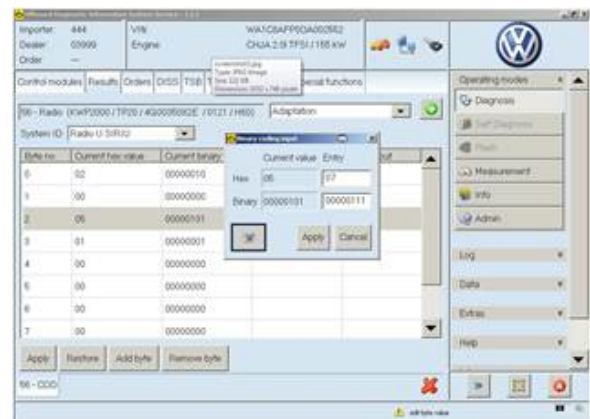
Figure 3. Changed radio coding.

4. Verify the coding in byte 2 is HEX 07.

- If it is not HEX 07, change the coding to HEX07. Apply changes (Figure 3).

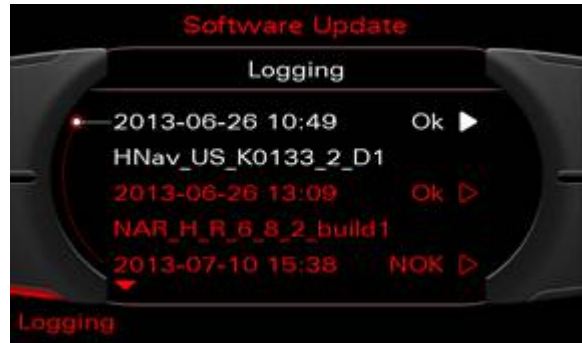
Figure 4. Software update log showing a successful software installation.

7. Verify that the software update has been completed successfully by accessing the logging page (Figure 4). To access this screen, proceed to step 8 in TSB 2028141 and press the lower left softkey.

After a successful update, the screen will show the date on which the update was performed and the software that was installed (HNav_US_K0133_X_XX — The X characters will be one of several different numbers or letters). 'Ok' will be listed on the right. If K0133 does not have any rows with 'Ok', the update must be retried until it is successful.

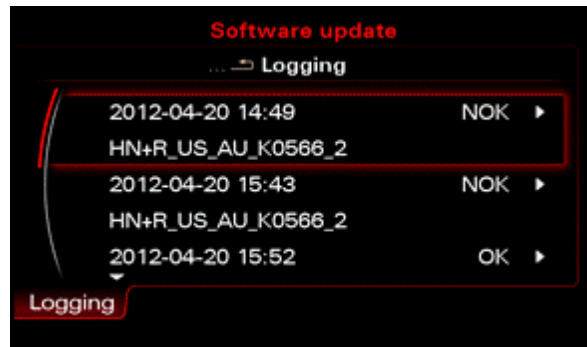
Figure 5. Software update log showing 2 failed attempts before a successful installation (MMI 3G+ screenshot used as reference).

Tip: If the update must be performed two or more times because the modules are not updating correctly, a screenshot of the software update log is required (Figure 5). This should be kept on-hand for warranty auditing purposes. To take a screenshot, insert an SD Card into slot 1 and press and hold the left and right arrow keys at the same time. All 4 softkeys will flash when the screenshot is taken. A screenshot should be taken of each page in the logging display.
