Technical Service Bulletin

91 MMI display mount will not open or close and/or makes noise

91 13 15 2035755/1 November 11, 2013.

Model(s)	Year	VIN Range	Vehicle-Specific Equipment
A8	2003 - 2010	All	MMI display

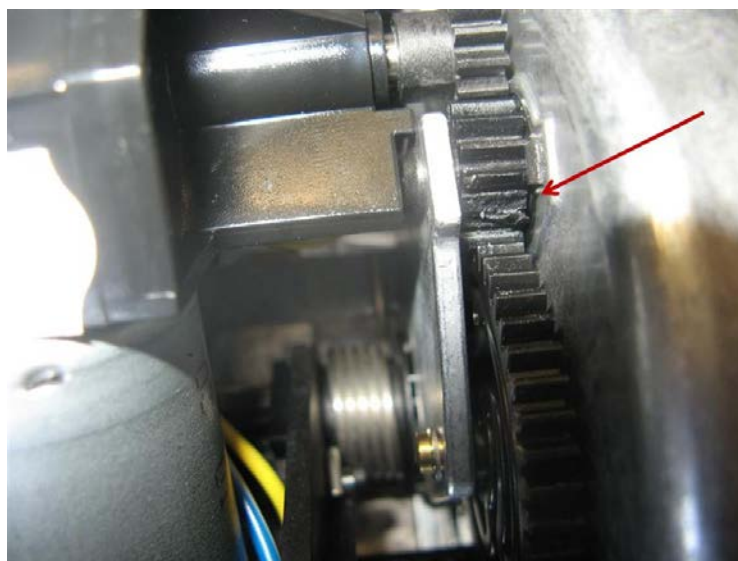
- A supplier error affecting certain MMI display mounts can cause the internal gear of the mount to get stuck after a few cycles (Figure 1).
- MMI display mounts produced between October 2012 and September 2013 with part number **4E0857273F** are affected.

Figure 1. Damage to the internal gear after it has gotten stuck.

4. • **If the production date is *between* October 2012 and September 2013:**
 - Replace the display mount. Verify that the production date of the replacement part is October 1, 2013 or later. If the production date of the replacement part is not October 1, 2013 or later, order another part.
 - If replacing under Parts Warranty, record the production date of the replaced display mount on the repair order.
 - Reassemble the vehicle and test the operation of the MMI display.
- **If the production date is October 1, 2013 or later:**
 - Continue with diagnosis of the issue. This TSB does not apply.

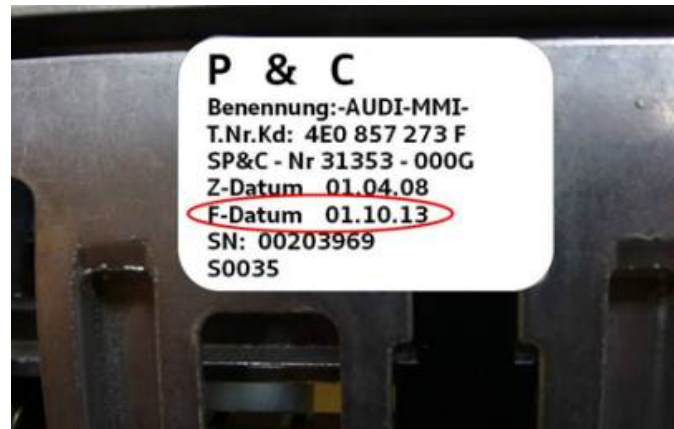
Figure 2. Location of the production date.
