# Technical Service Bulletin

## PSS 91 MMI 3G+ GPS Inaccurate

91 13 17 2035919/1 December 3, 2013.

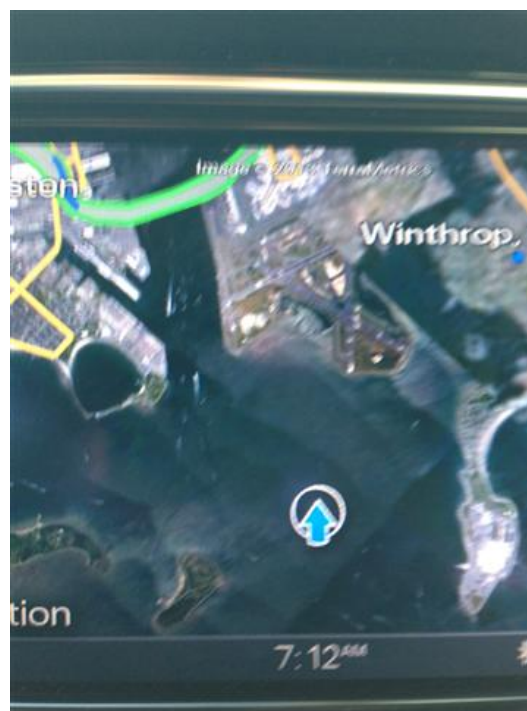
Customer states the navigation system is not tracking the vehicle correctly (Figure 1).

- No DTCs related to the GPS antenna or MMI system are present.
- The issue occurs after the vehicle is parked overnight or for several hours in a parking garage or other similar *enclosed* space. A private home garage does not apply.
- The issue does *not* occur if the vehicle is parked overnight or for several hours in an open-sky environment.
- The condition continues for the duration of the drive. The issue only corrects itself with a 3-finger reset or during a vehicle sleep cycle.

**Figure 1.** GPS location incorrect.

1. Diagnose the vehicle according to the instructions listed below. If customer's vehicle condition matches the condition listed in the *Condition* of this PSS TSB, explain to the customer that a solution is forthcoming and that no repairs are necessary at this point.
2. Do not replace any components for this condition because doing so will not resolve the customer's concern.
3. Create a PSS record in the PSS application via the hyperlink in Accessaudi.com (Figure 2) or Technical Assistance page in Elsa (Figure 3).

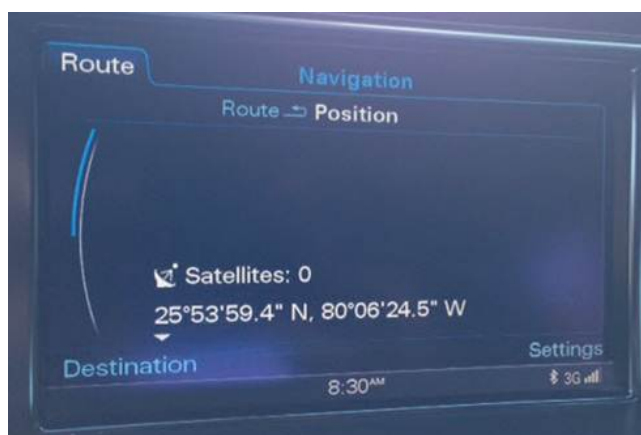
Figure 4. Number of satellites received.

3. To view the number of satellites being received, go to *Nav >> Route >> Current Position (first item in list) >> Scroll up* (Figure 4). If the system does *not* locate the vehicle during this timeframe or does not receive any satellites, this PSS does not apply. Proceed with standard diagnosis.
