# Technical Service Bulletin

## 91 Front TopView camera cannot be calibrated; picture appears upside down

91 13 16 2035912/1 November 27, 2013.

Model(s)	Year	VIN Range	Vehicle-Specific Equipment
A6/A7	2013-2014	Not Applicable	Top View / Corner View Camera System
A8	2013-2014	Not Applicable	Top View Camera System

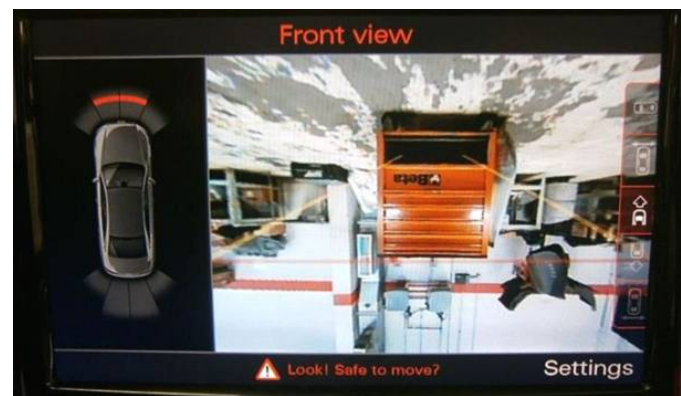
After the camera control module, J928, has been replaced, the front image is upside down and cannot be changed (Figure 1). The calibration cannot be completed.

Figure 1. Upside down image.

The coding of the camera control module is not completed correctly.

1. Using ODIS, enter binary coding of the J928 control module:

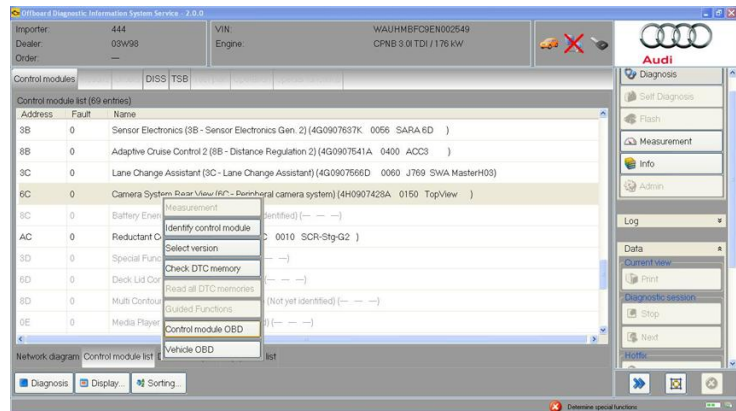
Figure 2. Selecting Control module OBD.

- a. Right-click on the 6C module, then select *Control module OBD* (Figure 2).

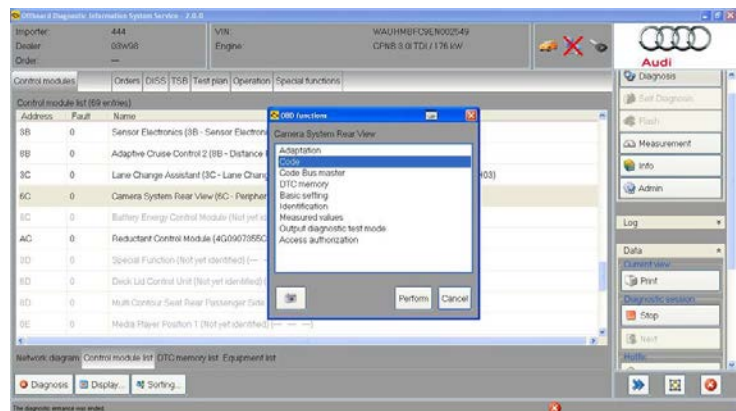
Figure 3. Selecting Code.

- b. Choose *Code* from the menu (Figure 3). The tester will state that the operation failed. Click past this warning message and proceed.

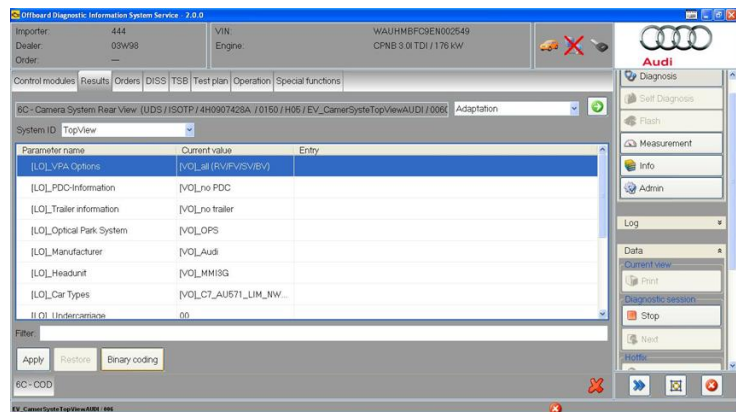
Figure 4. Binary Coding button at bottom of screen.

- c. Click the *Binary Coding* button at the bottom of the screen (Figure 4).

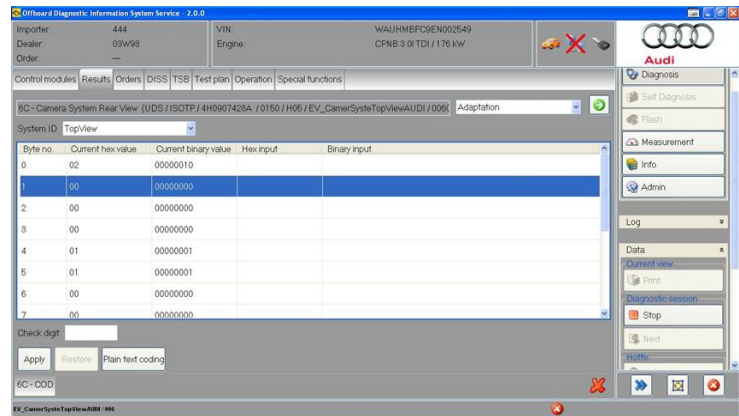
Figure 5. Current value of Byte 1.

2. Read the value of Byte 1 in the *Current hex value* column (Figure 5). Record this number for future use.

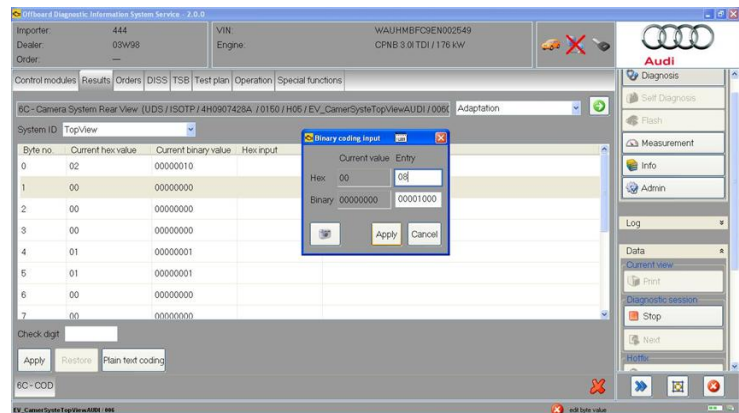
Figure 6. New HEX value entered. Click Apply button.

3. Click on the *Hex input* column next to Byte 1 and change the value based on the following list:
  - A6/A7: Change value to HEX 08
  - A8 MY2011-2013: Change value to HEX 02
  - A8 MY 2014+: Change value to HEX 13
4. Apply the value (Figure 6).

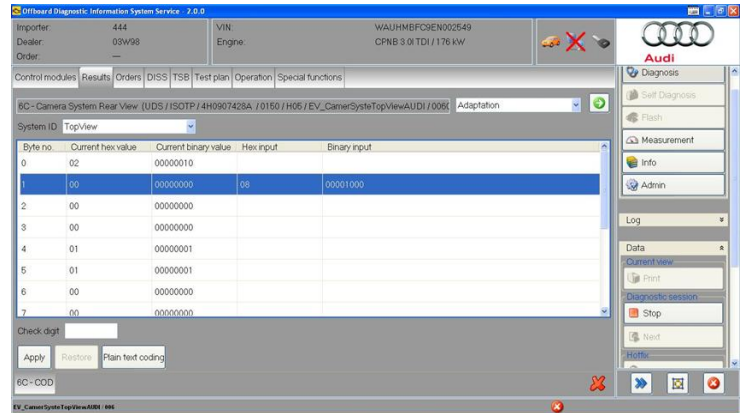
**Figure 7.** New HEX value entered. Click *Apply* button.

5. Choose *Apply* again (Figure 7).

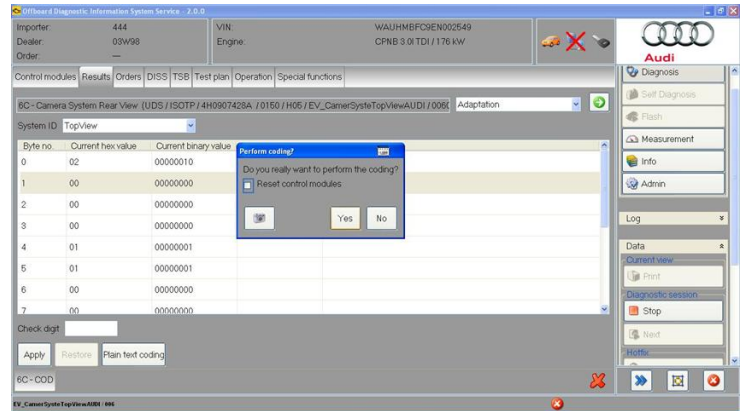
**Figure 8.** Uncheck ‘Reset control modules’. Perform the coding.

6. On the confirmation page, uncheck the option to *Reset control modules*. Select “Yes” (Figure 8). Two more errors will appear, stating that the values cannot be checked, and that the read operation failed. Click past these errors and the new coding value will now be in byte 1.

7. Repeat steps 3 – 6, but instead change Byte 1 back to the original value written down in Step 2. In Step 6, again uncheck *Reset control modules* when applying the coding.
