Technical Service Bulletin

PSS 91 MMI3G+ Google Earth will not load (Zug 566)

91 13 72 2032849/1 January 25, 2013.

Model(s)	Year	VIN Range	Vehicle-Specific Equipment
A8	2011-2013	All	MMI 3G+ with Audi Connect
A6/A7	2012-2013		
Q7	2012-2013		
A4/A5/Q5	2013

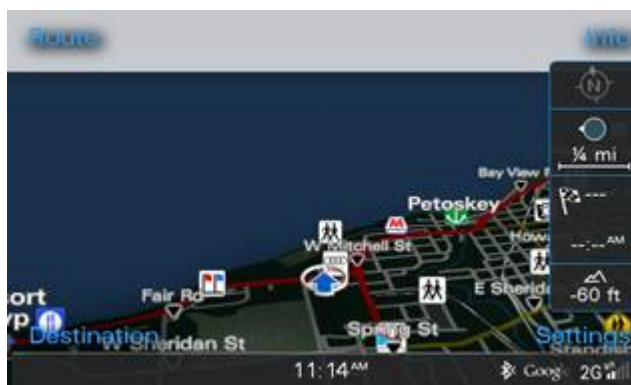
The Google Earth map will not load. The display shows an active data connection, and "Google" is almost fully white (Figure 1).

Figure 1. Google Earth will not load.

Certain Audi Connect partner carriers are transmitting data that is not supported by the MMI. The data disrupts the loading process of Google Earth and causes it to not load completely.

1. Explain to the customer that a solution is forthcoming and that no repairs are necessary at this point. Do not replace any components for this condition since this will not resolve the customer's concern.
2. Create a PSS record in the PSS application via the hyperlink in Accessaudi.com (Figure 3) or Technical Assistance page in Elsa (Figure 4).

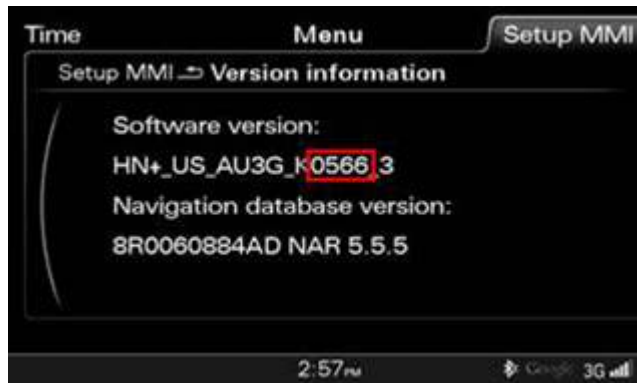
- The vehicle has MMI software 0566 installed (Figure 2). This can be located under *Menu >> Setup MMI >> Version information*.

Figure 2. Location of MMI software level.
